# **Del Mar Bluffs Stabilization Project 2 – Preserving Trackbed Support**

## **Evaluation of Existing Seawalls**

Submitted to:  
**North County Transit District**  
810 Mission Avenue  
Oceanside, CA 92054

June 18, 2004

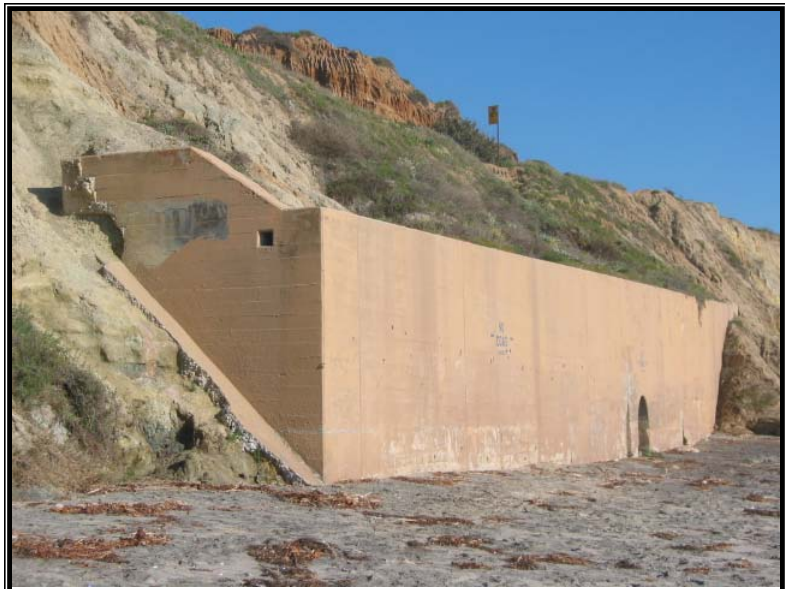
**Figure 2. Gravity Wall at Anderson Canyon (BR 245.4)**

The overall condition of the wall appears very good. No major cracks exist except for those due to thermal effects at vertical control joints. Calculations show the wall to be adequately stable for both sliding and overturning. Bearing pressure under the toe of the wall is high, but it is assumed that an aggregate slurry exists beneath the wall which is much stronger than typical soil. The assumed presence of an aggregate slurry is based on the fact that aggregate slurry is visible beneath the wall at BR 245.16 and construction methods are likely similar for both walls. Since the backfill soil rests at a steep angle it is unlikely that an increase in soil loading will occur.

Loss of soil foundation material is not evident along the face of the main wall, but some loss is evident along the base of the return wall. However, as it stands now, the soil loss at the return wall is not undermining the structural integrity. Because of this, along with its short length and short average height, it is reasonable to assume that loss of the return wall is not a highly probable event in the near future.

Based on the overall condition and projected time-based structural changes, calculations show that the wall will remain intact and will provide support to the bluff for the next 20 years.

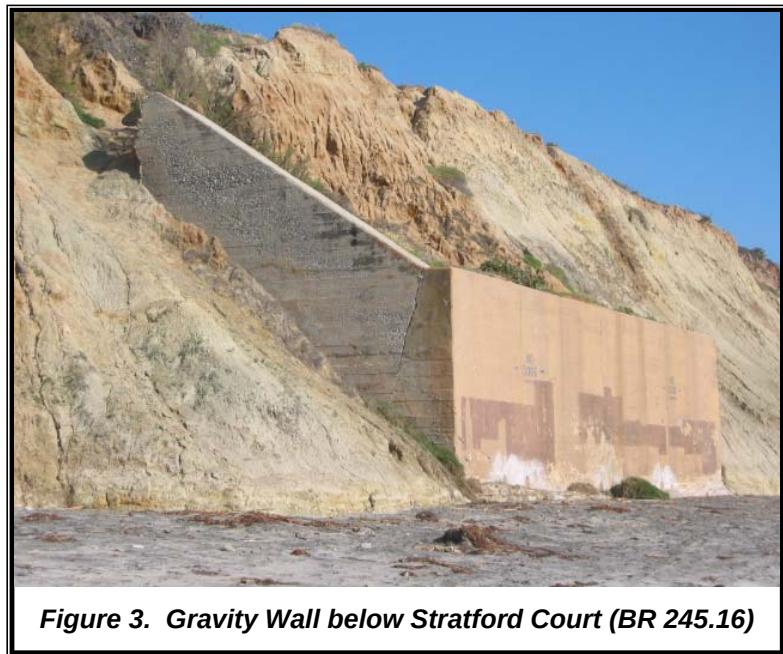
**Figure 3. Gravity Wall below Stratford Court (BR 245.16)**

Calculations for overturning and sliding show the Stratford Court wall to be currently stable. Like the Anderson Canyon wall this wall has high footing toe pressures, but the aggregate slurry is providing the required strength to resist these large pressures.

The overall condition of the wall is reasonable considering its age; however, there is a major crack (approximately 0.6" wide) at the interface between the main wall and return (Figure 4). This crack may be attributed to movement of the wall, thermal loads or a combination of both effects. A micrometer gauge was installed on the crack in 2002 by Leighton & Associates, and no displacement has been observed in the past year indicating that the wall is stable.

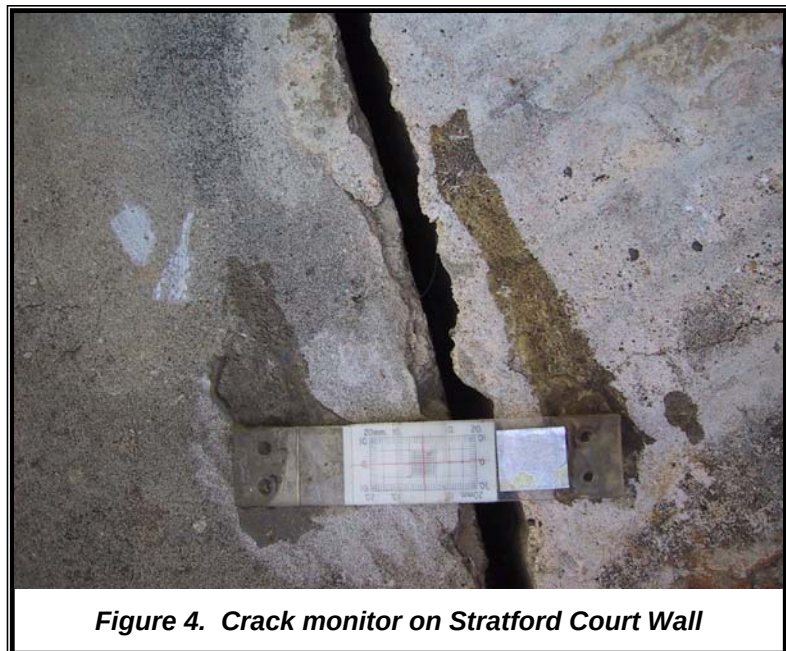
**Figure 4. Crack monitor on Stratford Court Wall**

An additional concern is soil loss at the foundation. Because the main portion of wall is founded on an aggregate slurry, soil loss around the foundation should not be a problem. Erosion

is evident at the foot of the return wall and if this progresses it could result in undermining of this portion of the wall. However, the bulk of the erosion seems to be directed out from the footing and not under it, so realistically the return wall foundation should not be compromised.

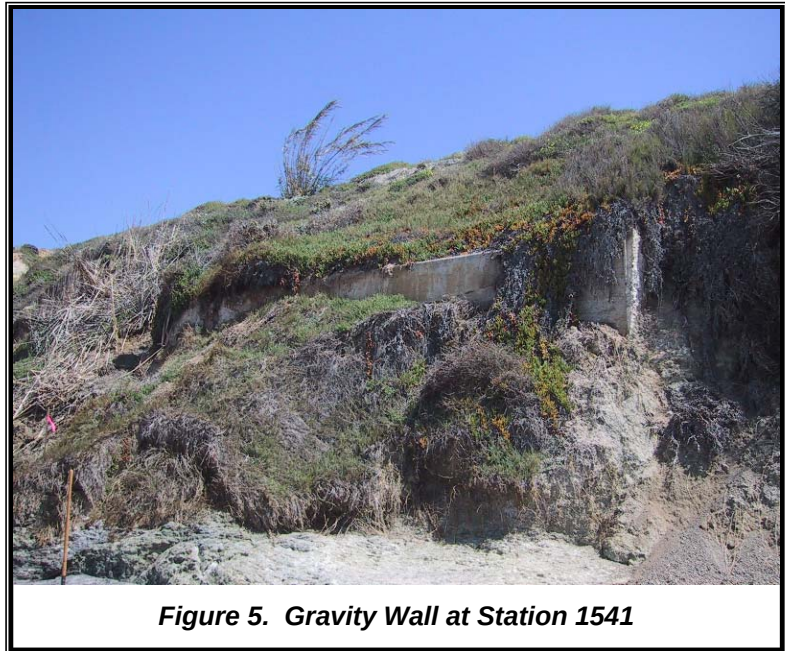
**Figure 5. Gravity Wall at Station 1541**

A large amount of soil exists in front of the wall, which requires an educated guess as to the wall height. Based on the distance from top of wall to the base of competent foundation material it appears that the wall height is 15 feet. This is within the same range as heights at Stratford Court and Anderson Canyon.

The soil in front of the wall will tend to protect the foundation from scour. The back slope has a fairly steep angle with a significant amount of vegetation so the possibility of additional soil loading is not high. Thus, this wall should last an additional 20 years without major problems.

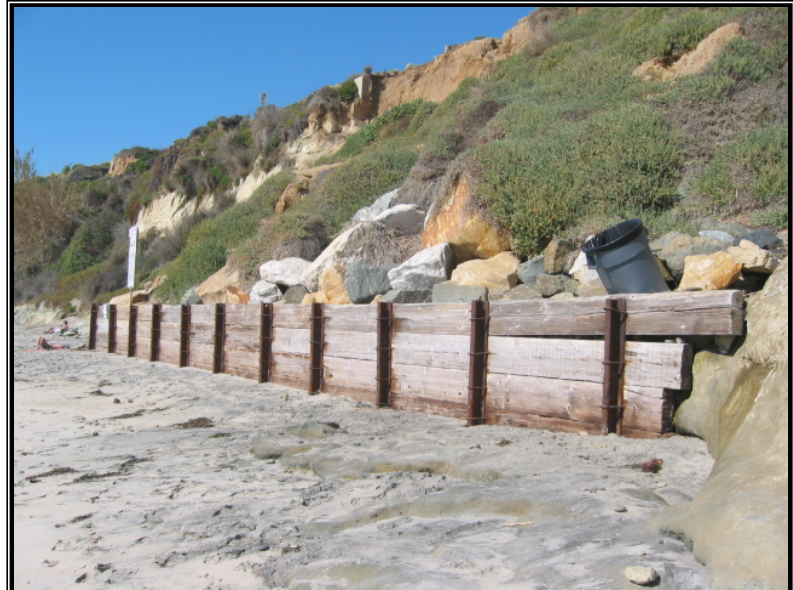
**Figure 8. Timber Wall at Station 1514**

As the rails have corroded their strength capacity has decreased. Assuming that the load demand on the rails will be constant for the next few decades, a chart of safety factor versus time has been created (see Appendix B). From this analysis a failure date in 2049 is projected for the rails, which demonstrates they will likely remain intact for at least the next 20 years.

The condition of the wood timber is good when compared to the older timber wall built in 1964 between 11<sup>th</sup> and 12<sup>th</sup> Street. Based on the 13-year difference between these walls, the projected condition of the timber in 20 years will probably be poor, but intact.

Because the wall is not very tall the soil loading is low, which indirectly benefits the longevity of this wall. The assumption that the load is not expected to change over time is based on the backfill soil's steep angle which won't allow much additional soil to build up. Thus, based on the expected rate of deterioration of the wall over time it should remain sound for the next 20 years.

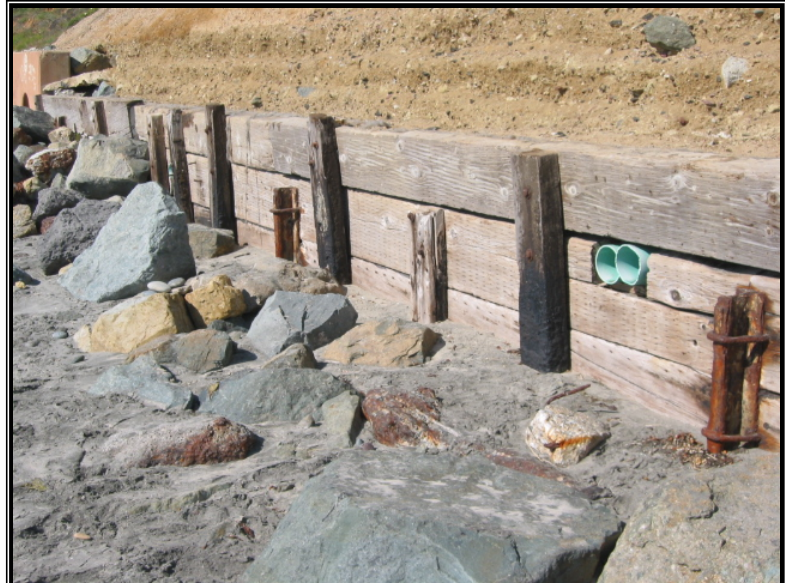
**Figure 9. Timber Wall at Twelfth Street**

At present the wall has 2 feet of cover in the form of sand and rip-rap in front. The presence of rip-rap will help maintain this cover over time, but it can't be completely counted on. One concern is that the as-built plans illustrate the concrete post hole extending only 4 feet deep. Calculations showed this to be an inadequate length if the cover is removed, which immediately lends doubt to the integrity of the wall over the next 20 years.

Because of their age the rails have already seen a high amount of corrosion and diminished strength capacity. Calculations project the rail to fail in 2022 or 18 years from now, which further demonstrates the inadequacy of this wall over time.

The condition of the wood is poor. The timber height extension which was placed 20 years ago has already failed in one section at the south end. Moreover, these extensions are held to the main wall with timber vertical posts that are in very poor condition. These extensions are allowing large deflections which are especially noticeable near the north end of the wall.

From the standpoint of foundation integrity, rail corrosion, and wood deterioration this wall will not provide the required reliability to last the next 20 years. More than likely the first mode of failure will be the loss of the timber extension over an extended period of time. The failure of the foundation is linked to the rather erratic loss of beach sand, while corrosion of the rail is a steady process that will eventually compromise the entire system.

The timber wall at Twelfth Street is showing significant signs of distress and will require maintenance to survive an additional two decades. The wall extension built in 1981 has already failed in some locations and is deflecting considerably along the majority of its length. The primary weakness of the extension is the timber vertical support members. The likely minimum corrective measure for this wall would be the replacement of these members with new pressure-treated timber or steel sections. This would stabilize the uppermost portion of the wall.

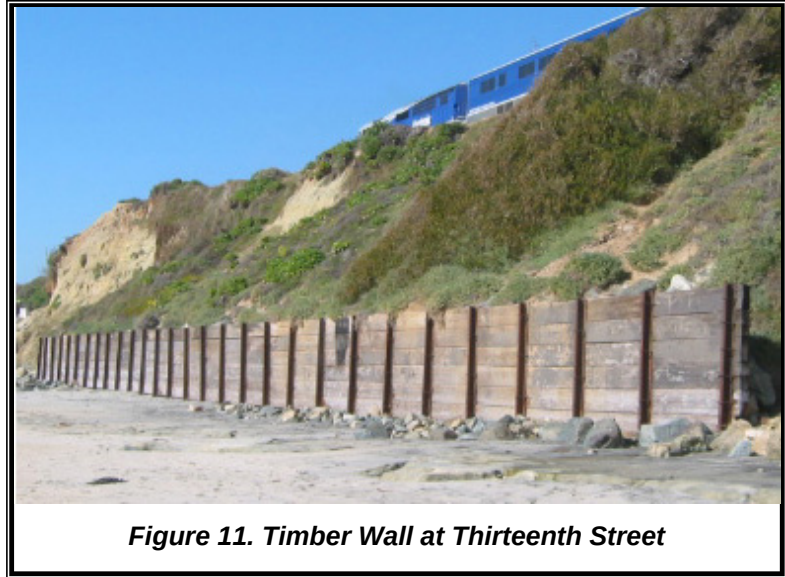
**Figure 11. Timber Wall at Thirteenth Street**

to assume that the foundation is performing satisfactorily. There is a small gap between the formational base and the bottom horizontal timber which could allow sea water to scour the backfill during seasons where the level of beach sand is low enough to expose this opening.

The materials are showing signs of aging. As would be expected corrosion is slowly degrading the strength capacity of the rails. However, the projected failure date of the rails is 2051, which suggests they will perform well through the next 20 years. The timber is holding up adequately. Though the wood is likely to degrade to a poor state over the next 20 years, it should not have any significant problems.

The one concern for this wall is a significant lateral deflection of 5 inches at the top of wall that occurs over about 40 feet of the wall length. Calculations do not support that the deflection is a result of a typical amount of soil loading deflecting the rail. One possible cause may be that a small landslide has occurred since the wall has been standing. The initial loading from the slide may have been much higher than a typical soil loading because of dynamic effects. The other possibility is that the foundation is poorly designed and is allowing a rotation at the base.

Though the deflection is a concern, it is not grounds for rejection. So based on its overall condition, as well as the low probability of higher future soil loading, this wall should perform well for the next 20 years.
