DEL MAR BLUFFS STABILIZATION
PROJECT 2 – PRESERVING TRACKBED SUPPORT

**SUPPLEMENTAL GEOTECHNICAL EVALUATION
AND
DETERMINATION OF SITE SPECIFIC CONCEPTUAL REPAIR ALTERNATIVES**

Project No. 040151-009

June 2, 2003
(Revised November 5, 2003)

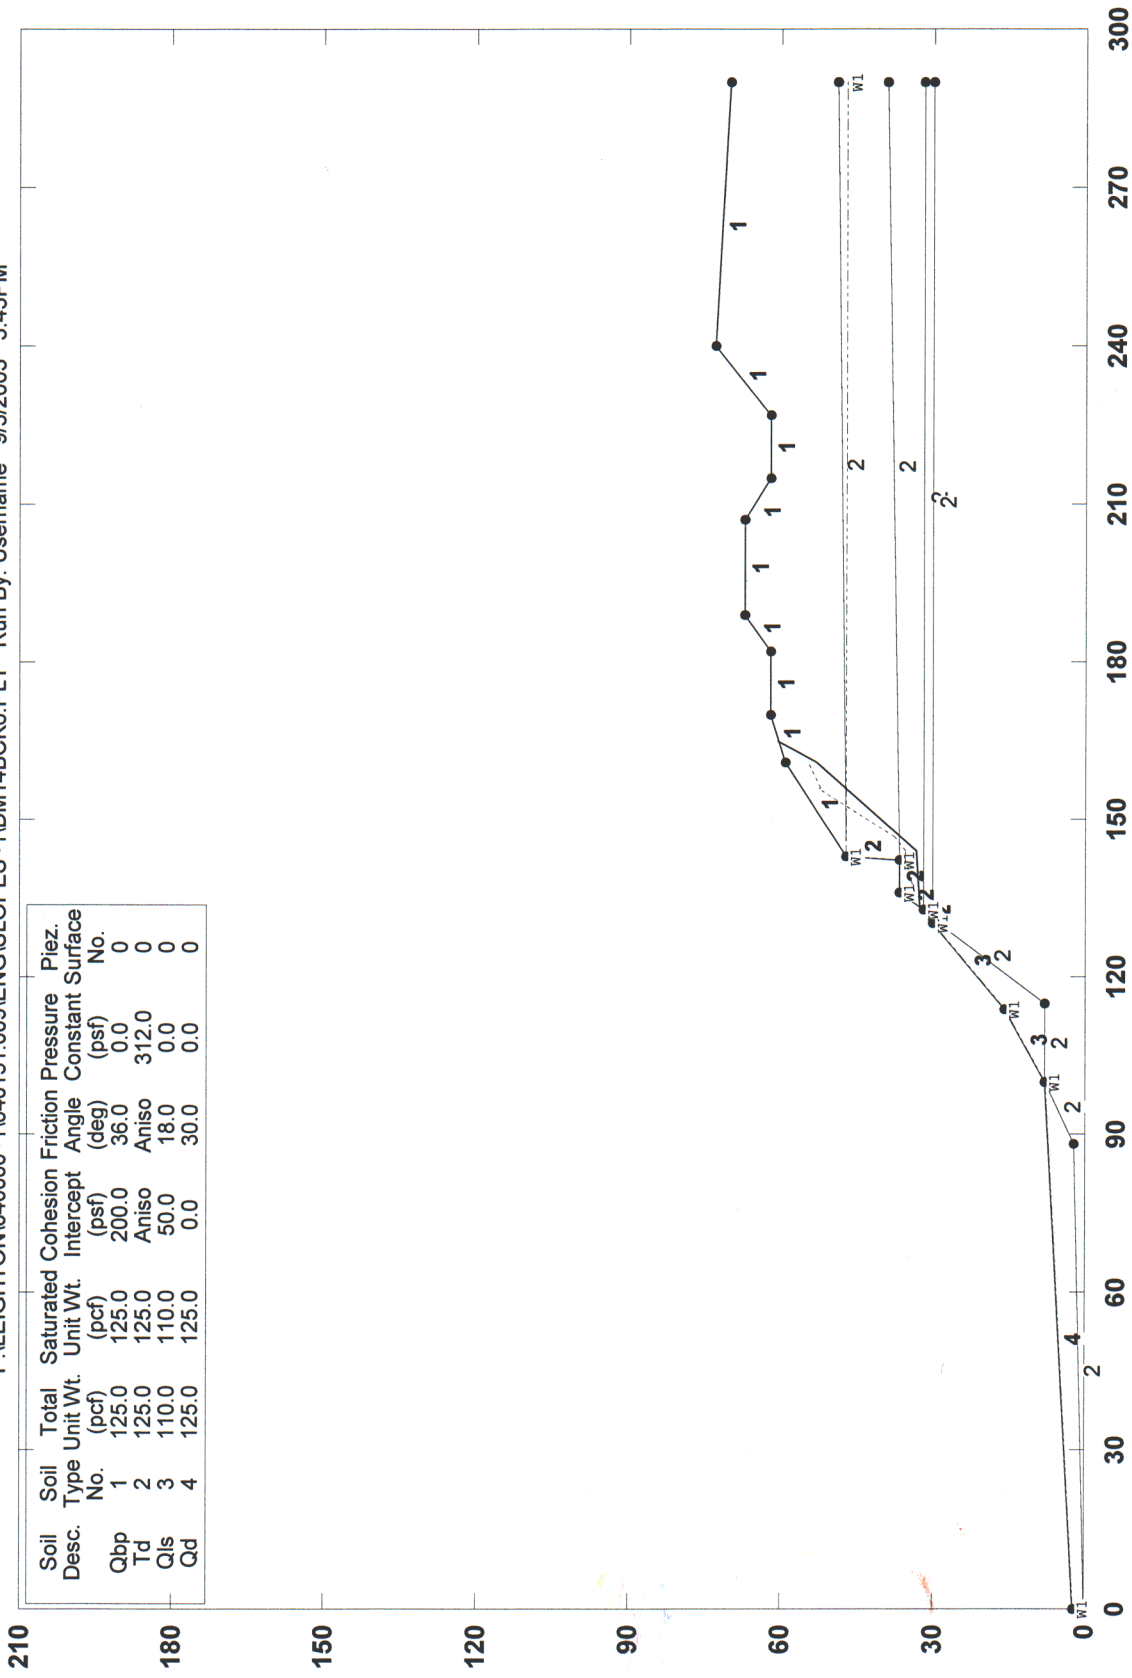
SECTION 14-14' (PREVIOUSLY H-H')
View north - M.P. 244.47 (STA. 1529+60)

GSTABL7 v.2 FSmin=1.07
Factor Of Safety Is Calculated By GLE (Spencer's) Method (0-2)

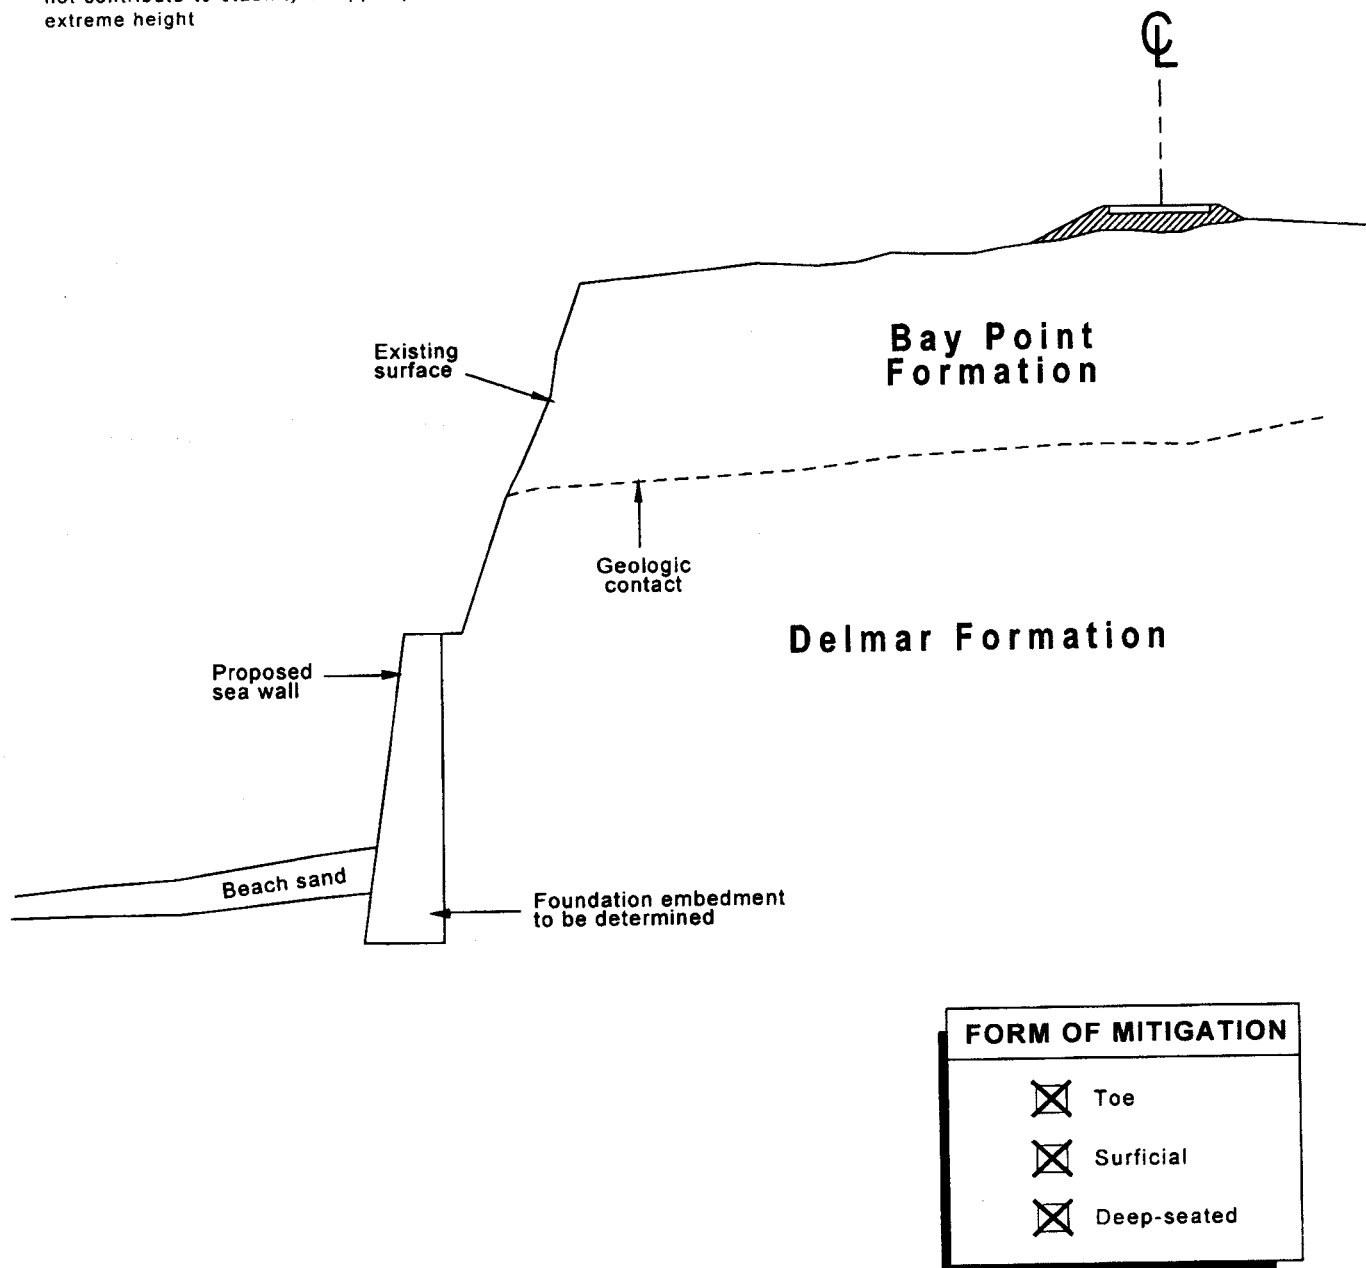
FIGURE 1: SEA WALL AT BLUFF TOE

Will improve or maintain factor of safety for deep seated stability at toe; will improve surficial stability at lower portion of bluff; may not contribute to stability of upper portion of bluff unless wall is of extreme height

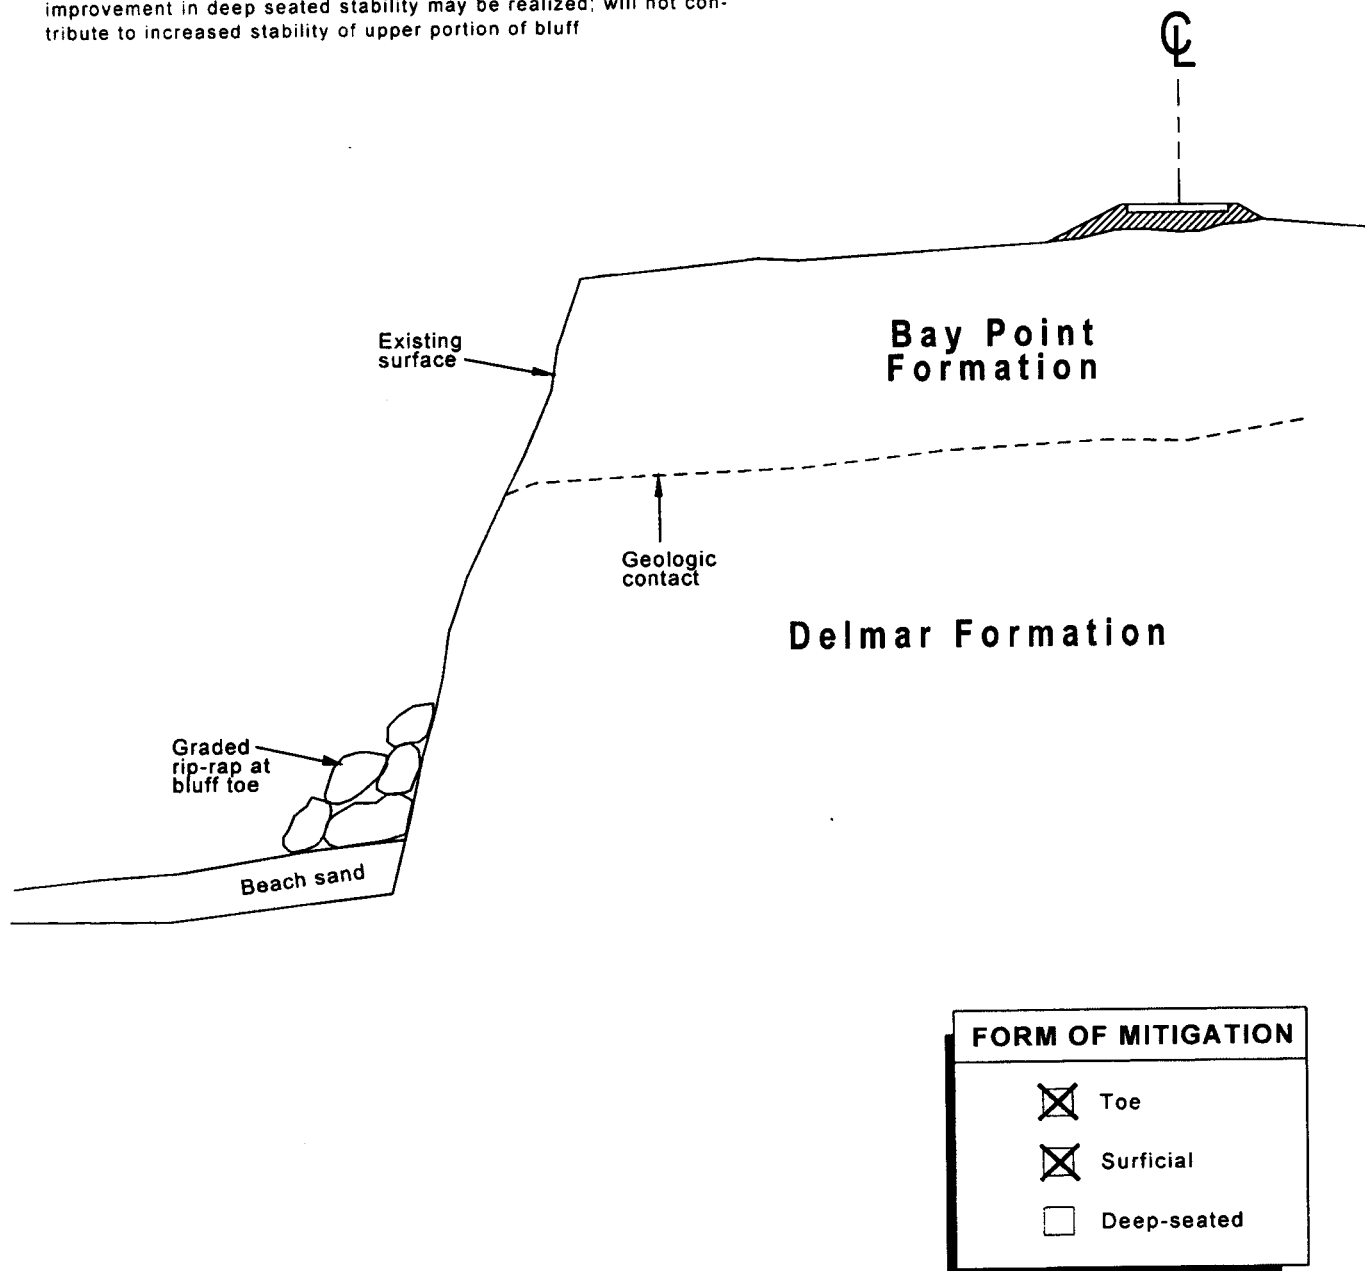
**FIGURE 2: ROCK REVETMENT
(RIP-RAP AT BLUFF TOE)**

Will increase surficial stability of toe area by reducing potential for continued erosion, with large amounts of rip-rap for a minor improvement in deep seated stability may be realized; will not contribute to increased stability of upper portion of bluff

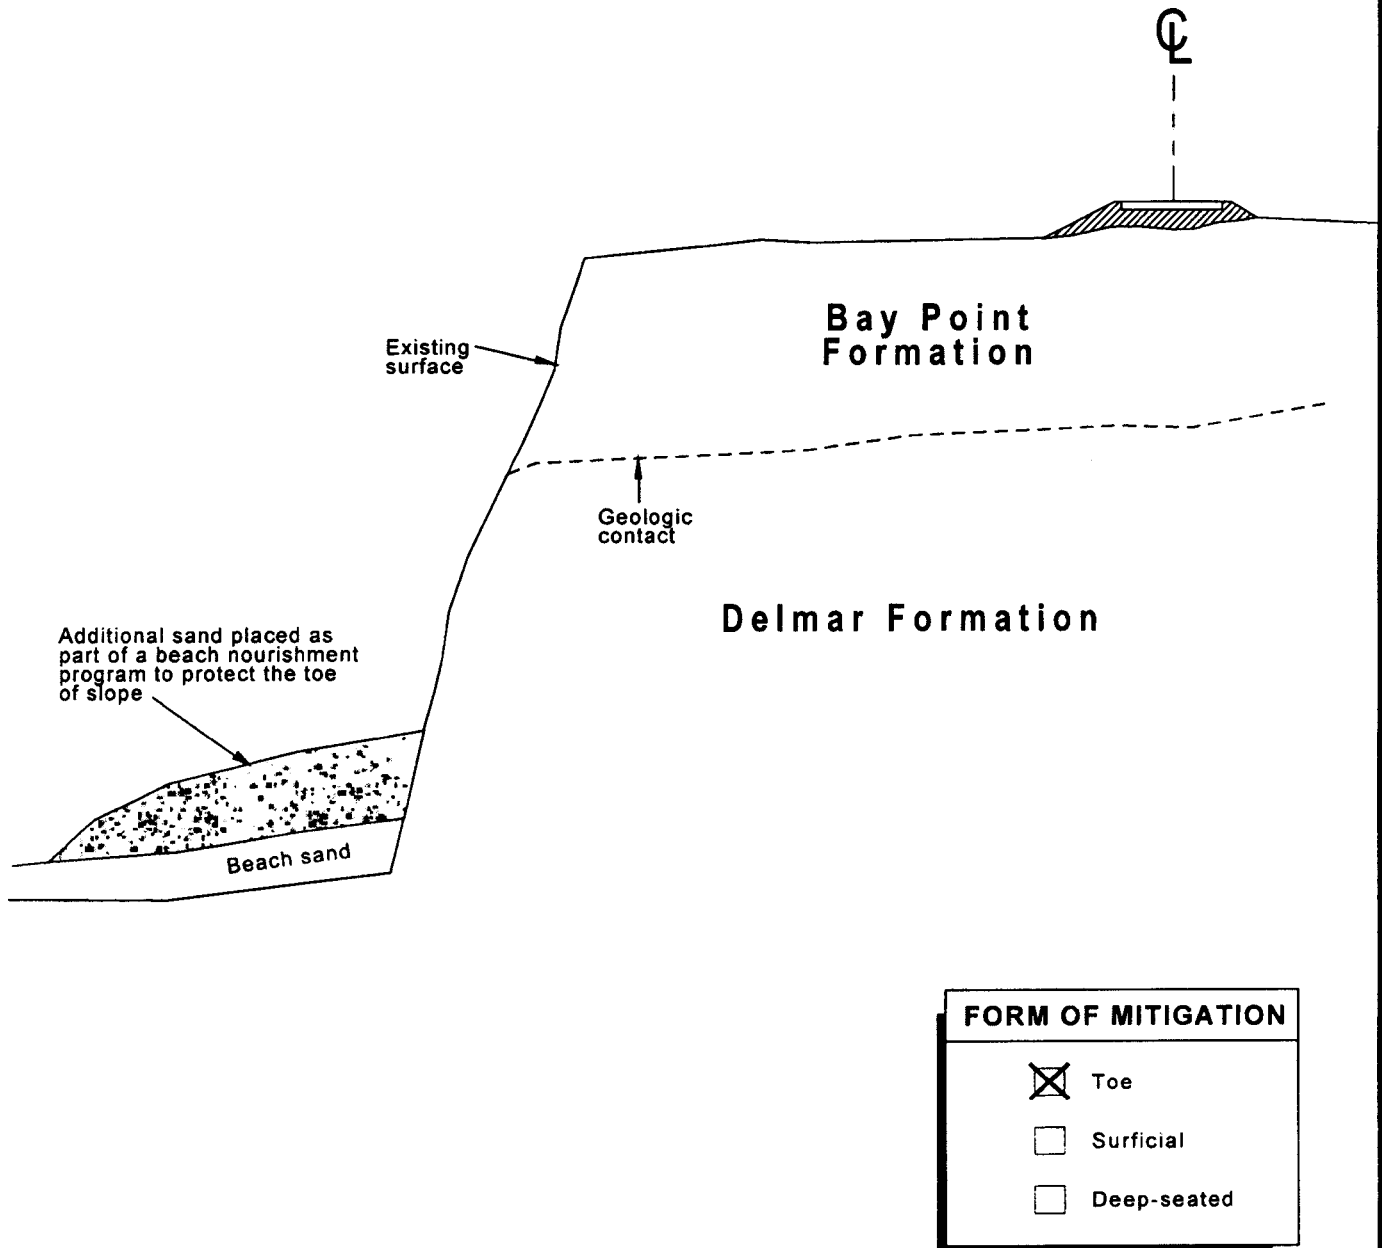
FIGURE 3: BEACH NOURISHMENT

Will add a buffer to erosion at toe; no measureable increase in factor of safety.

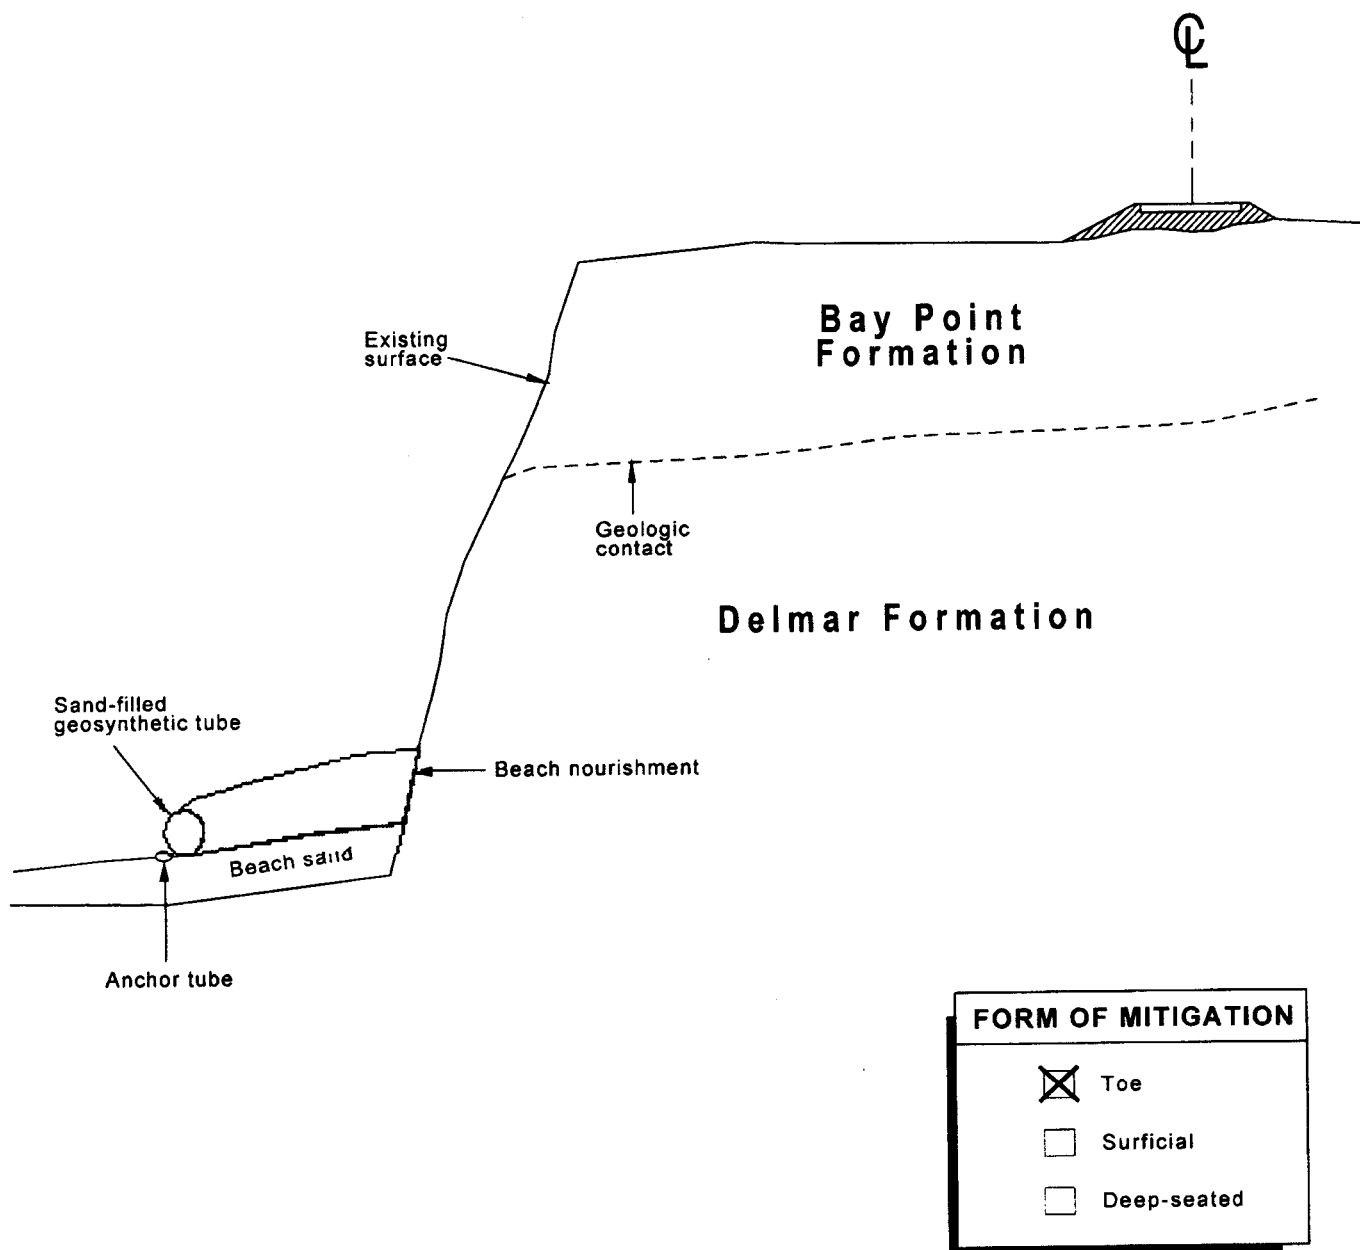
FIGURE 4: BEACH NOURISHMENT WITH GEOSYNTHETIC TUBE

Will reduce potential for erosion at toe; no measurable increase in factor of safety.

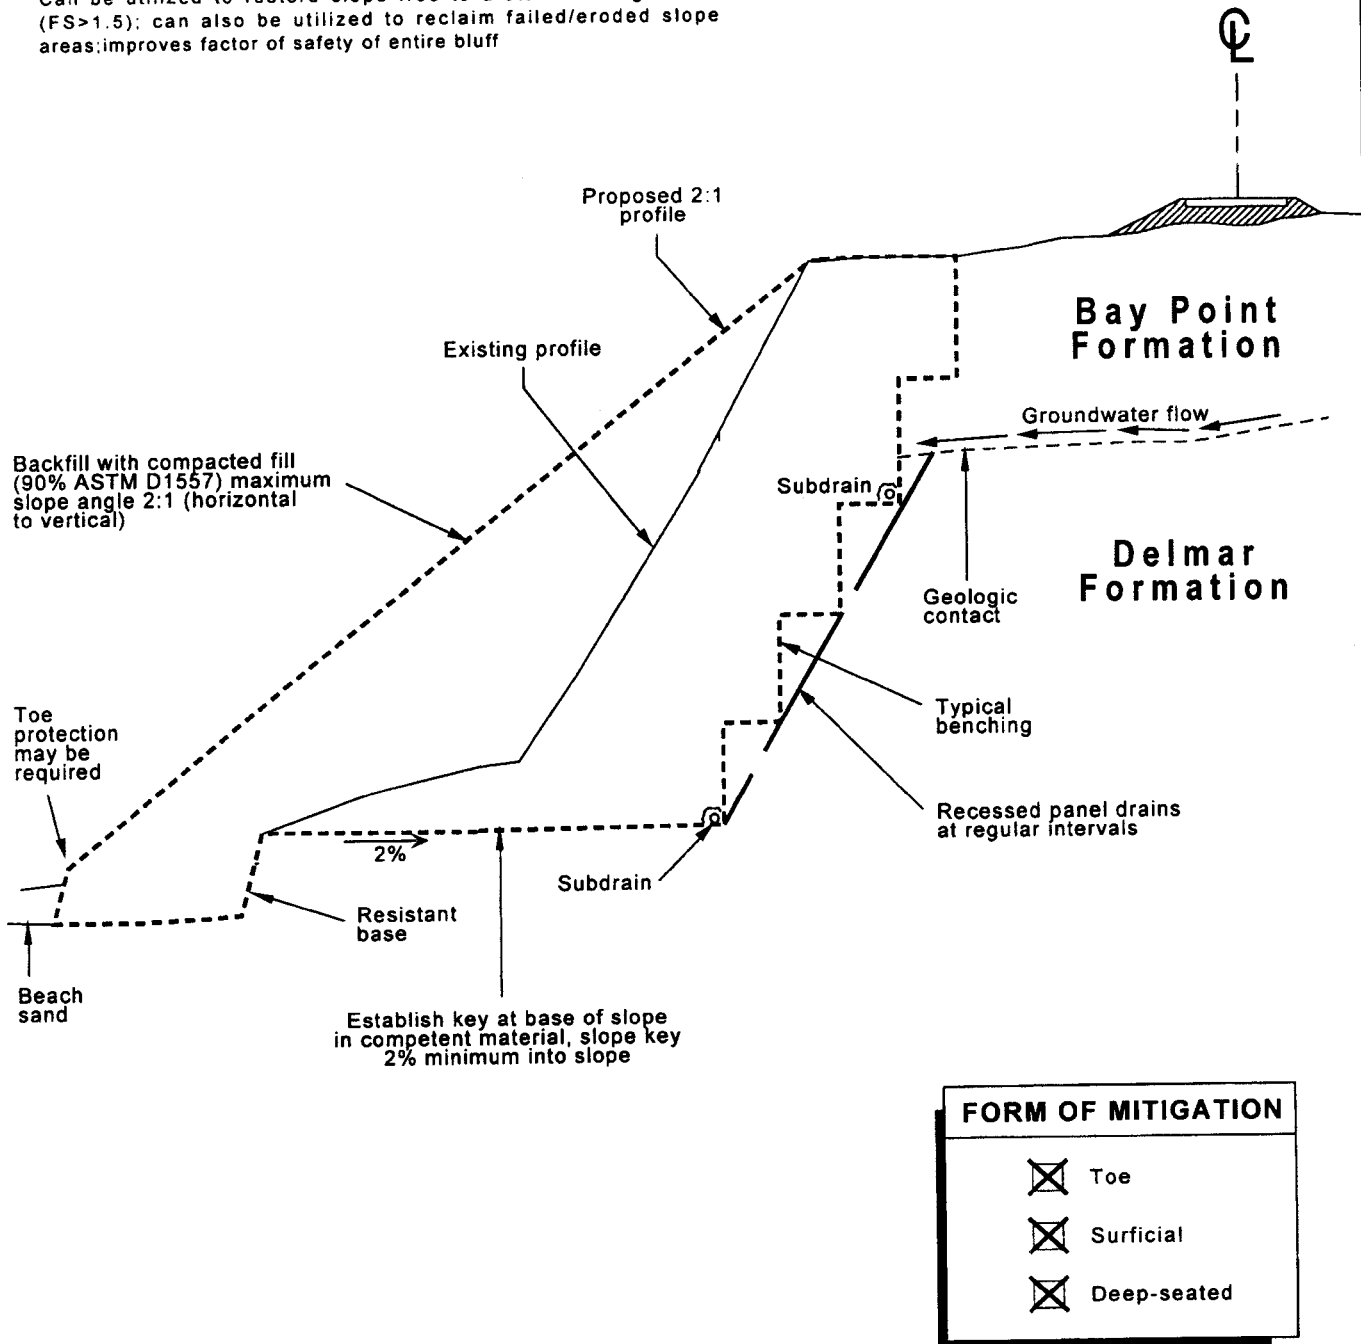
FIGURE 5: SLOPE GRADING

Can be utilized to restore slope free to a stable configuration ($FS > 1.5$); can also be utilized to reclaim failed/eroded slope areas; improves factor of safety of entire bluff

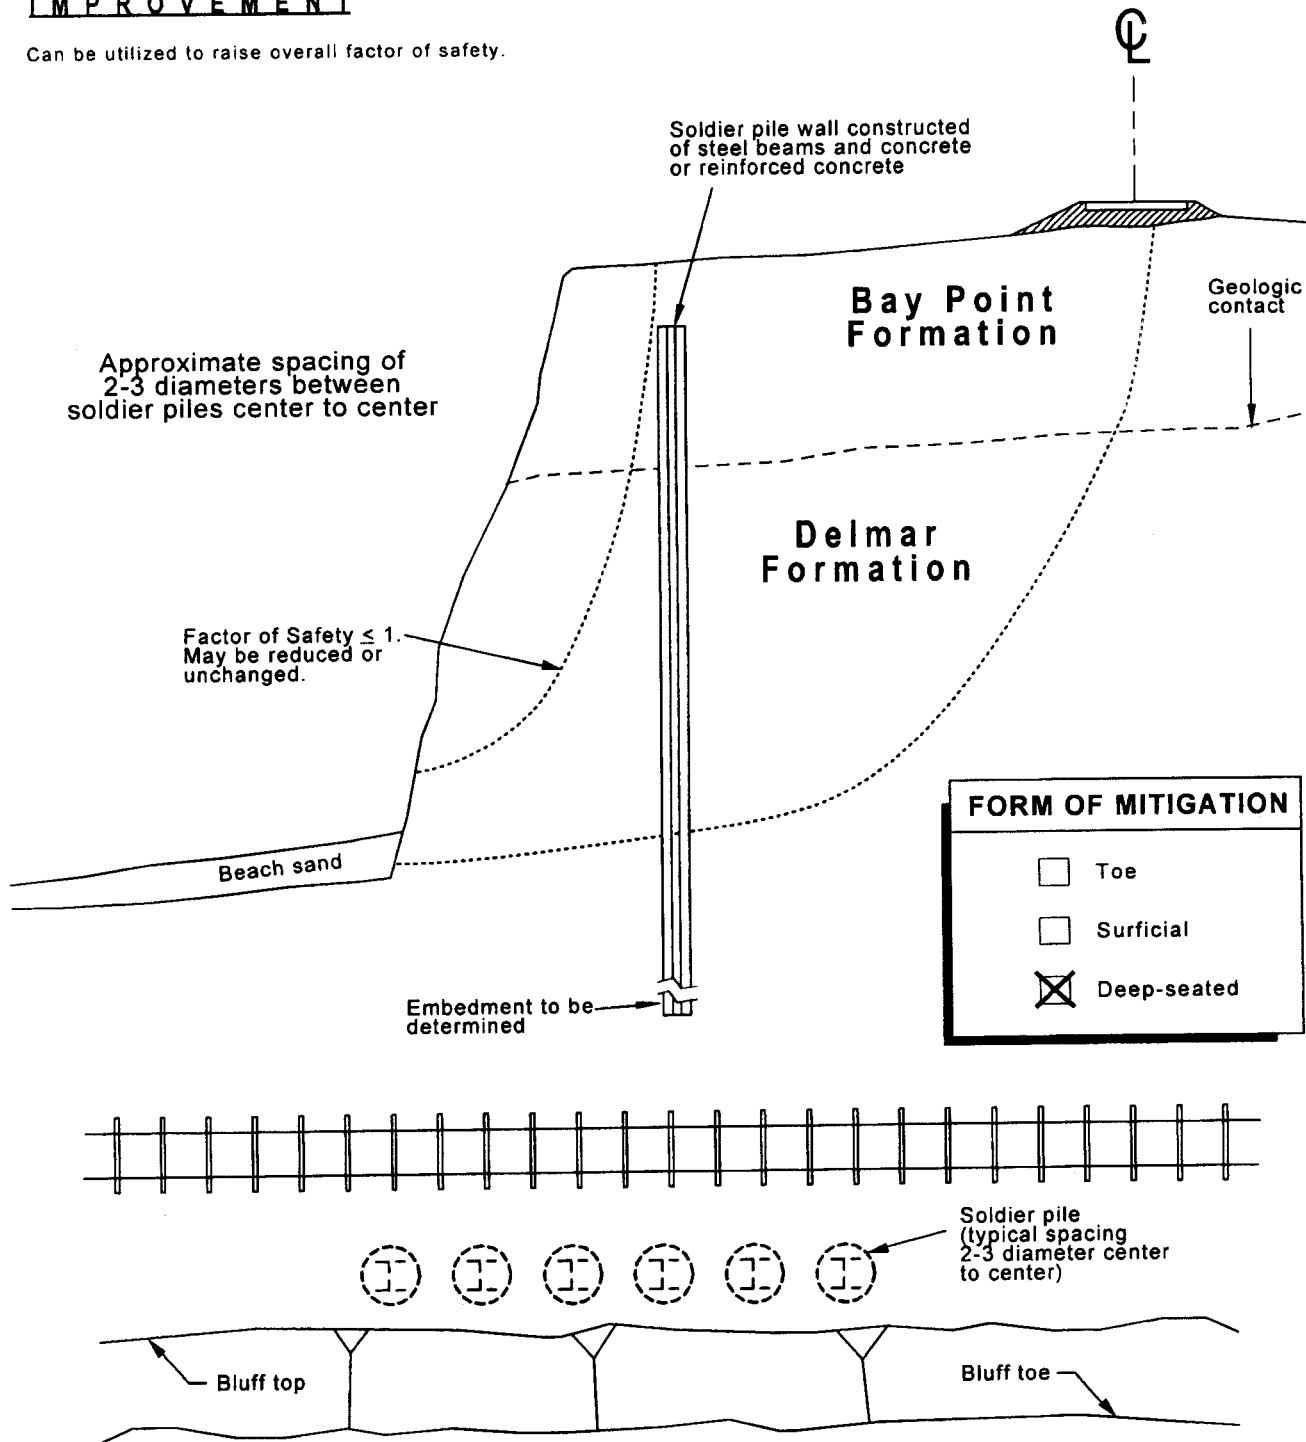
FIGURE 10: SOLDIER PILE STABILIZATION

Can be utilized to raise overall factor of safety.

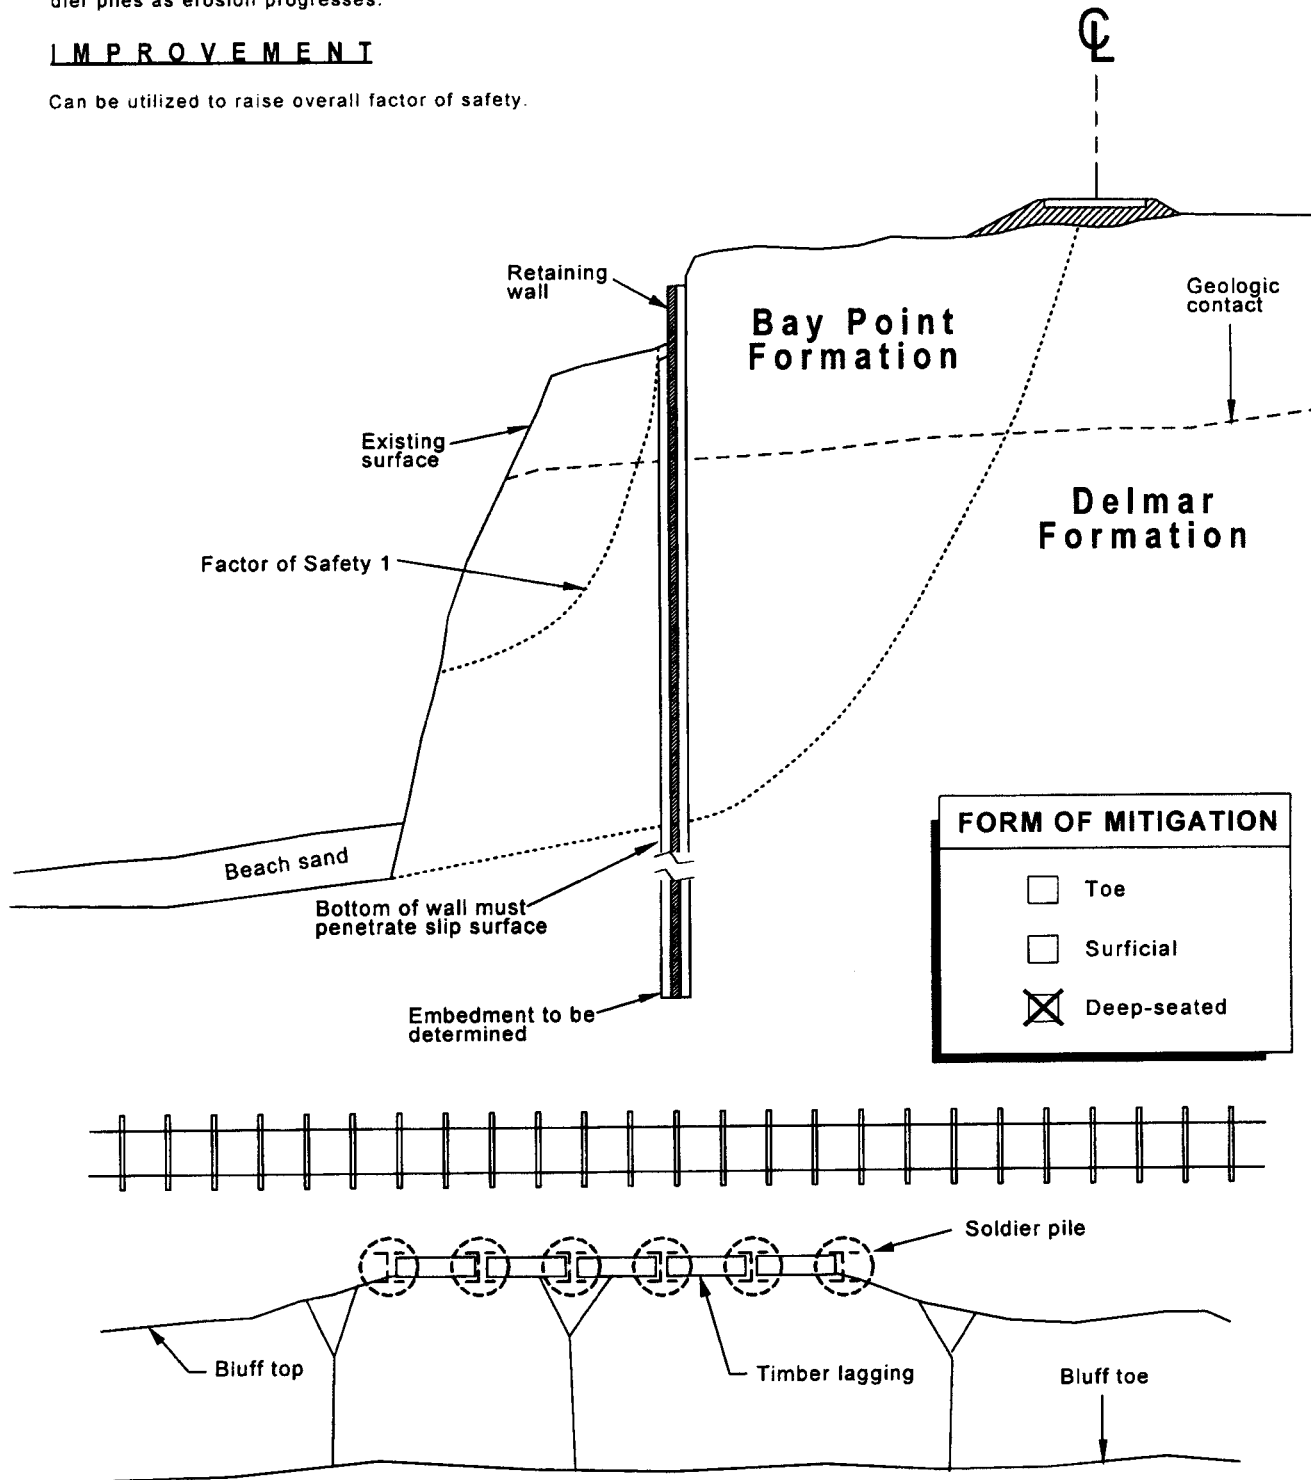
FIGURE 11: SOLDIER PILE WITH LAGGING

Can be utilized to raise overall factor of safety.

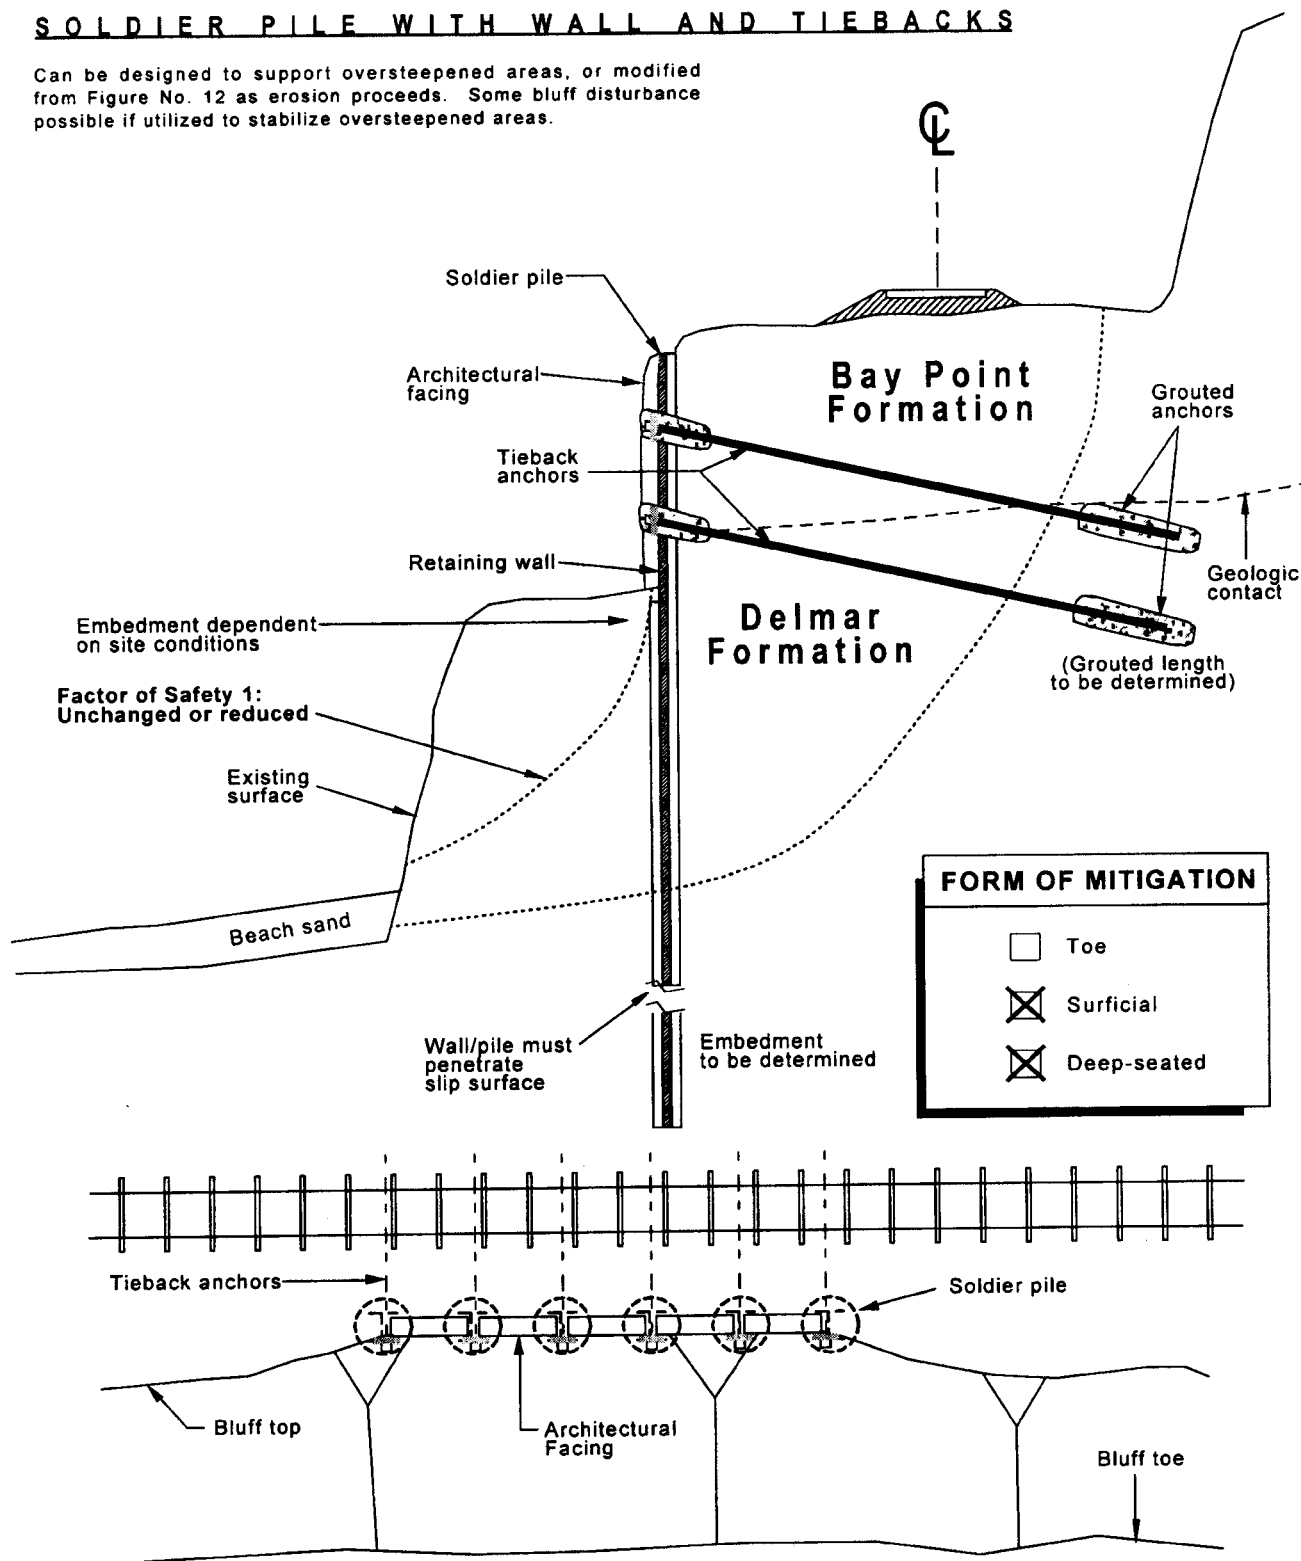
FIGURE 12: SOLDIER PILE WITH WALL AND TIEBACKS

Can be designed to support oversteepened areas, or modified from Figure No. 12 as erosion proceeds. Some bluff disturbance possible if utilized to stabilize oversteepened areas.

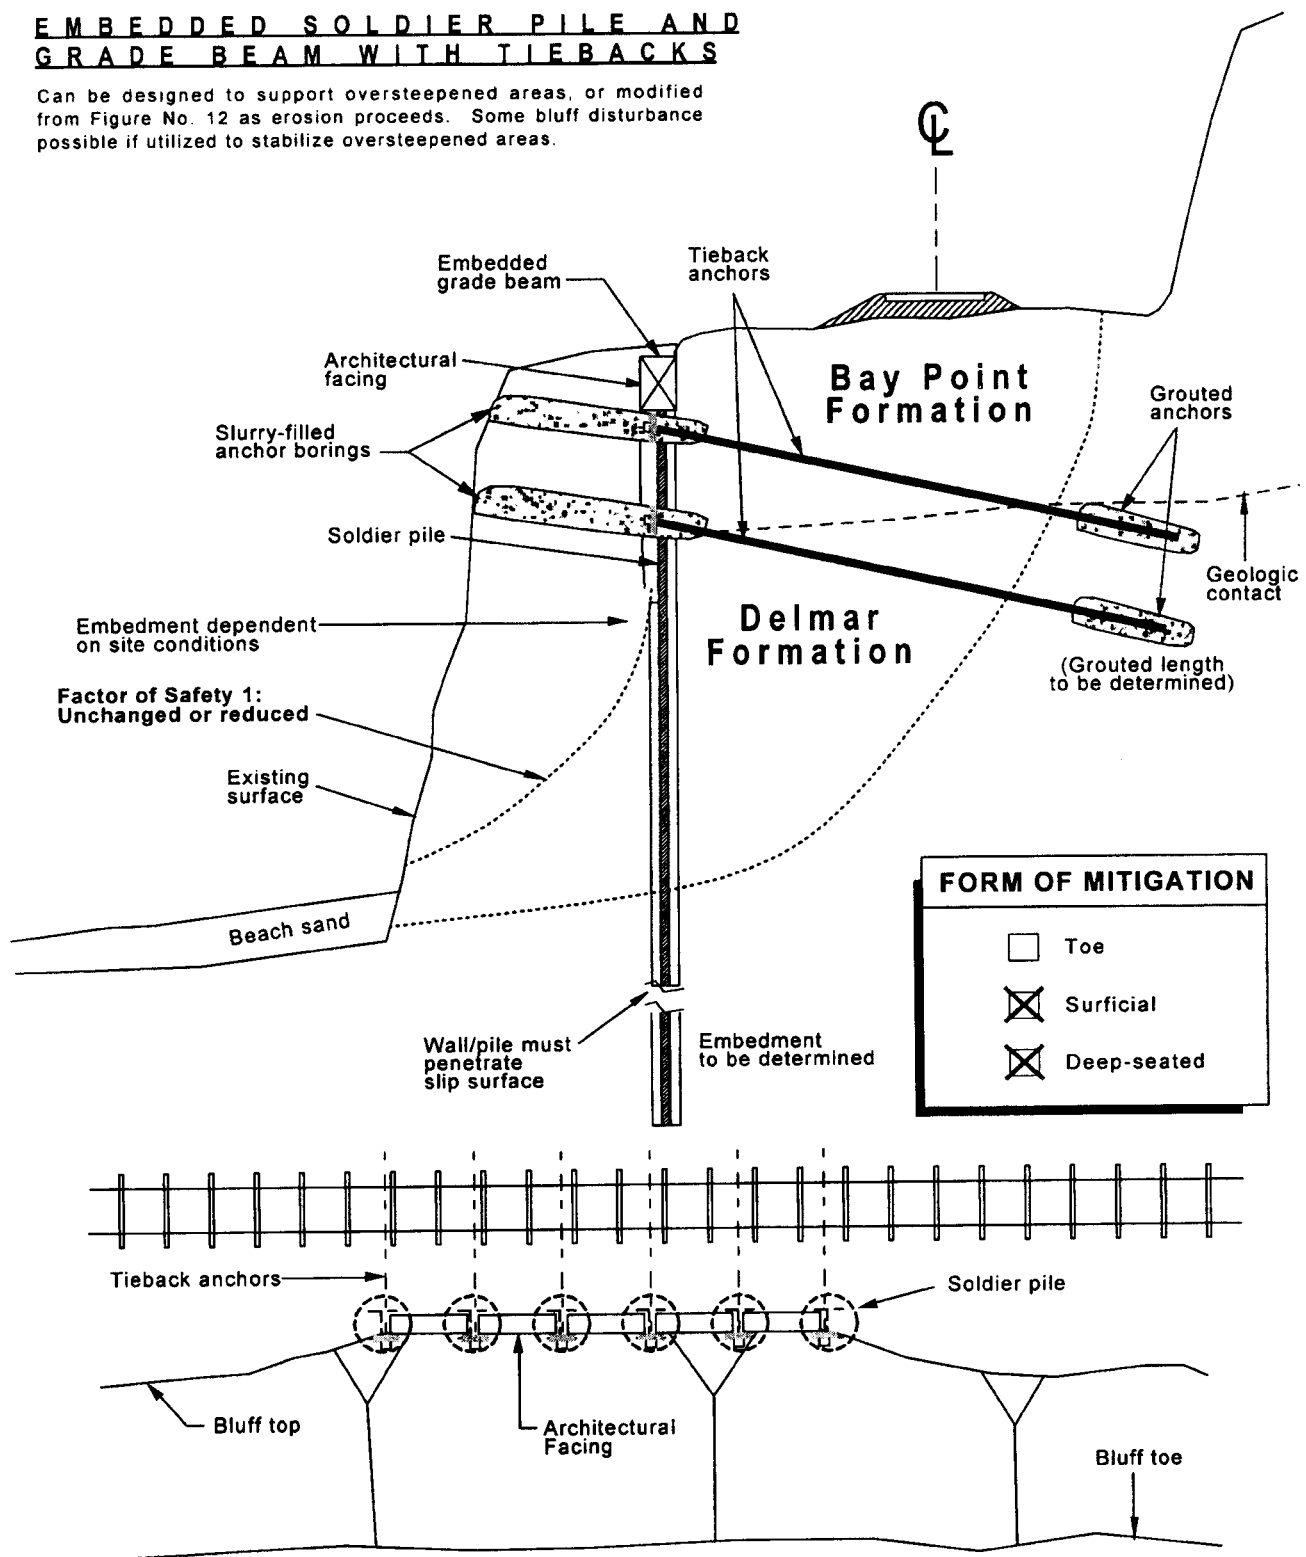
FIGURE 13: SOLDIER PILE WITH GRADE BEAM AND TIEBACKS

Can be designed to support oversteepened areas, or modified from Figure No. 12 as erosion proceeds. Some bluff disturbance possible if utilized to stabilize oversteepened areas.
