# **JURISDICTIONAL DELINEATION REPORT**

## **San Diego River Trail**

### **Carlton Oaks Golf Course Segment Project**

**January 2017**

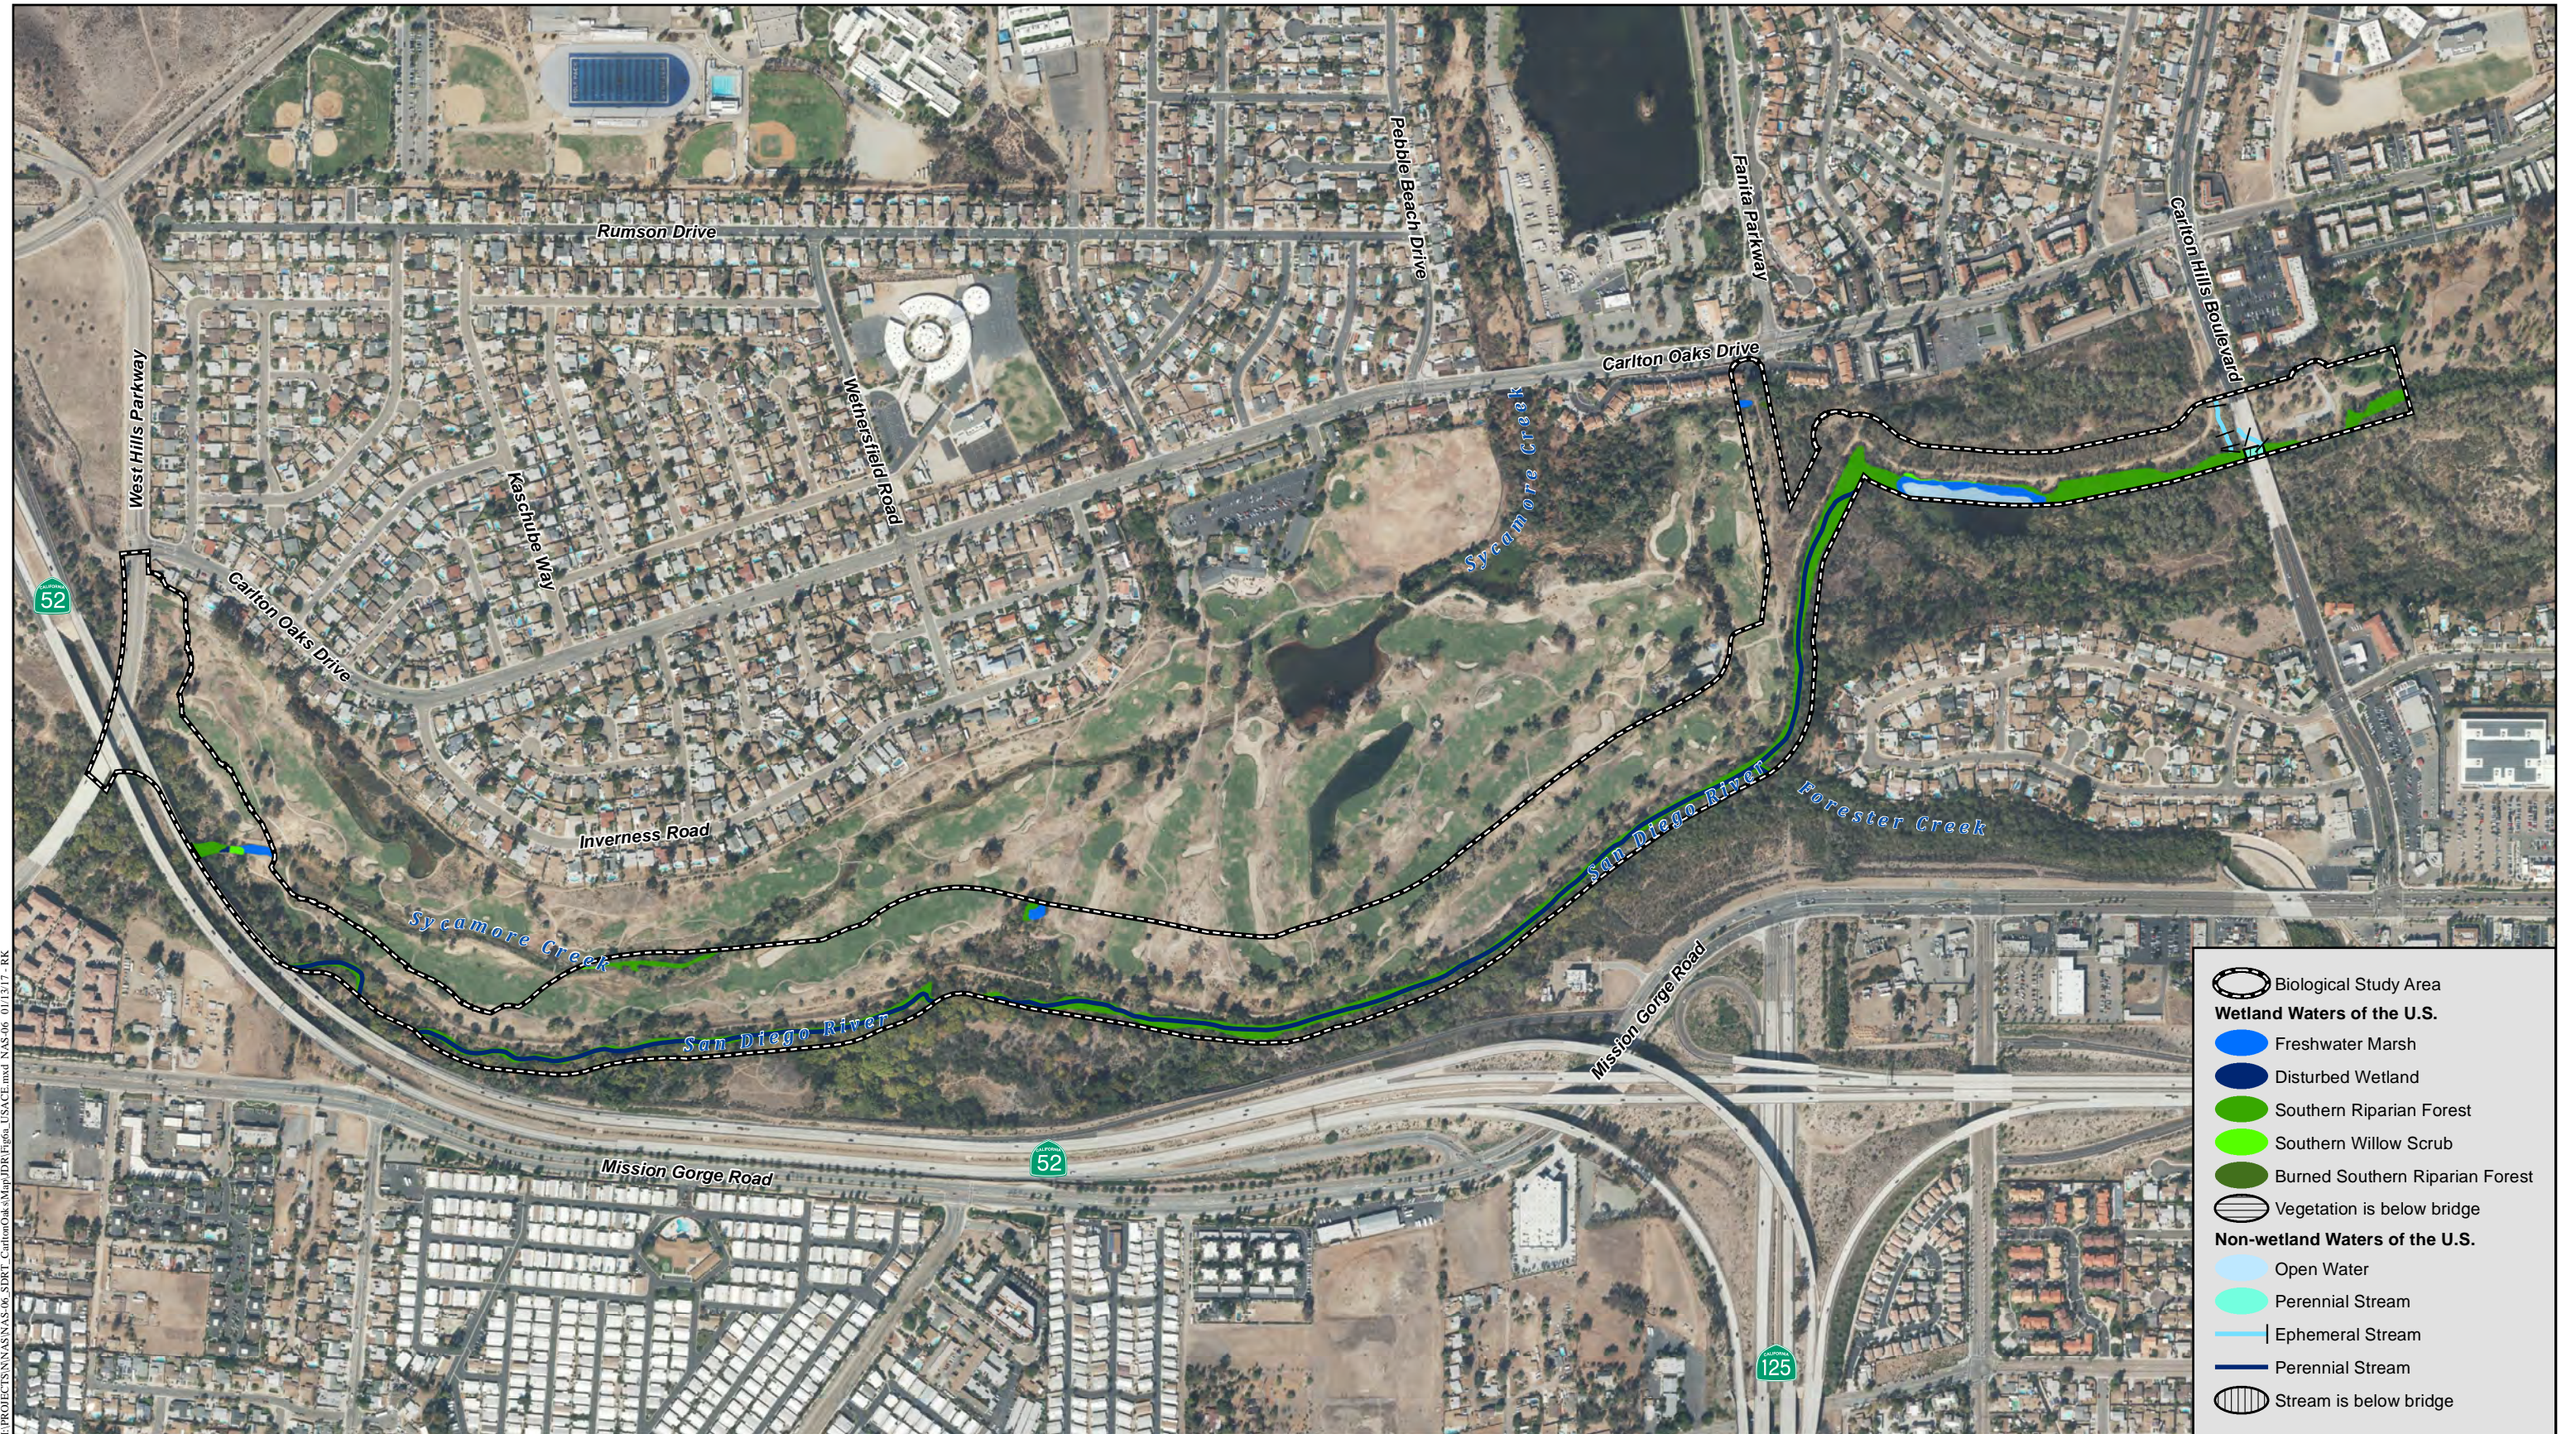
**Potential USACE Wetland and Non-wetland Waters of the U.S.**

Potential jurisdictional wetlands, habitats, and other resources observed in the BSA include southern riparian forest (including disturbed and burned), southern willow scrub, mule fat scrub, freshwater marsh, disturbed wetland, open water, and ephemeral and perennial streams. Depictions of resources within the BSA potentially subject to WUS and CDFW jurisdiction are presented in Figures 6a through 6e and 7a through 7e.

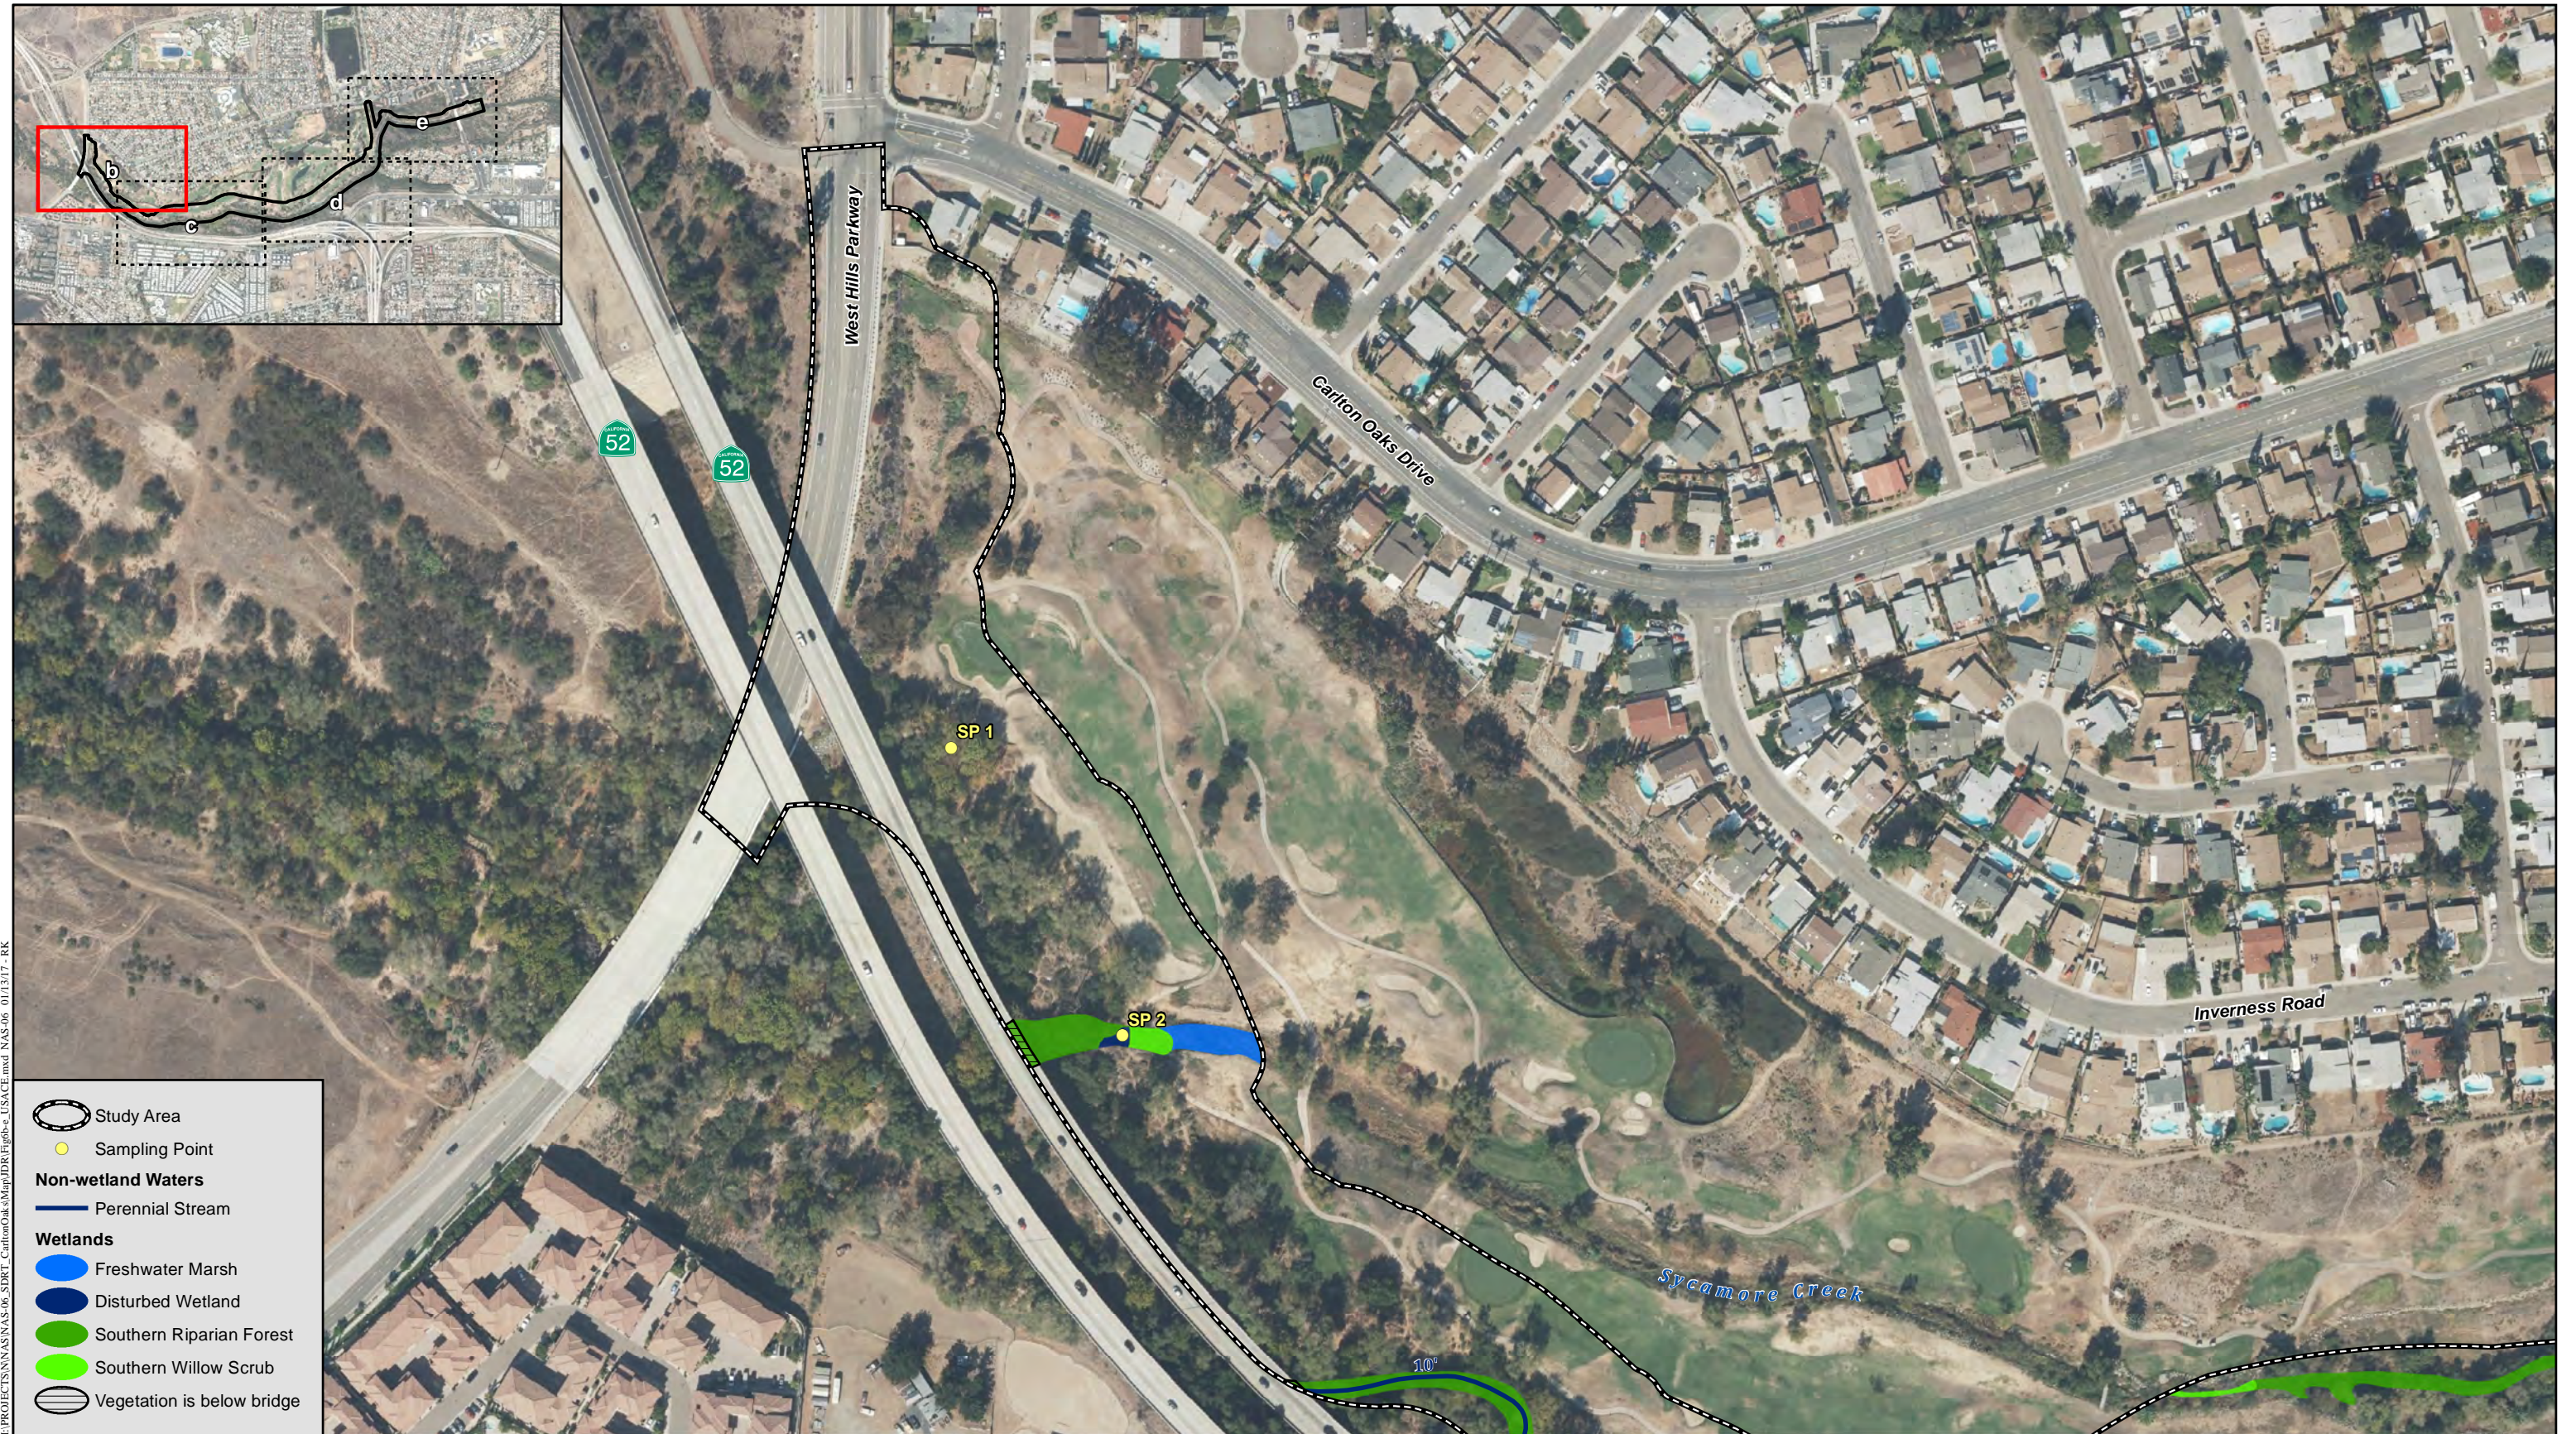
Figure 6b

**Potential USACE Wetland and Non-wetland Waters of the U.S.**

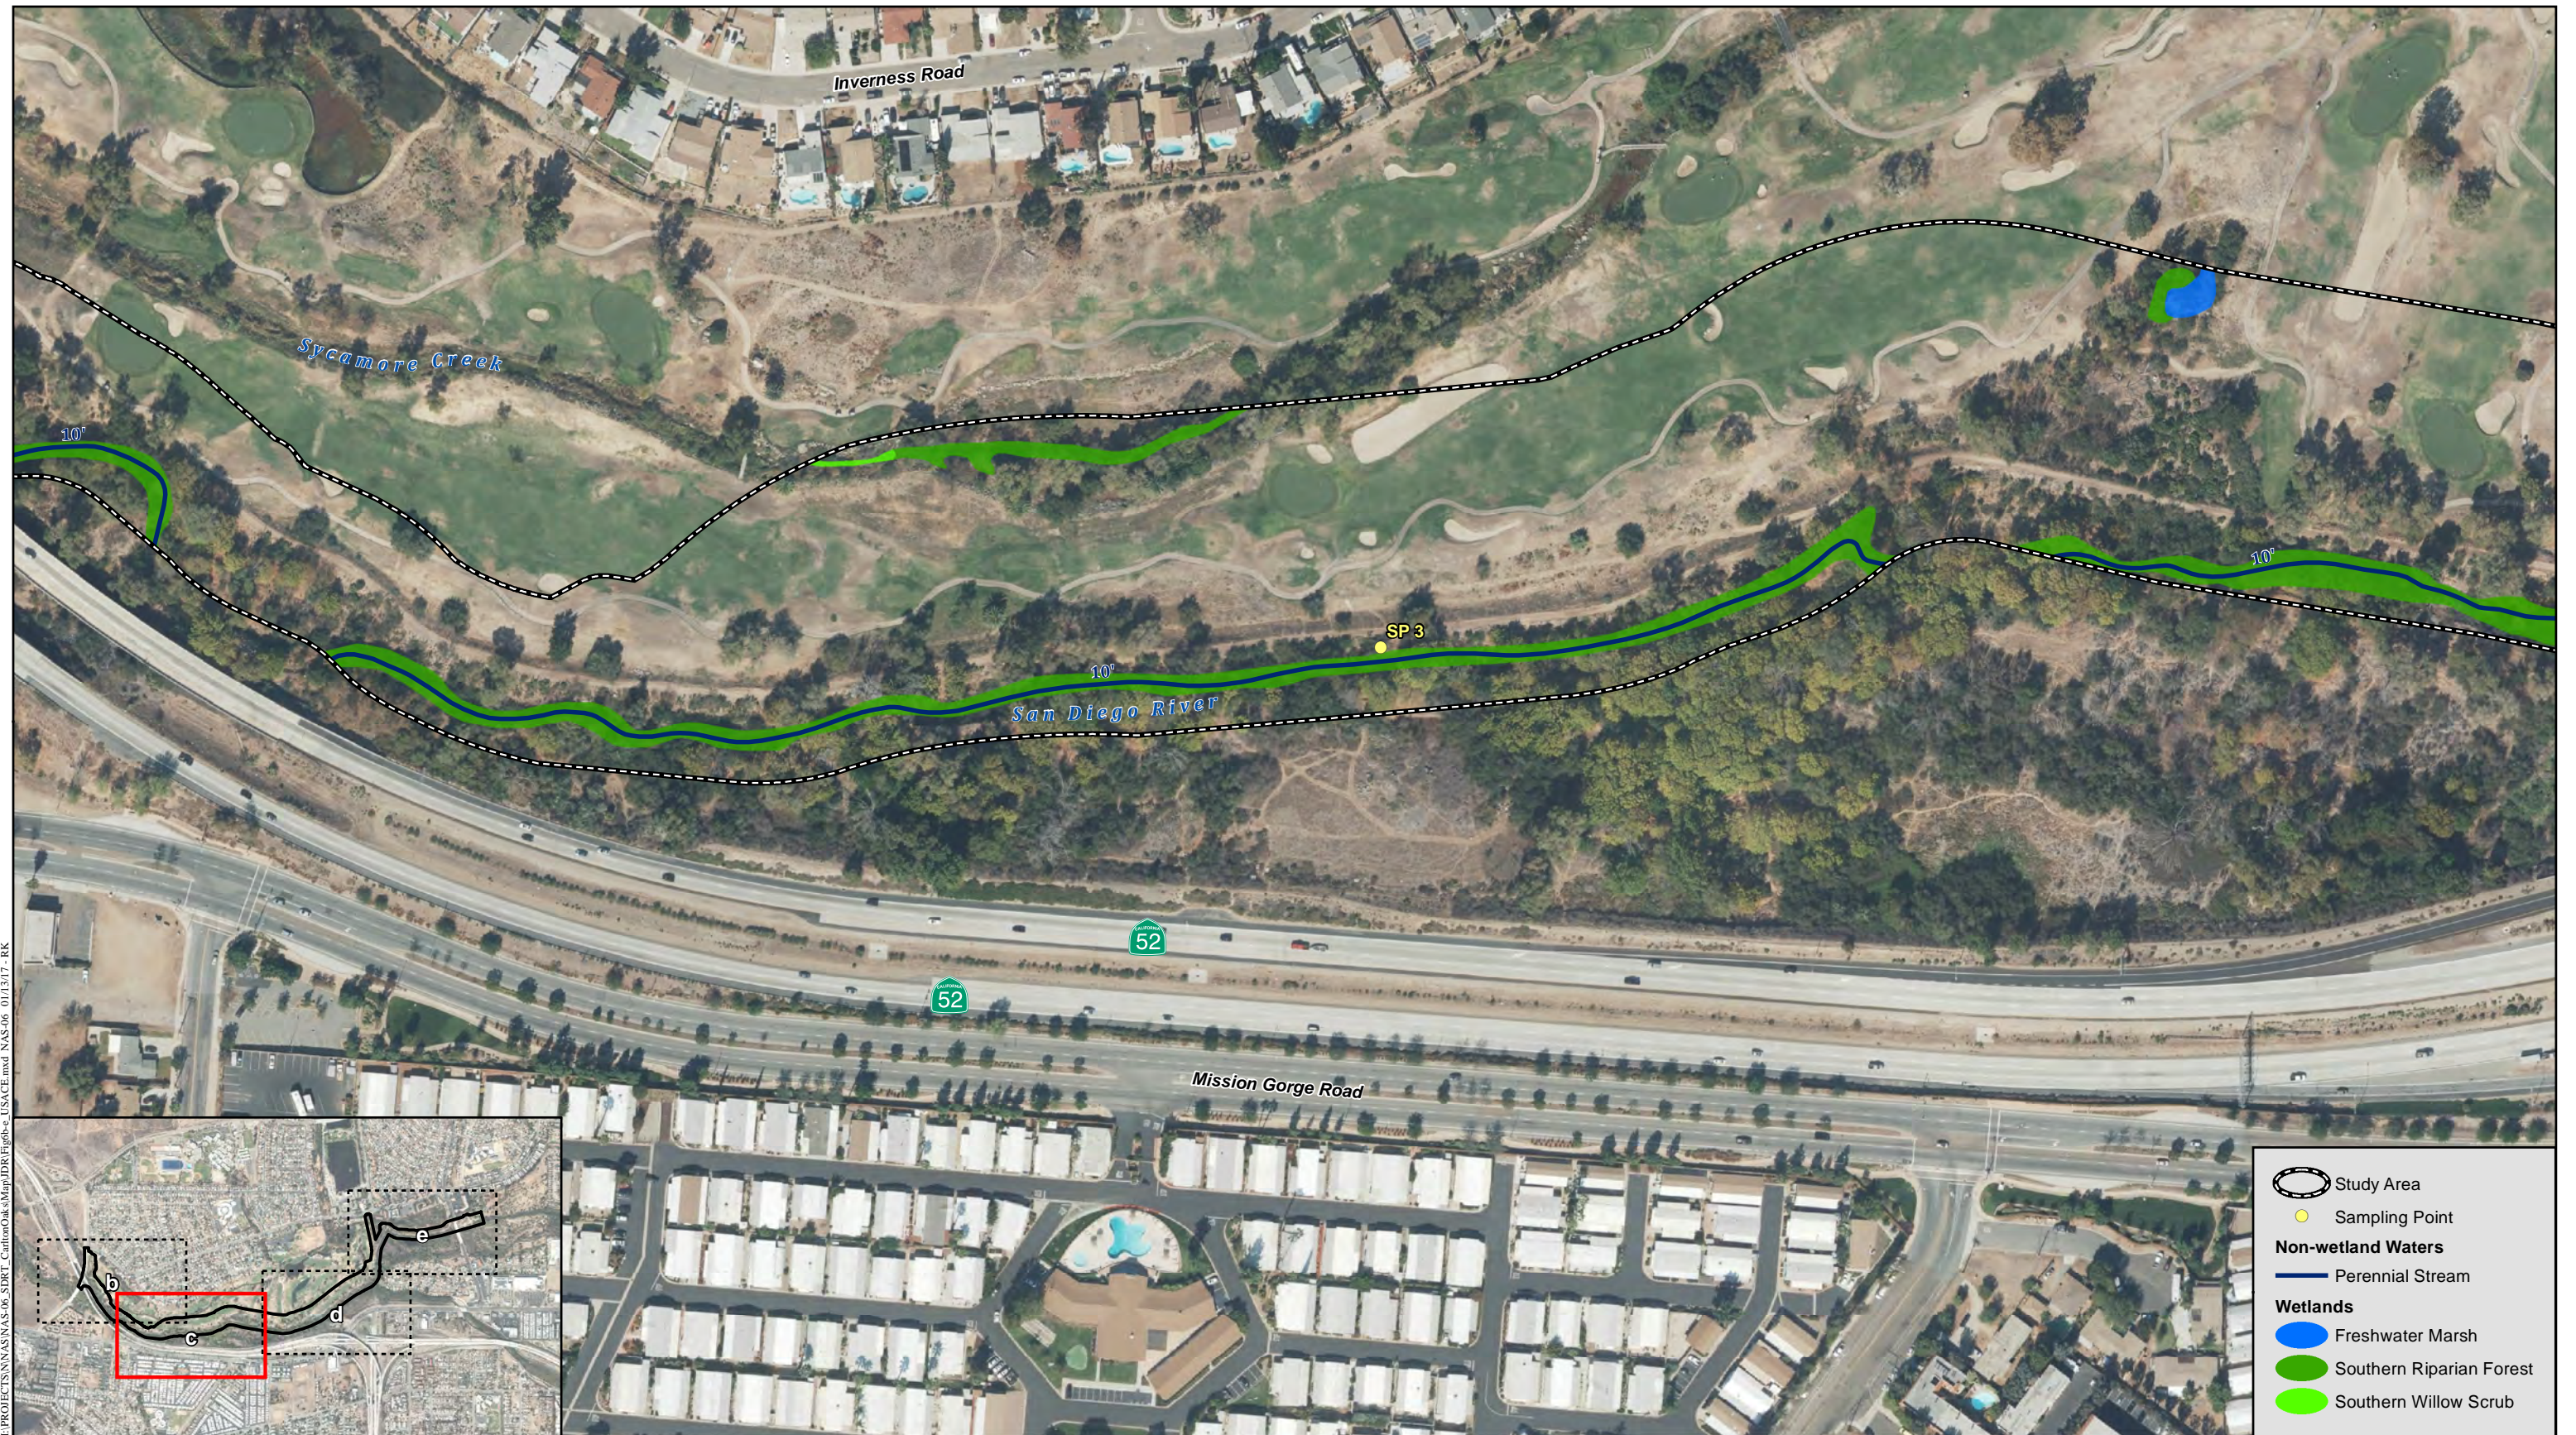
**Potential USACE Wetland and Non-wetland Waters of the U.S.**

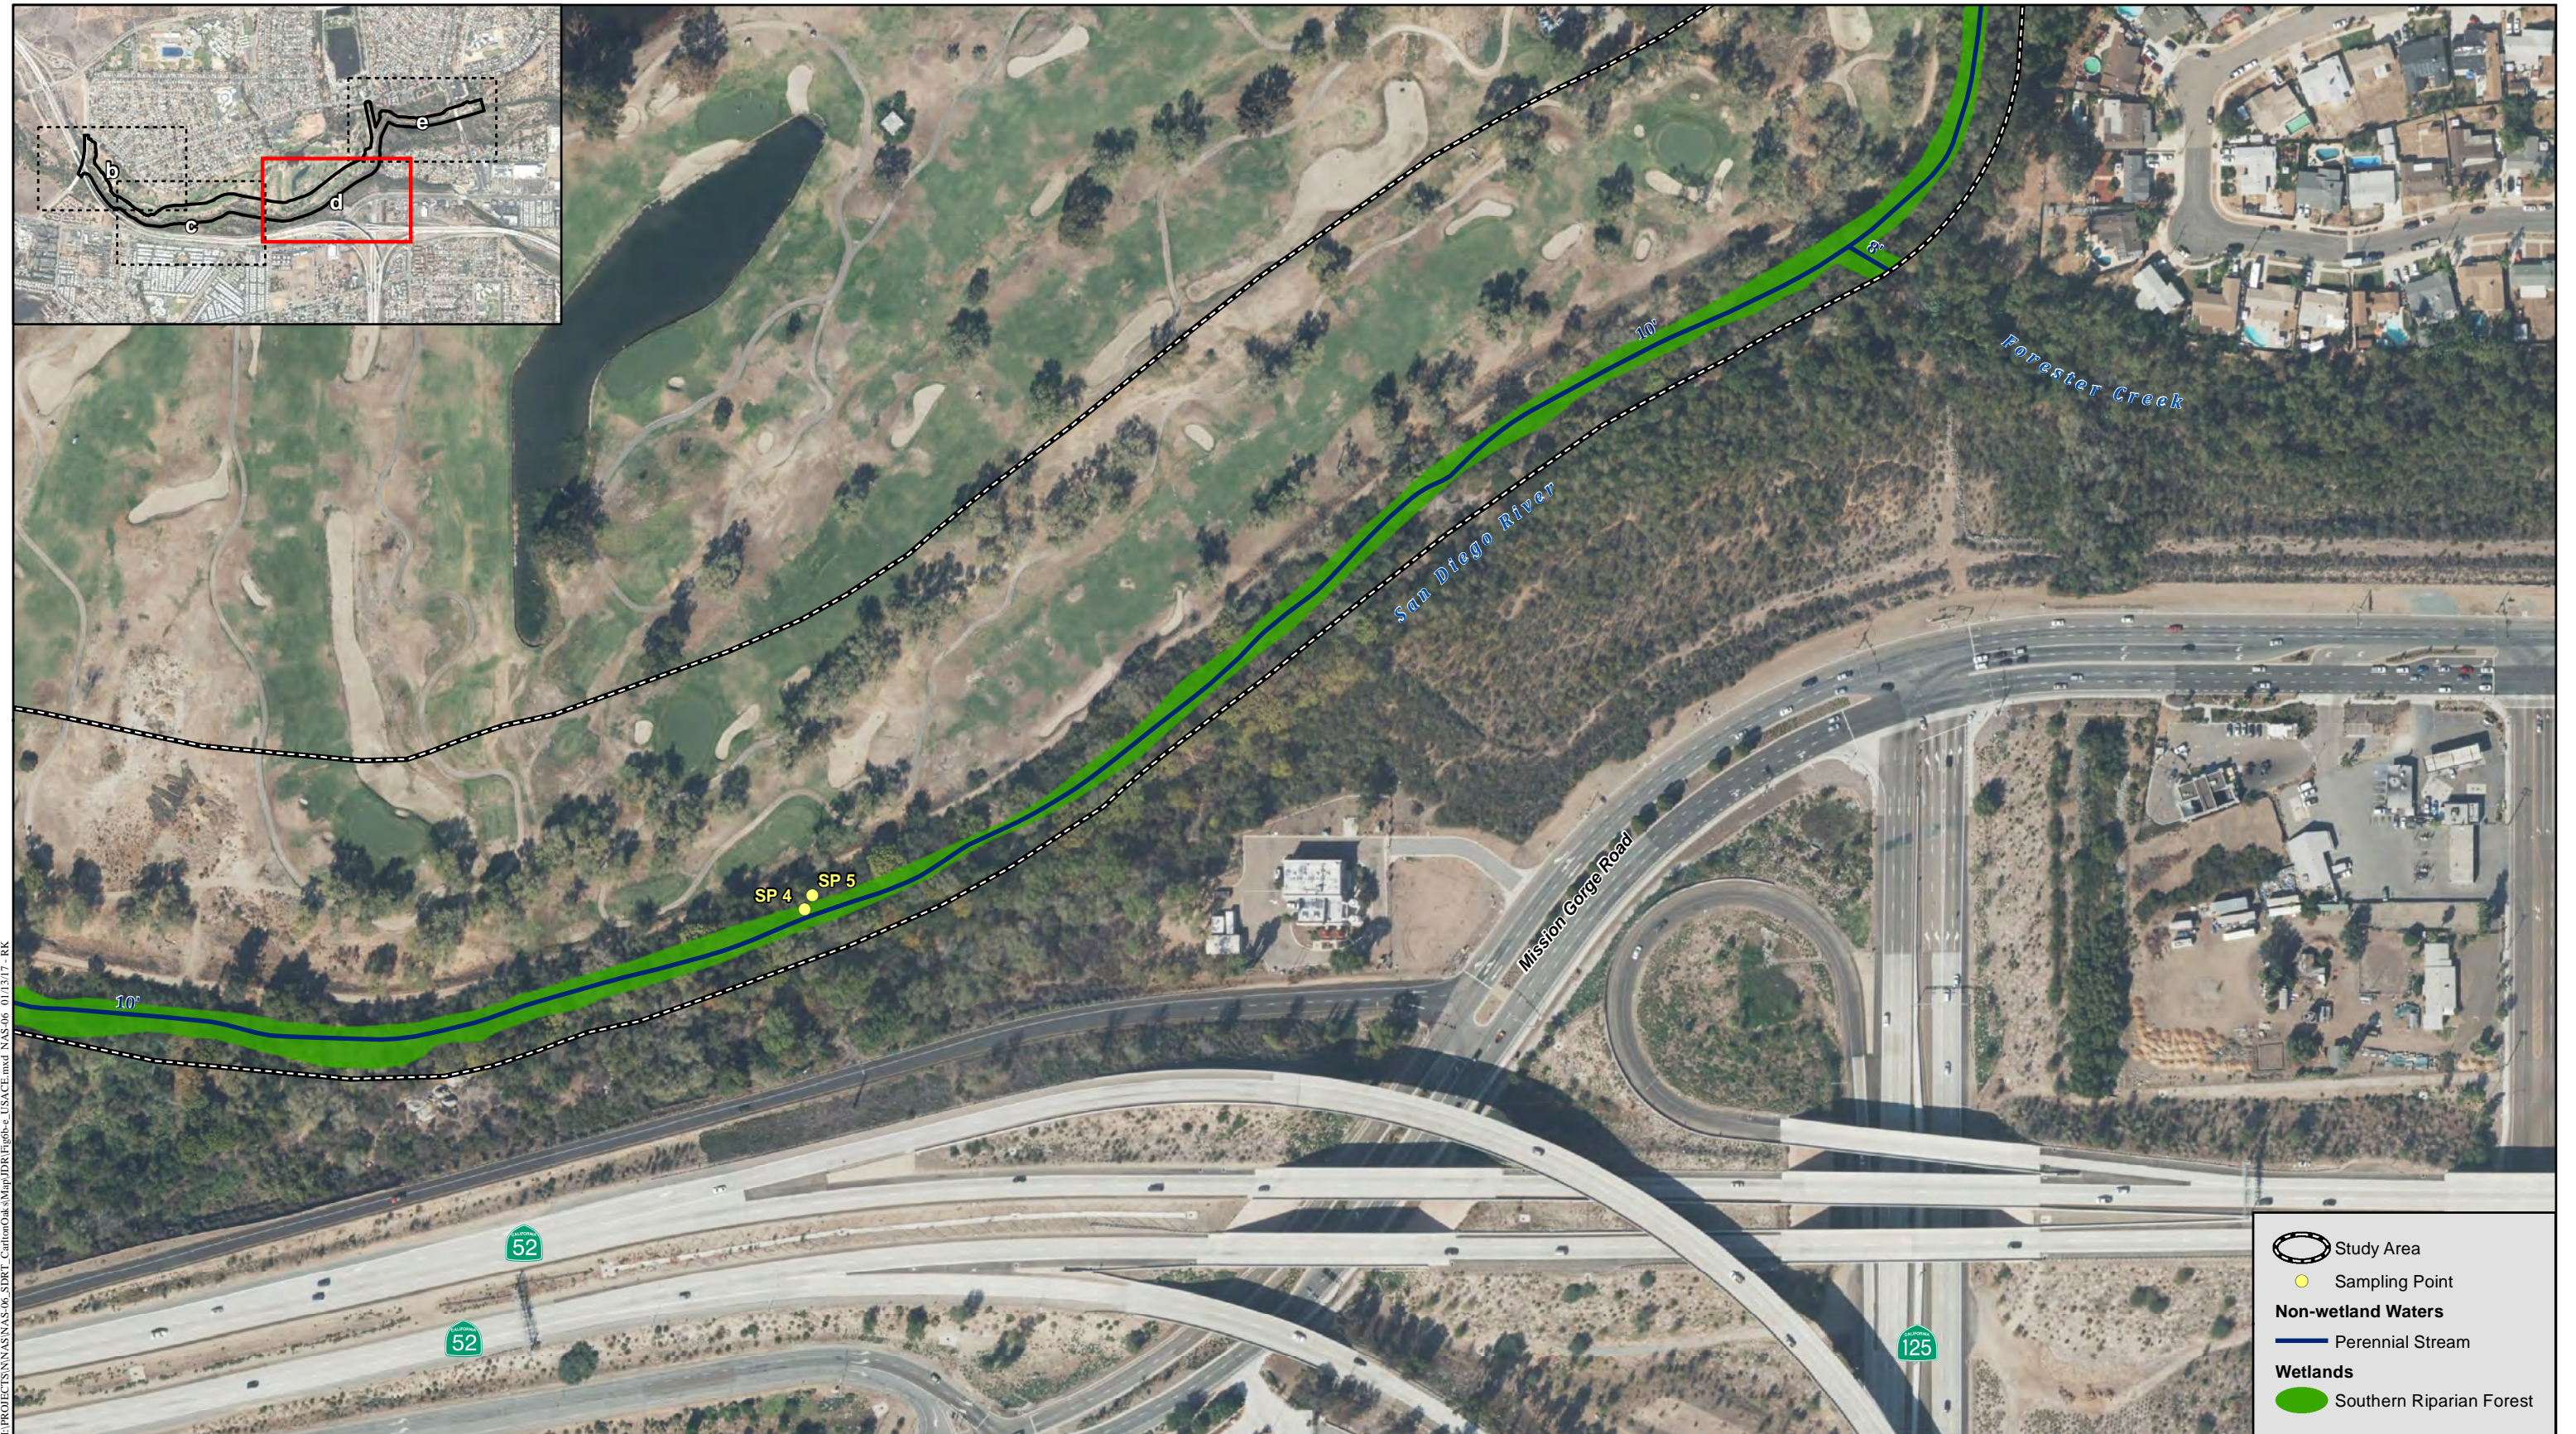
Figure 6d

**Potential USACE Wetland and Non-wetland Waters of the U.S.**

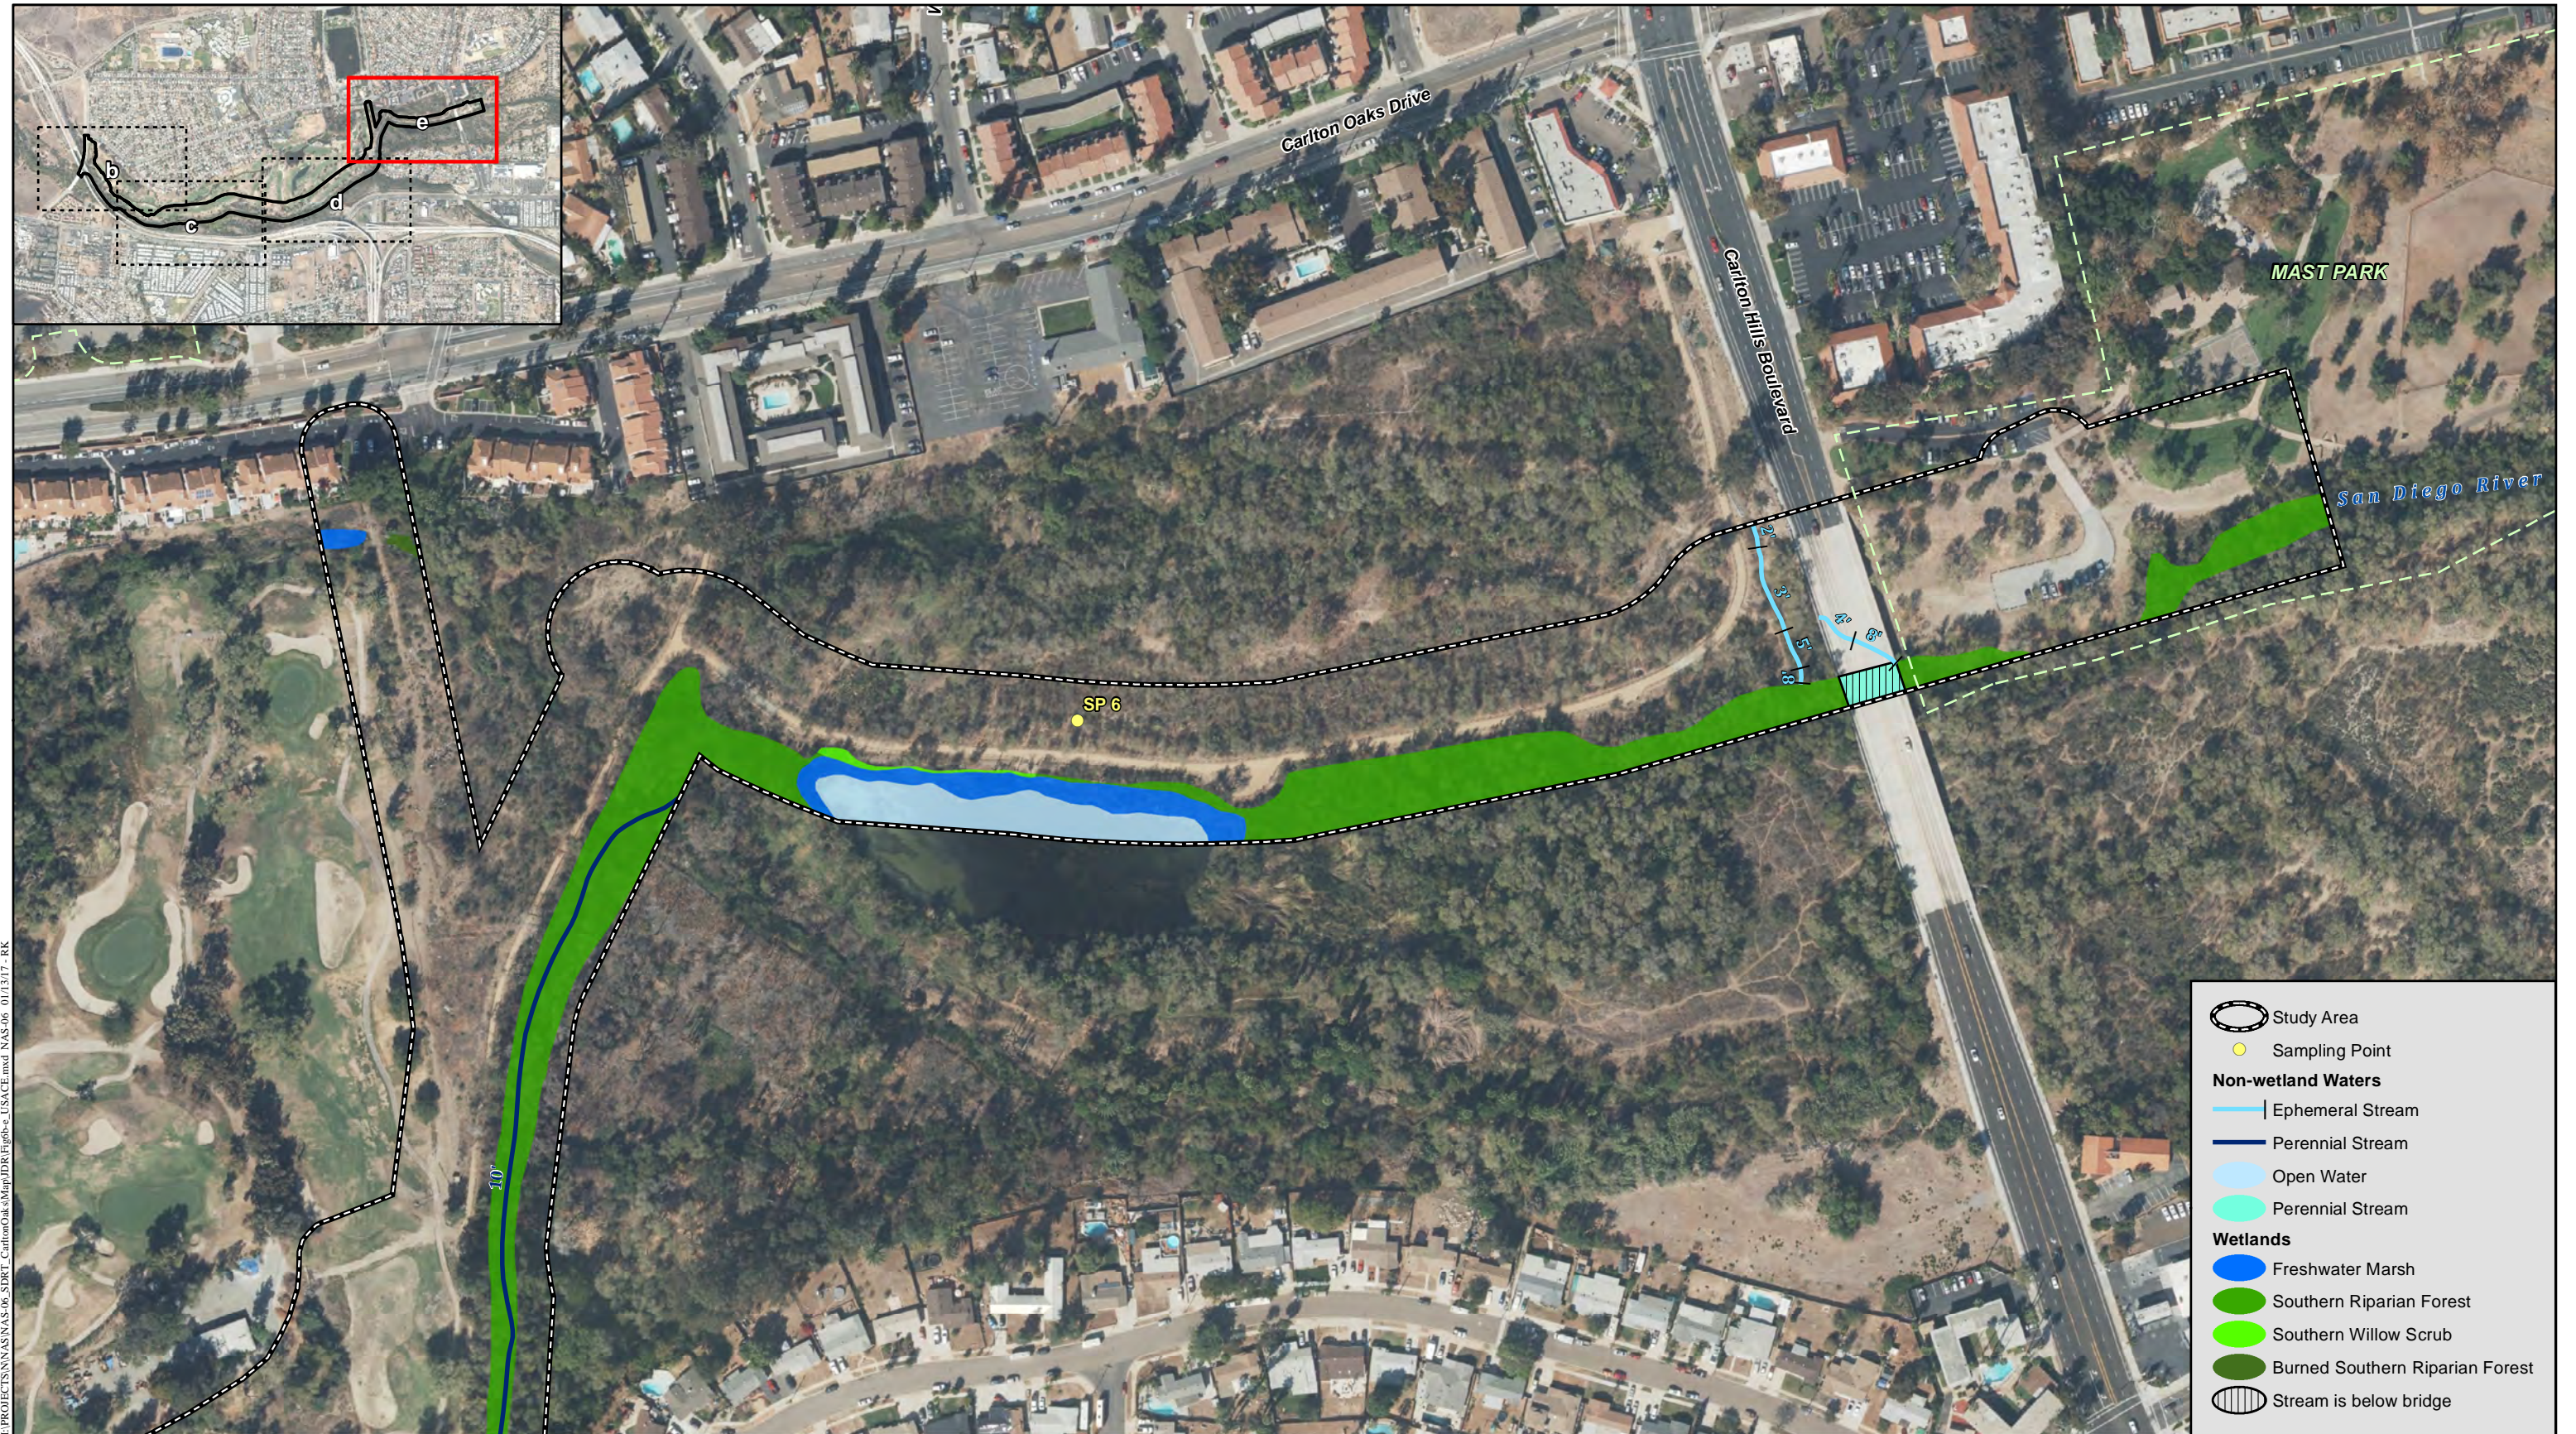
**Potential USACE Wetland and Non-wetland Waters of the U.S.**

Potential USACE jurisdiction within the BSA totals approximately 10.40 acres, made up of approximately 8.14 acres of wetland WUS and approximately 2.26 acres of non-wetland WUS (Figures 6a-6e; Table 3).

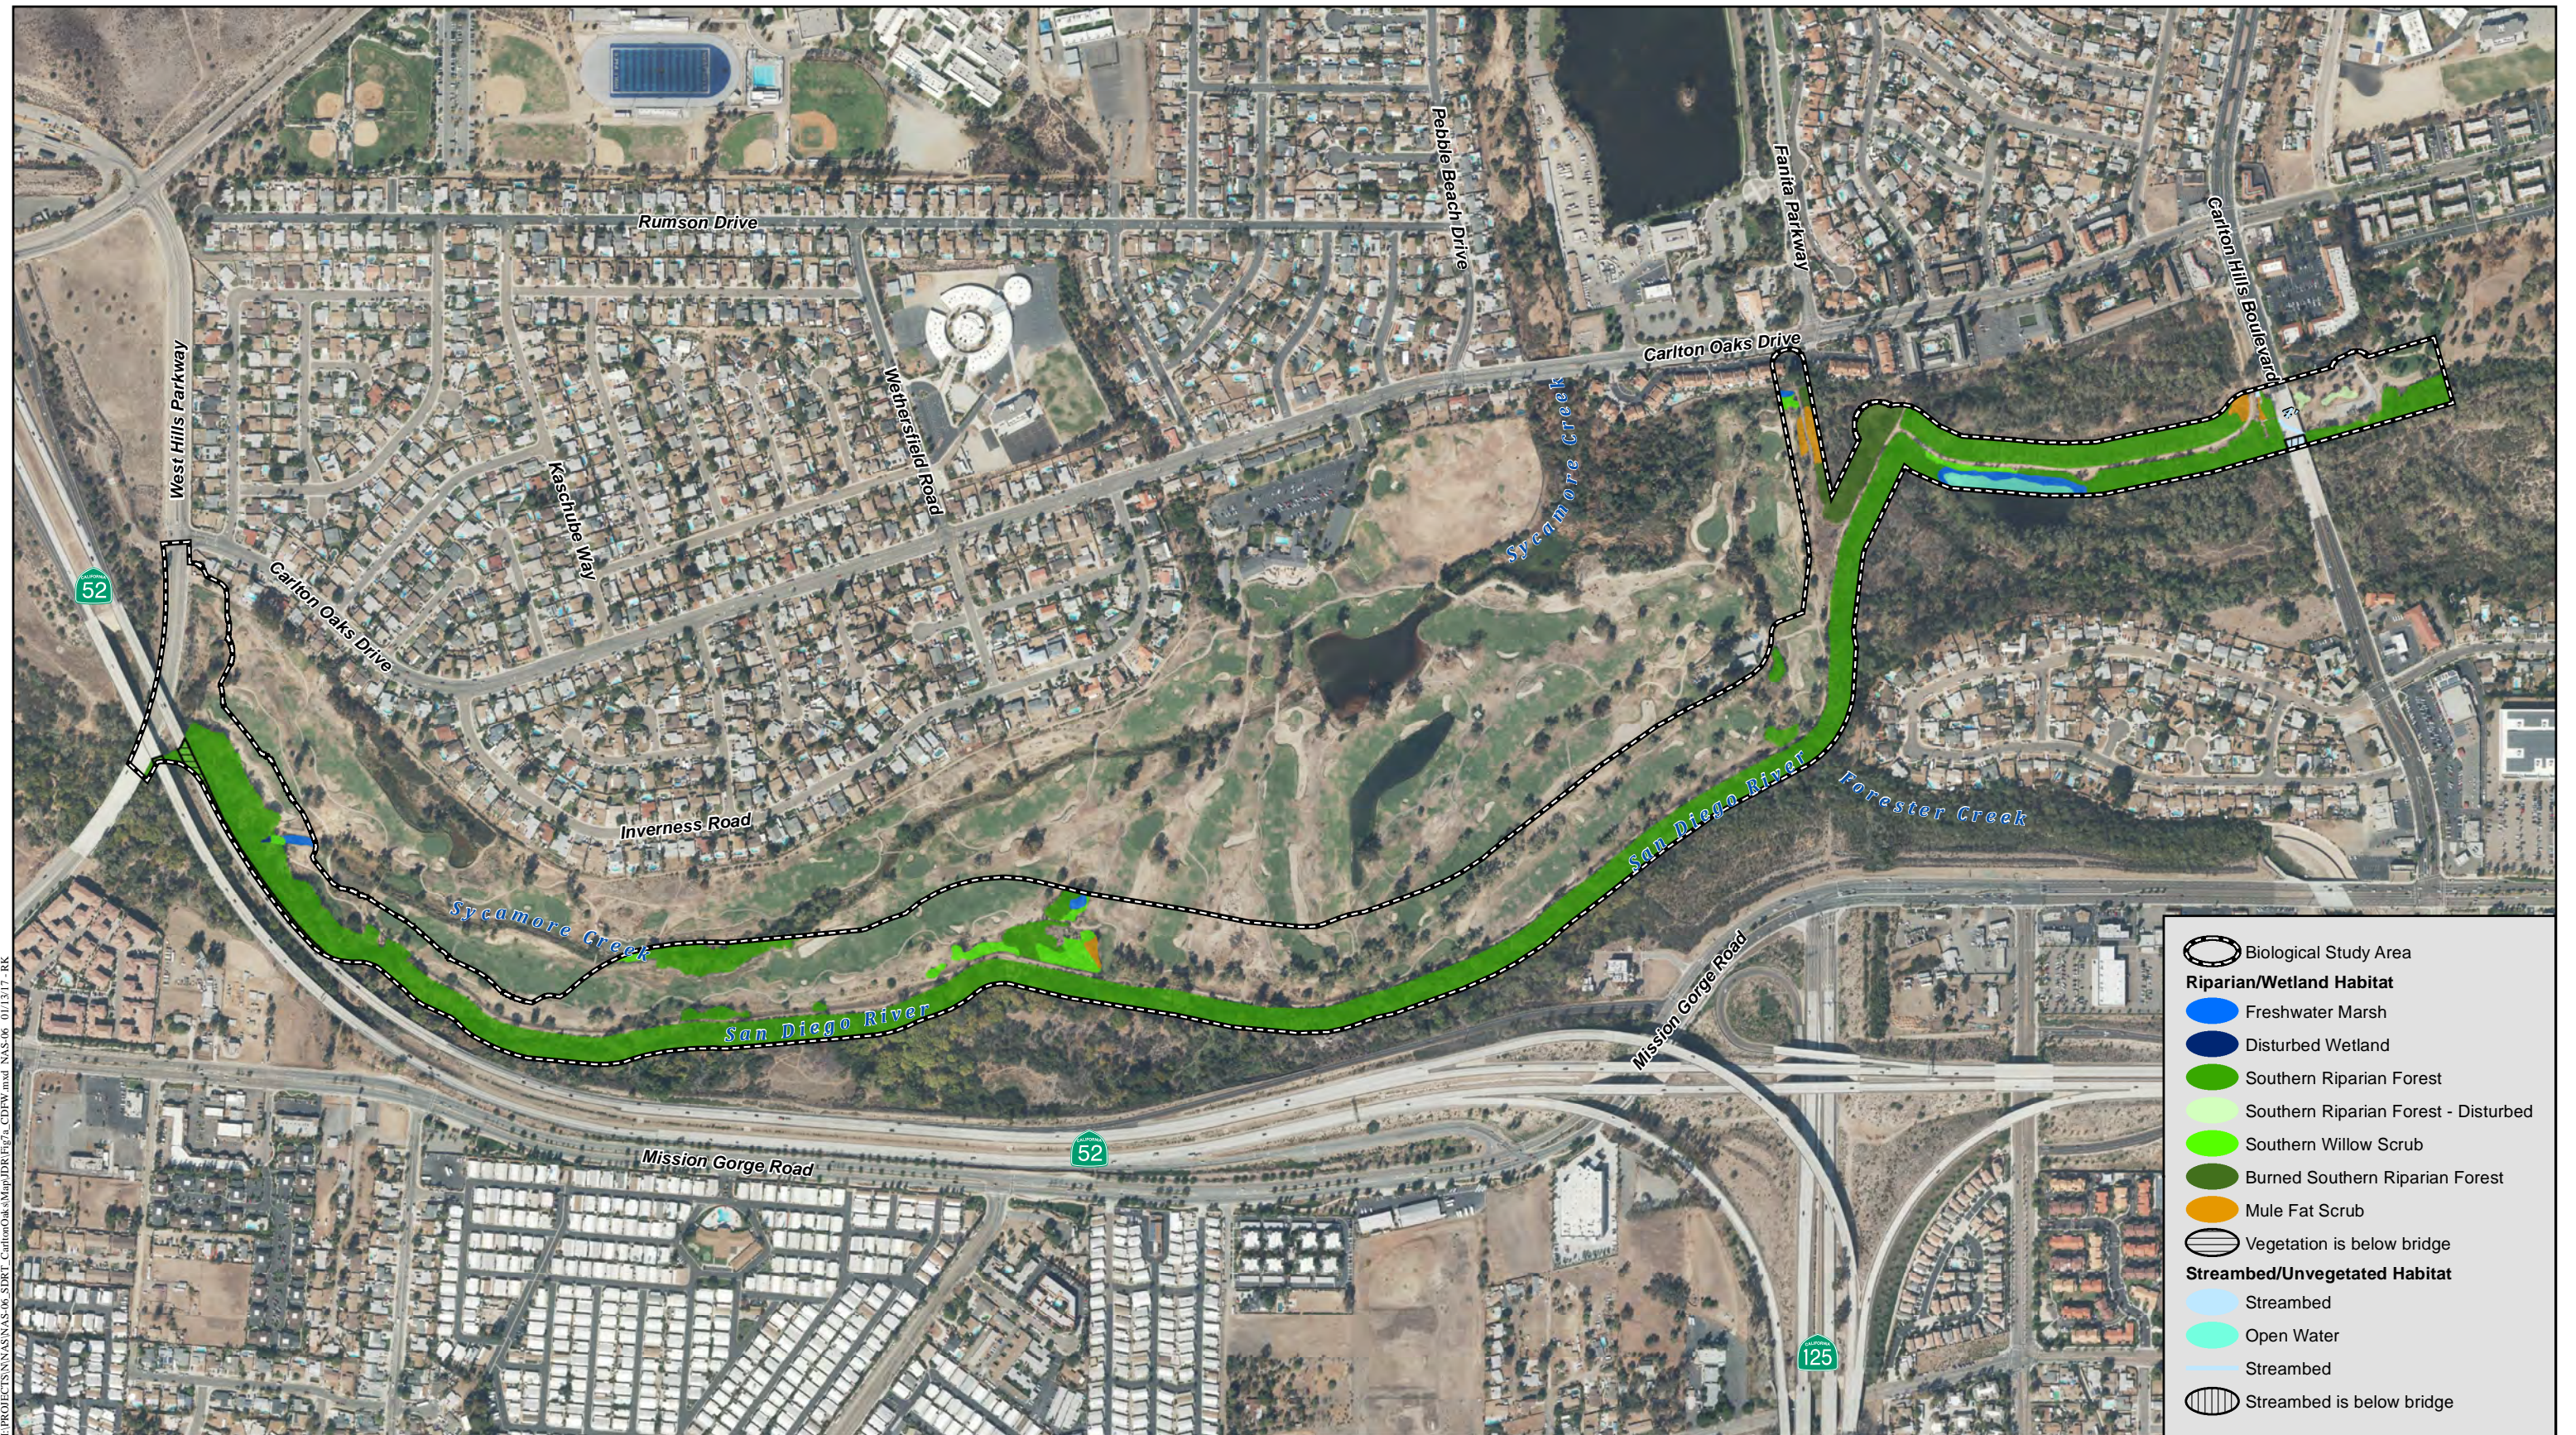
**Potential CDFW Jurisdictional Riparian and Wetland Habitat and Streambed**
