# **JURISDICTIONAL DELINEATION REPORT**

## **San Diego River Trail**

### **Carlton Oaks Golf Course Segment Project**

**January 2017**

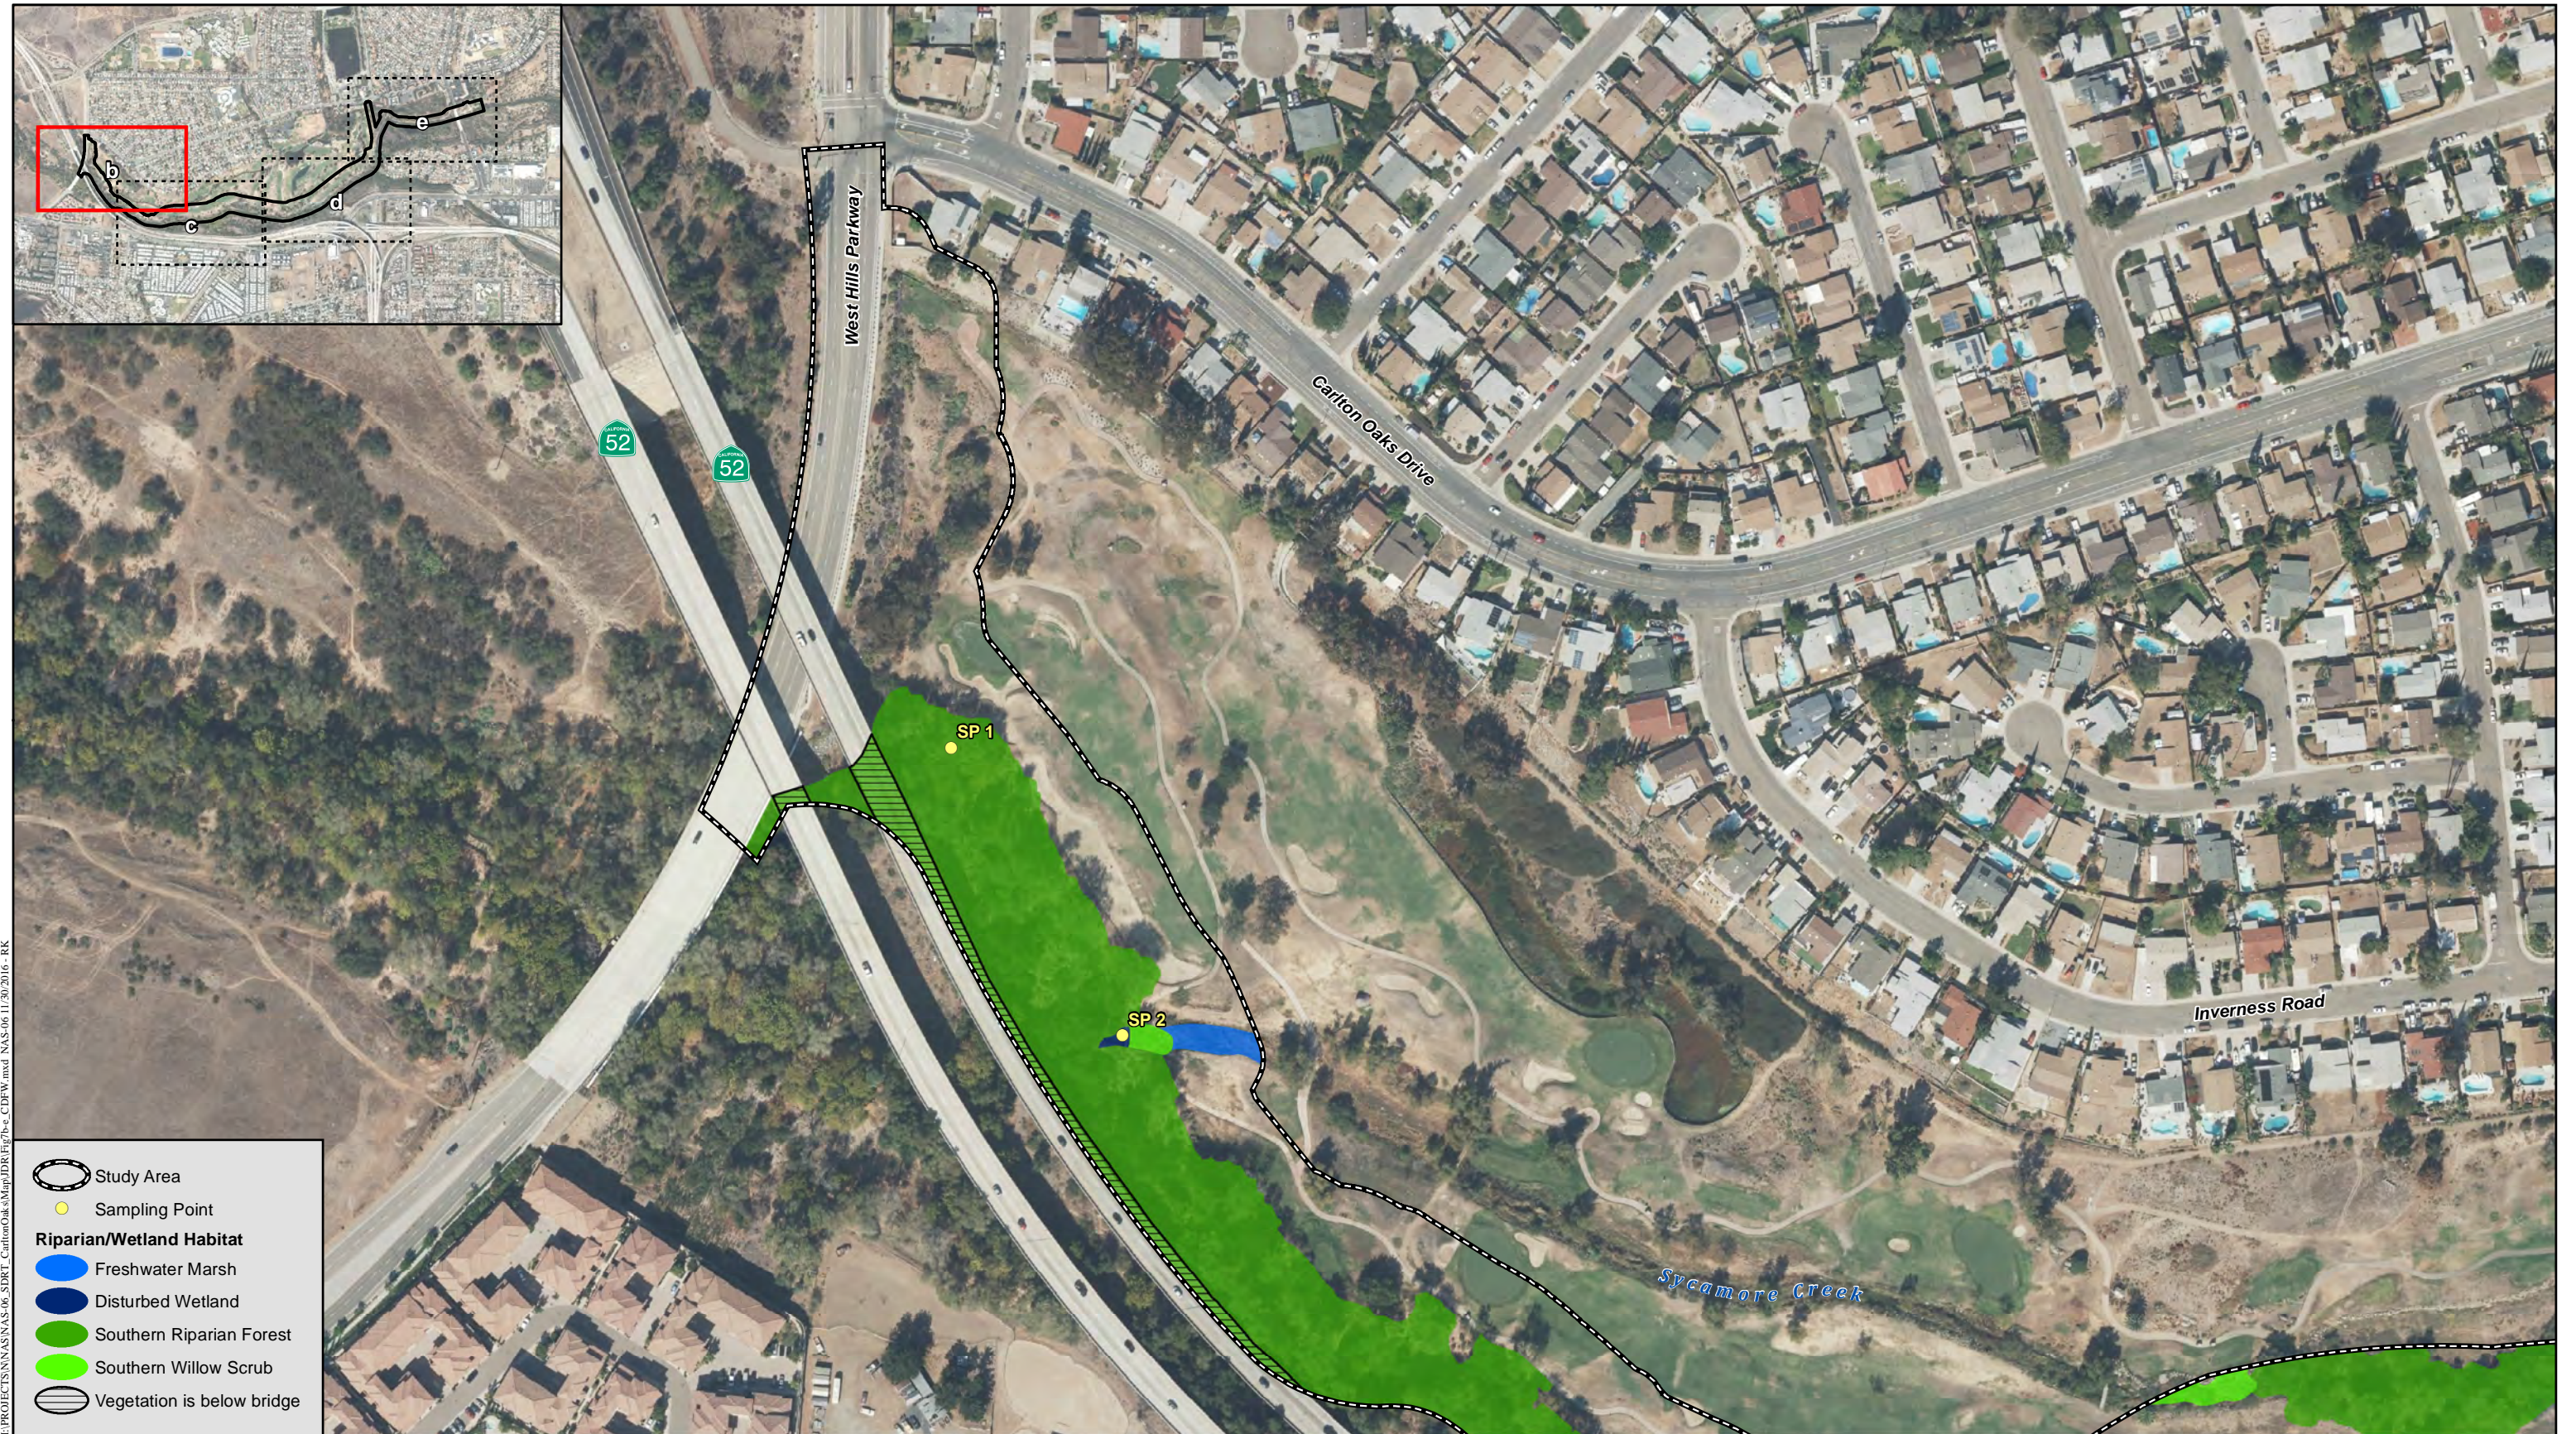
Figure 7b

**Potential CDFW Jurisdictional Riparian and Wetland Habitat and Streambed**

Potential jurisdictional wetlands, habitats, and other resources observed in the BSA include southern riparian forest (including disturbed and burned), southern willow scrub, mule fat scrub, freshwater marsh, disturbed wetland, open water, and ephemeral and perennial streams. Depictions of resources within the BSA potentially subject to WUS and CDFW jurisdiction are presented in Figures 6a through 6e and 7a through 7e.

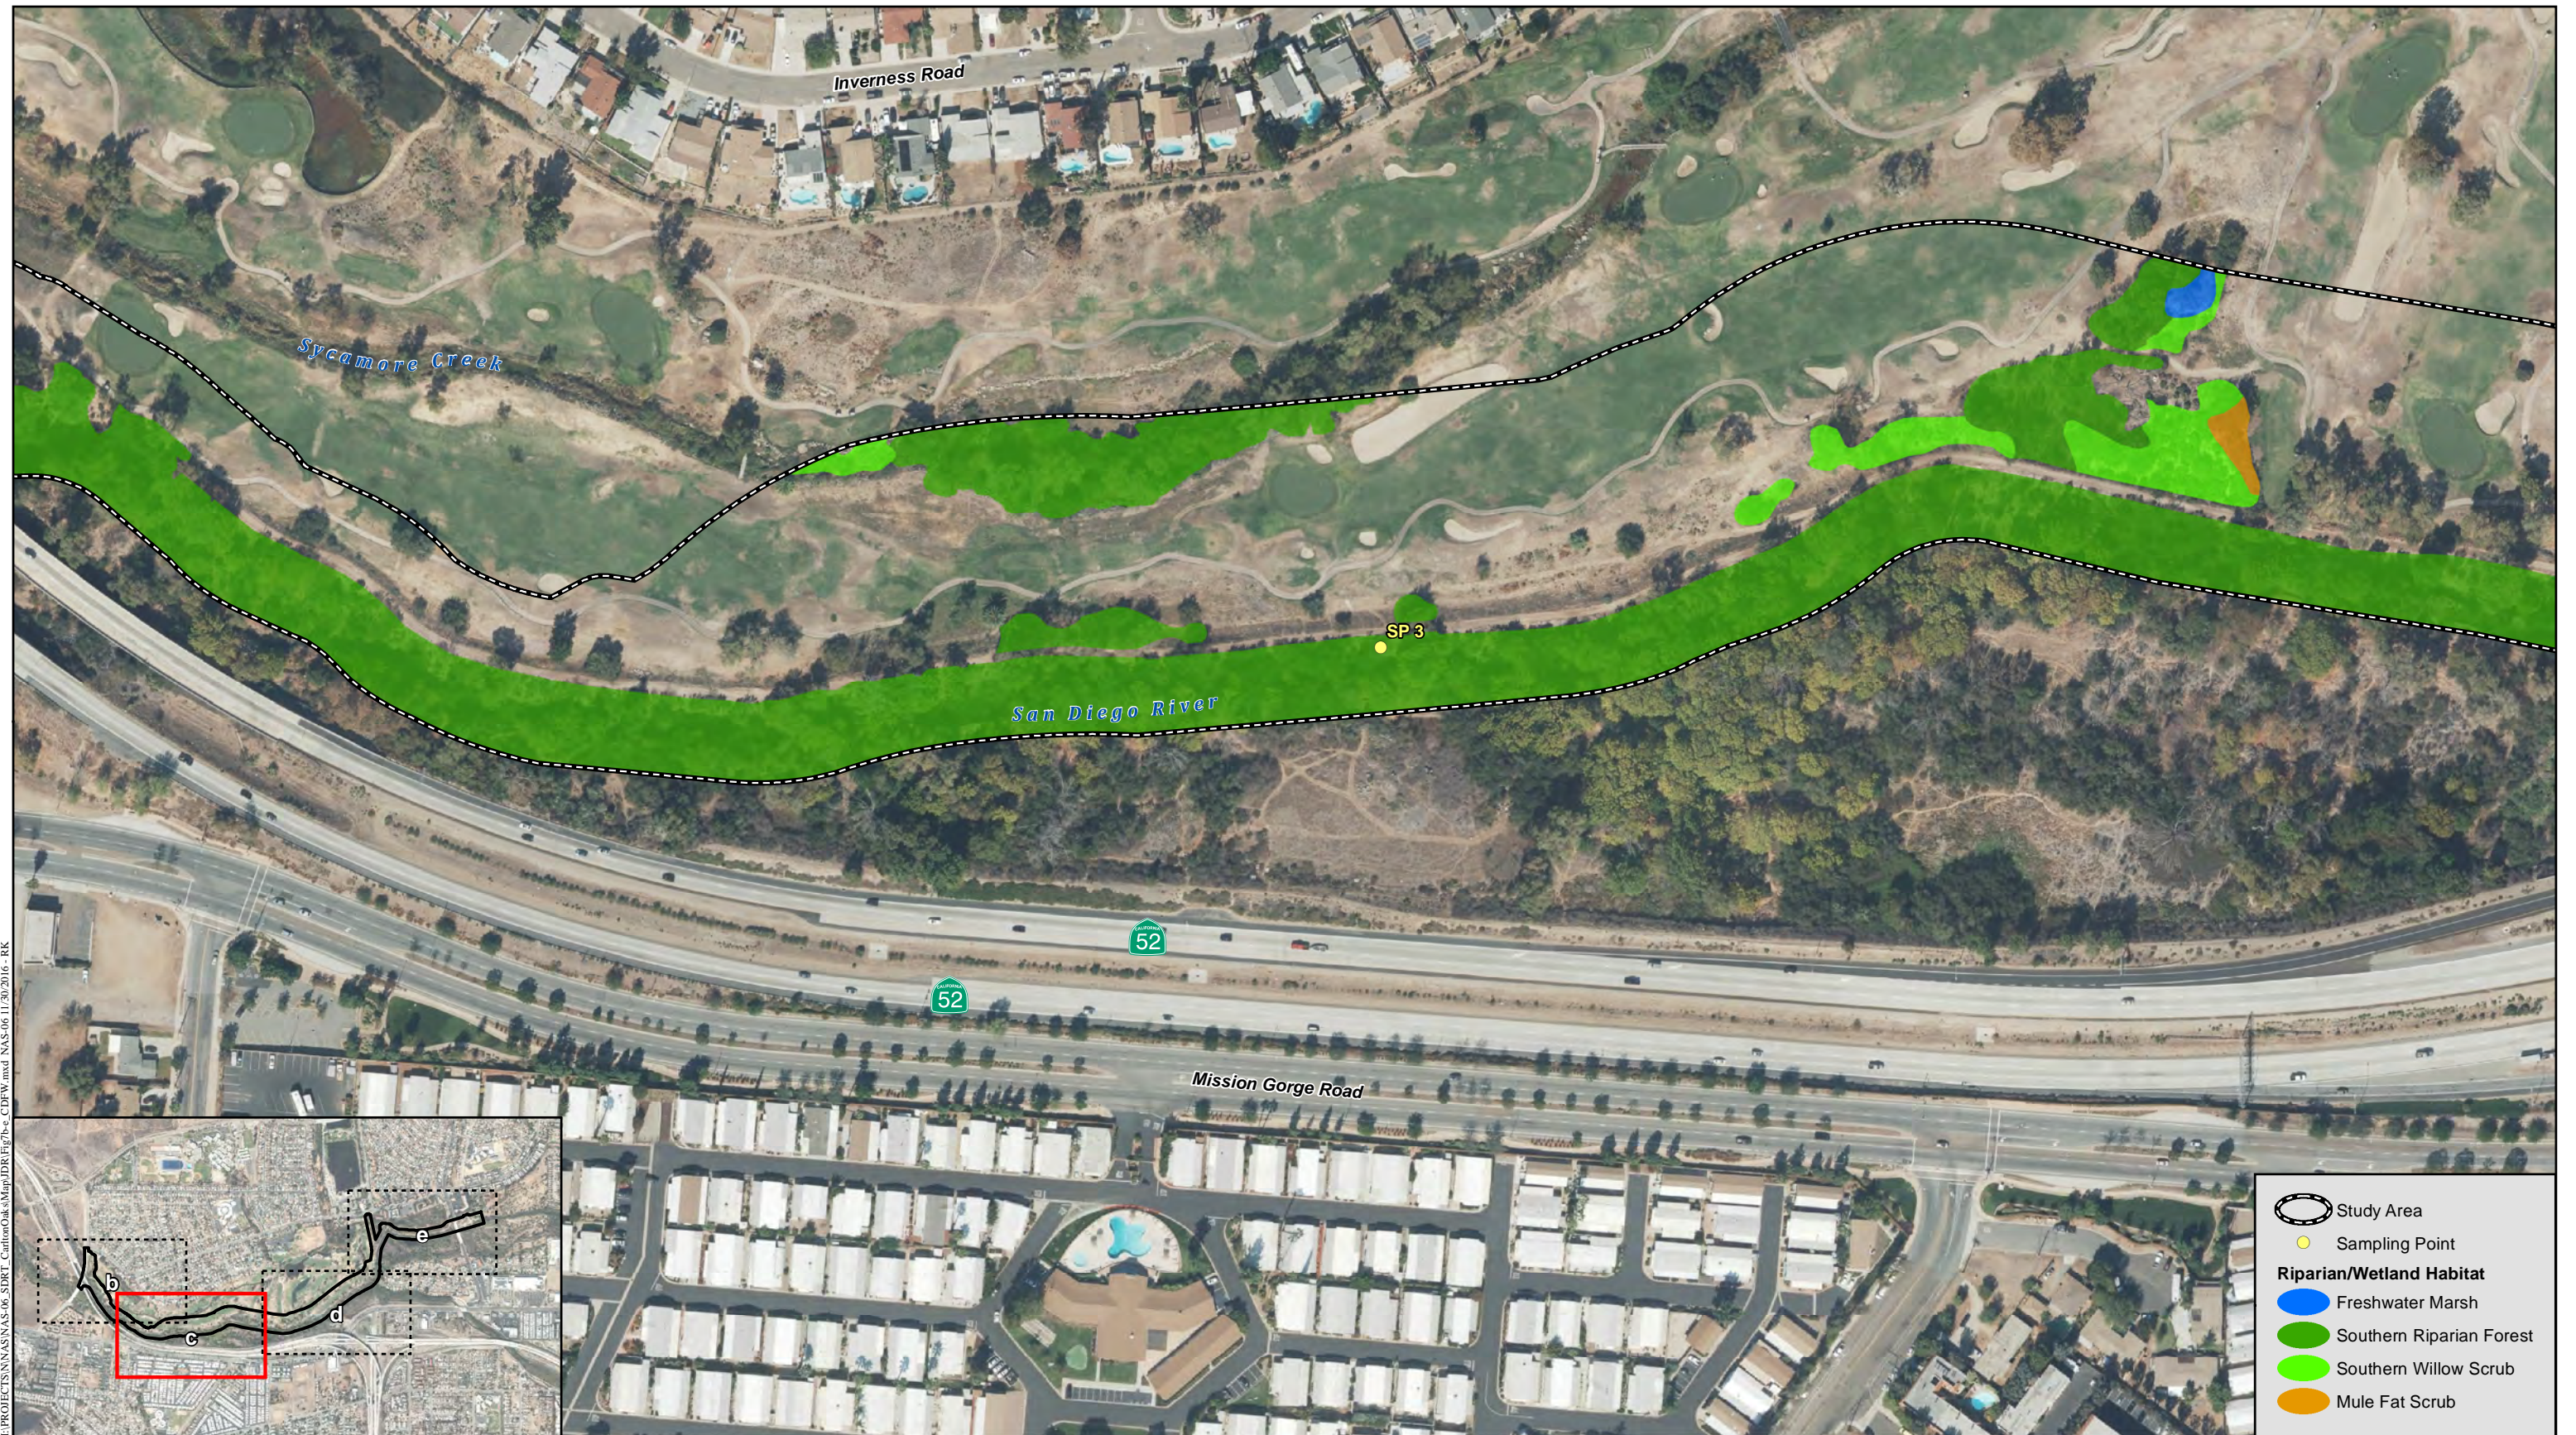
**Potential CDFW Jurisdictional Riparian and Wetland Habitat and Streambed**

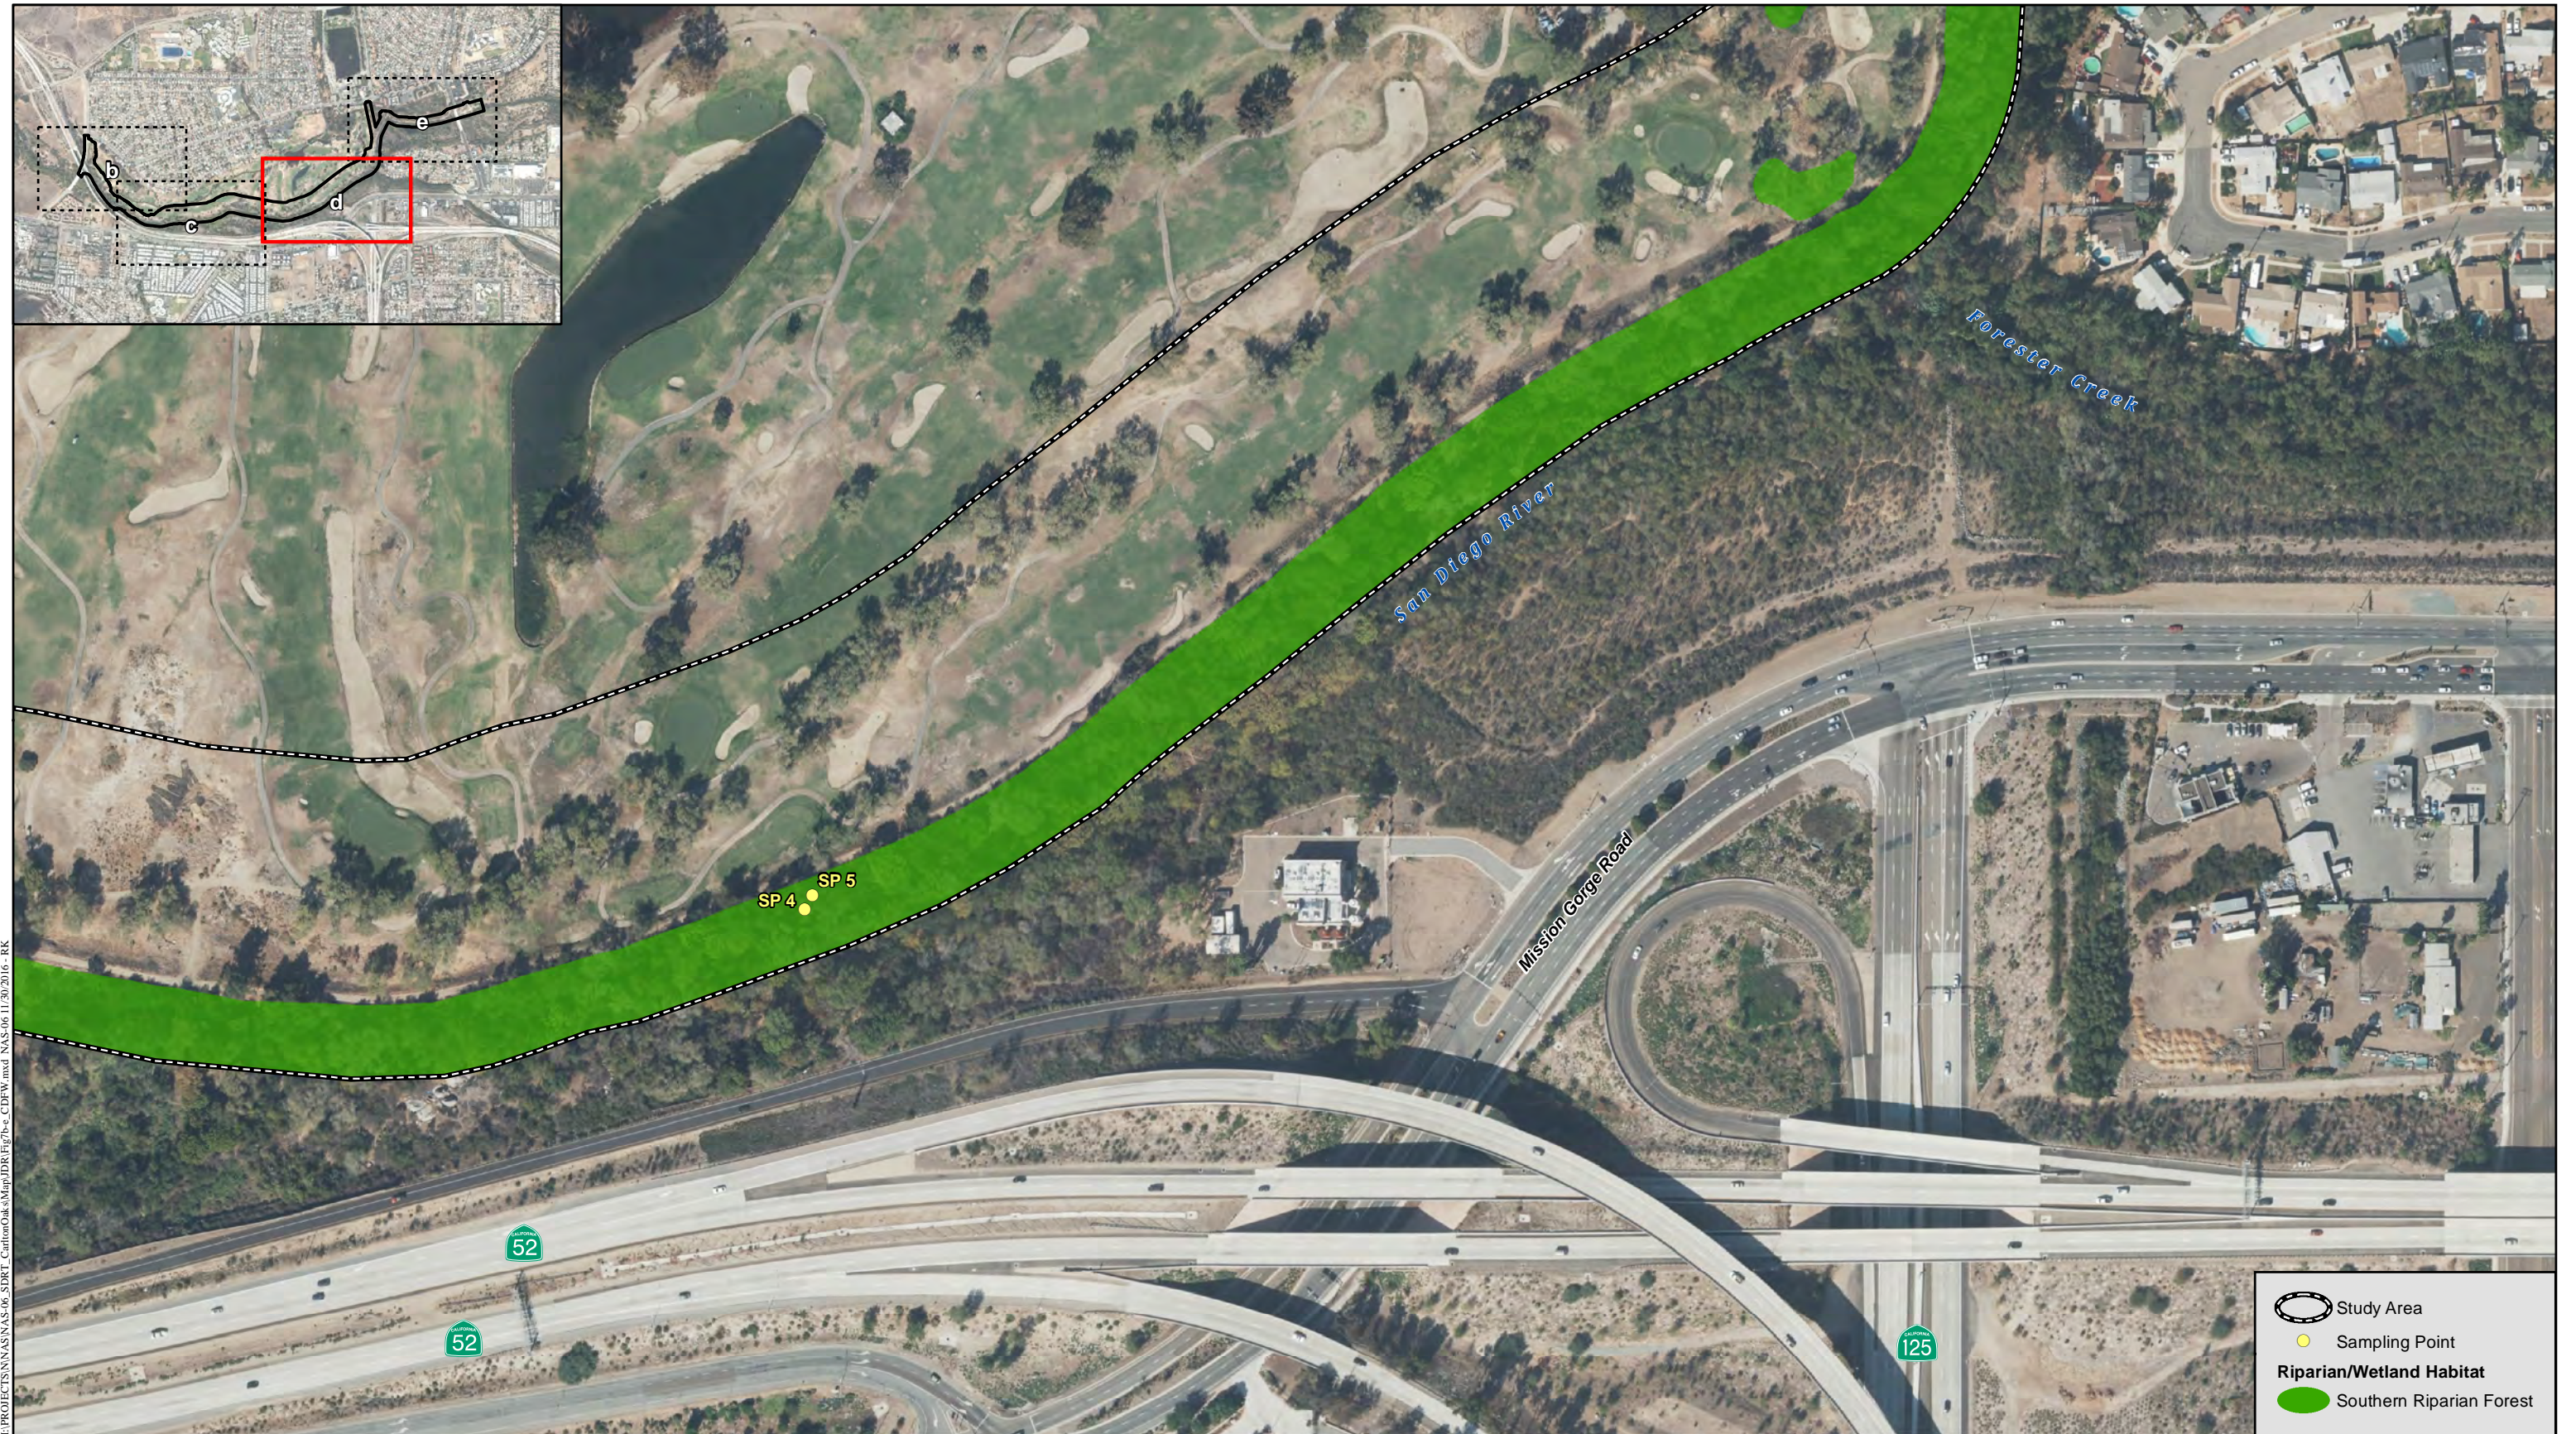
**Potential CDFW Jurisdictional Riparian and Wetland Habitat and Streambed**

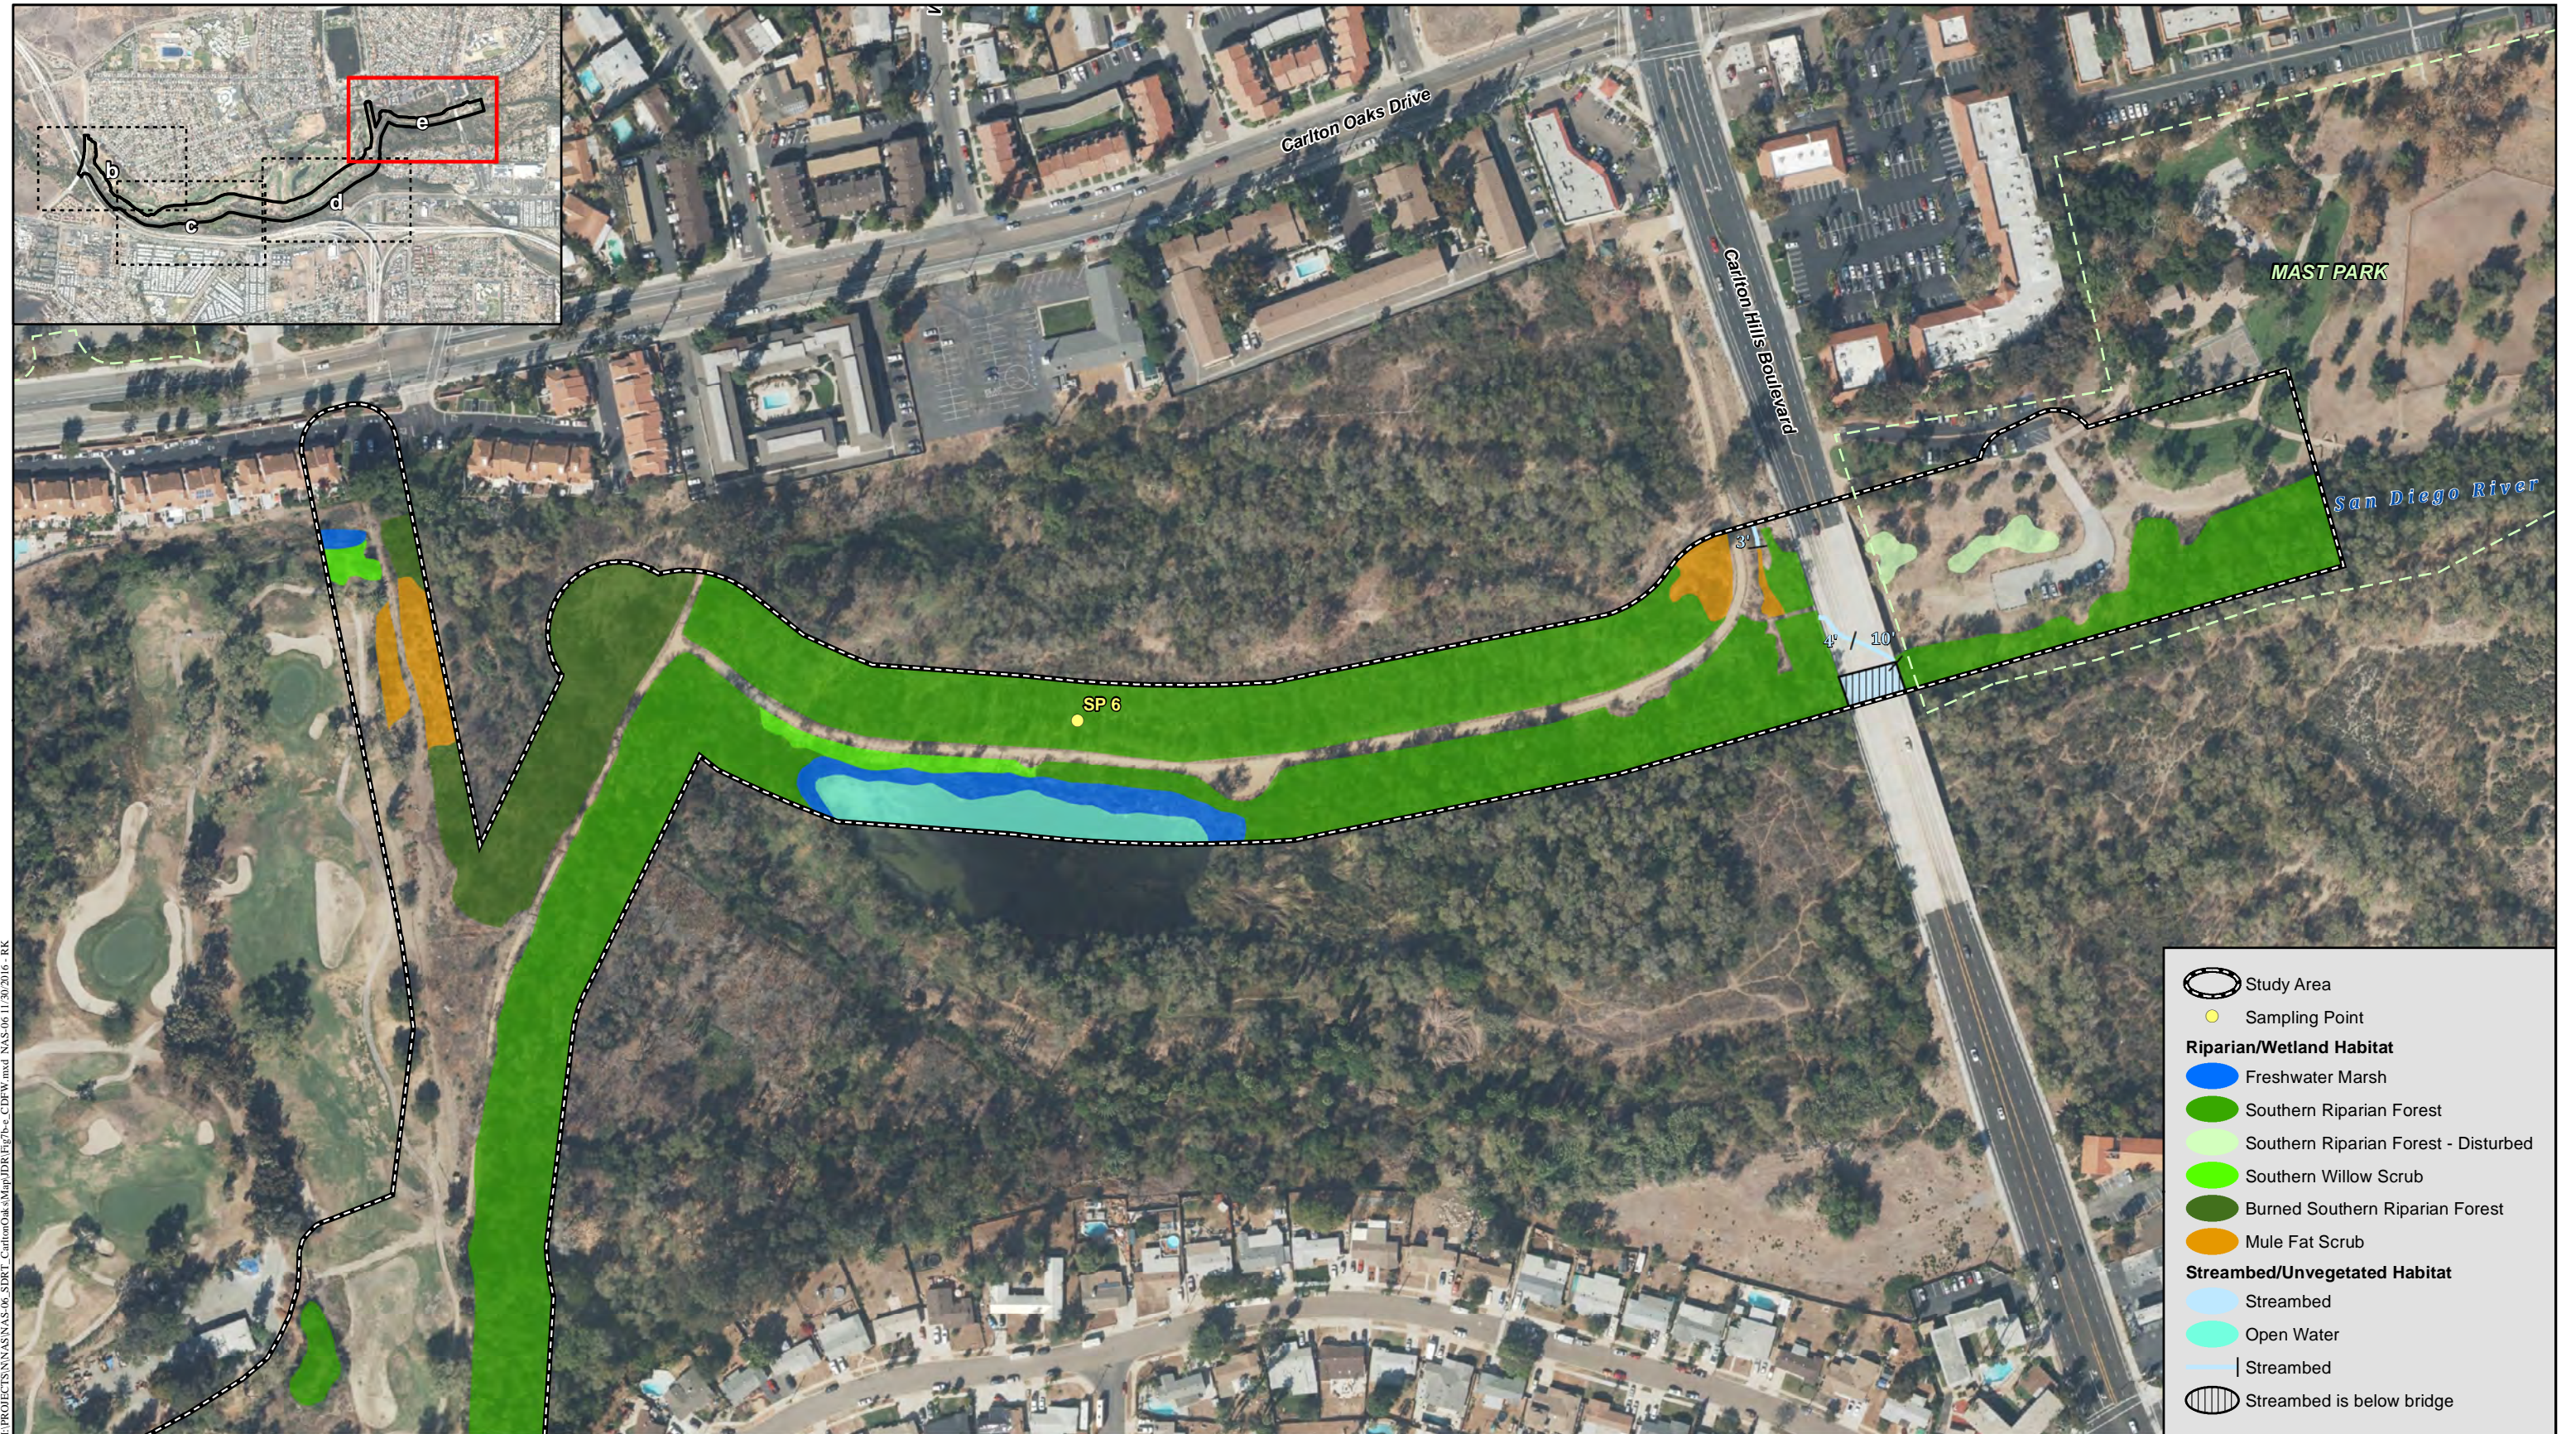
**Potential CDFW Jurisdictional Riparian and Wetland Habitat and Streambed**

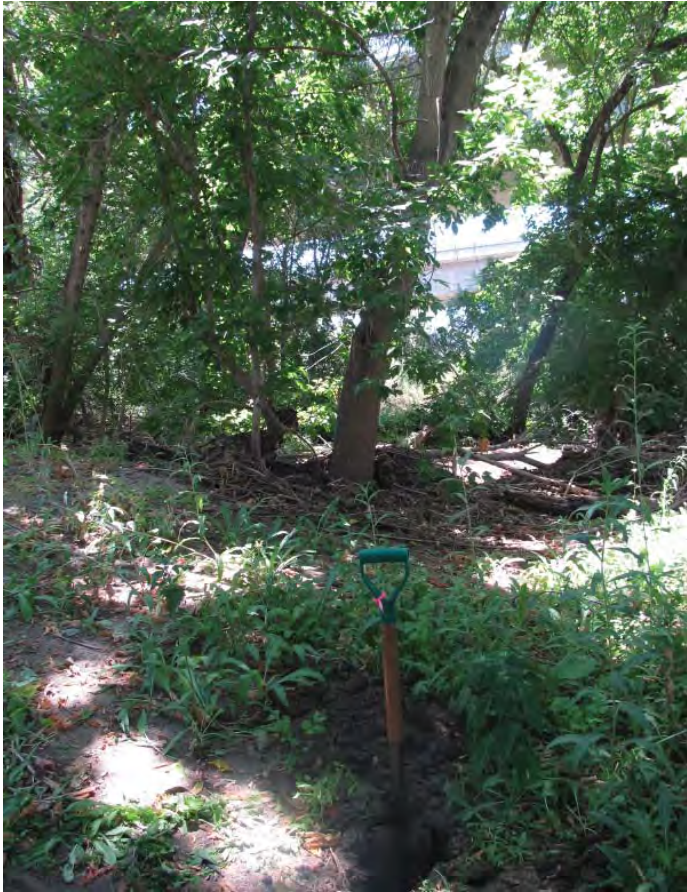
Sampling Point 1. Looking west at southern riparian forest in the western portion of the study area. Sampling point is within CDFW jurisdictional habitat.

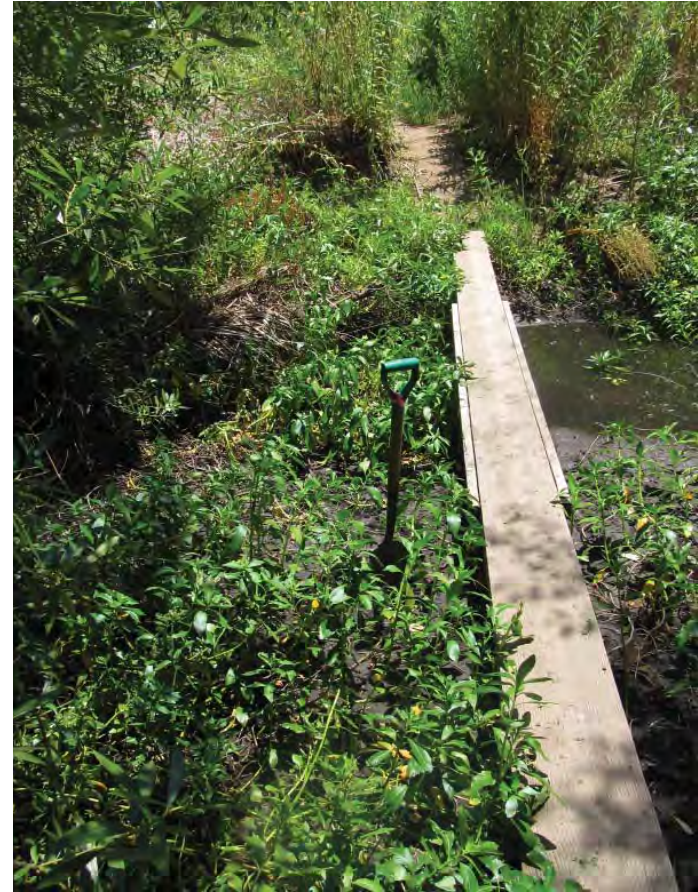
Sampling Point 2. Looking south at disturbed wetland in the western portion of the study area. Sampling point is within wetland Waters of the U.S. and CDFW jurisdictional habitat.

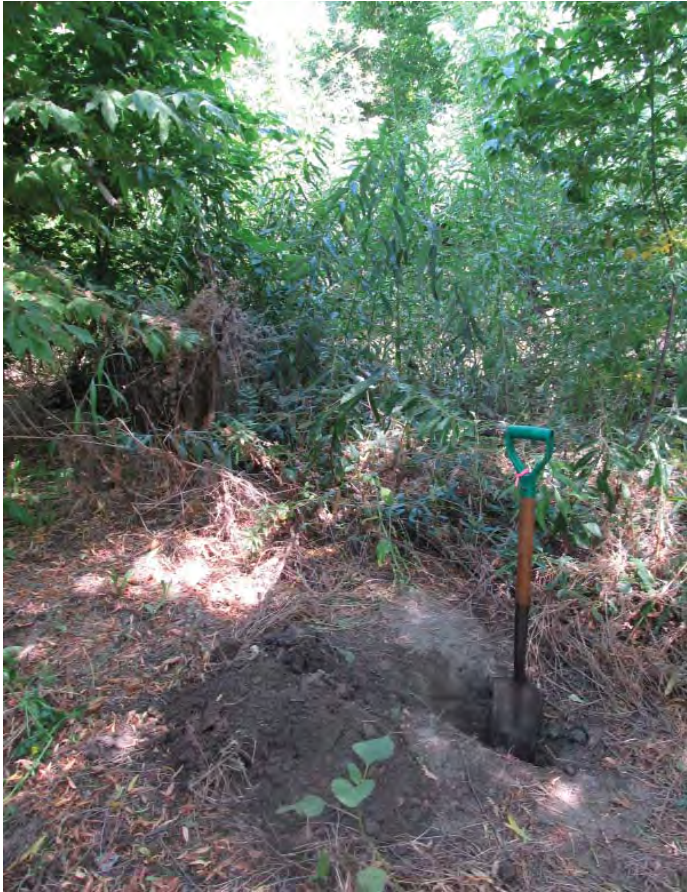
Sampling Point 3. Looking east at southern riparian forest along the San Diego River in the central portion of the study area. Sampling point is within CDFW jurisdictional habitat.

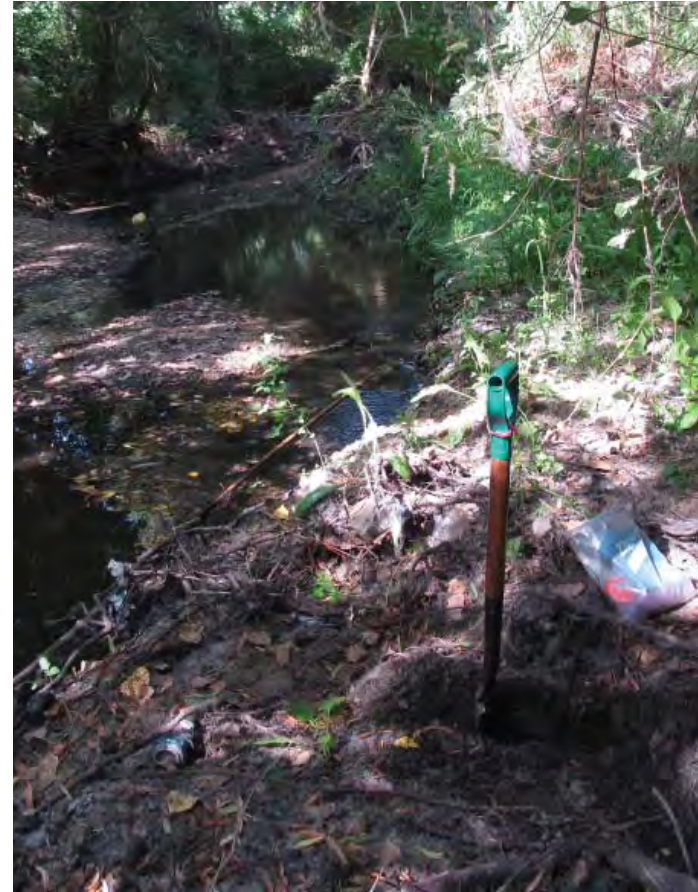
of inundation resulting in anaerobic conditions, coupled with dominance by obligate vegetation and an abrupt boundary between wetland and upland habitat. This sampling point met all three of the USACE wetland criteria and is potentially subject to USACE jurisdiction as wetland WUS. It is potentially subject to CDFW jurisdiction as riparian/wetland habitat.

Sampling Point 4. Looking north at southern riparian forest along the San Diego River in the central portion of the study area. Sampling point is within wetland Waters of the U.S. and CDFW jurisdictional habitat.

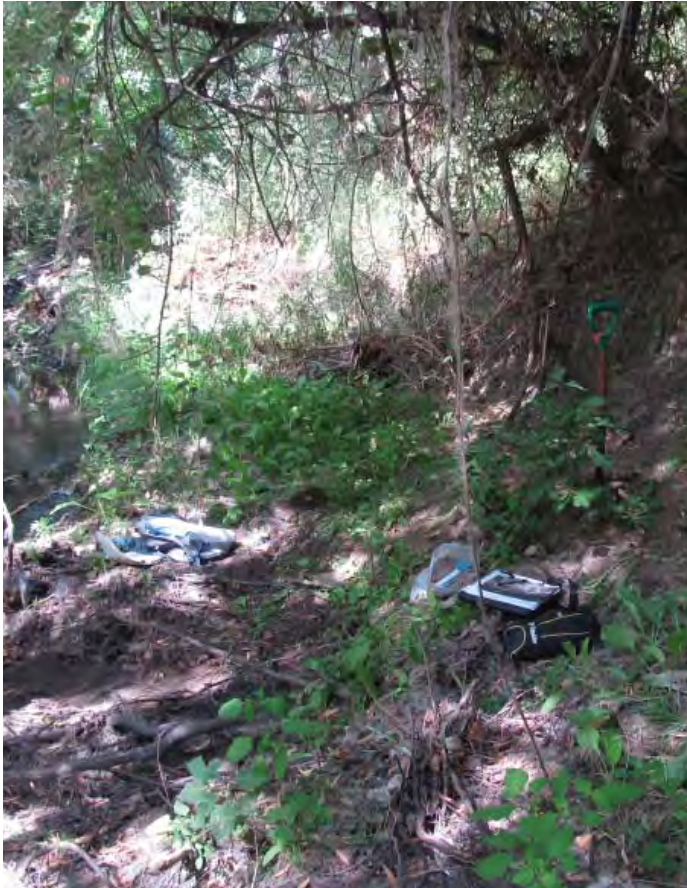
Sampling Point 5. Looking north at southern riparian forest in the central portion of the study area, just upslope of Sampling Point 4. Sampling point is within CDFW jurisdictional habitat.

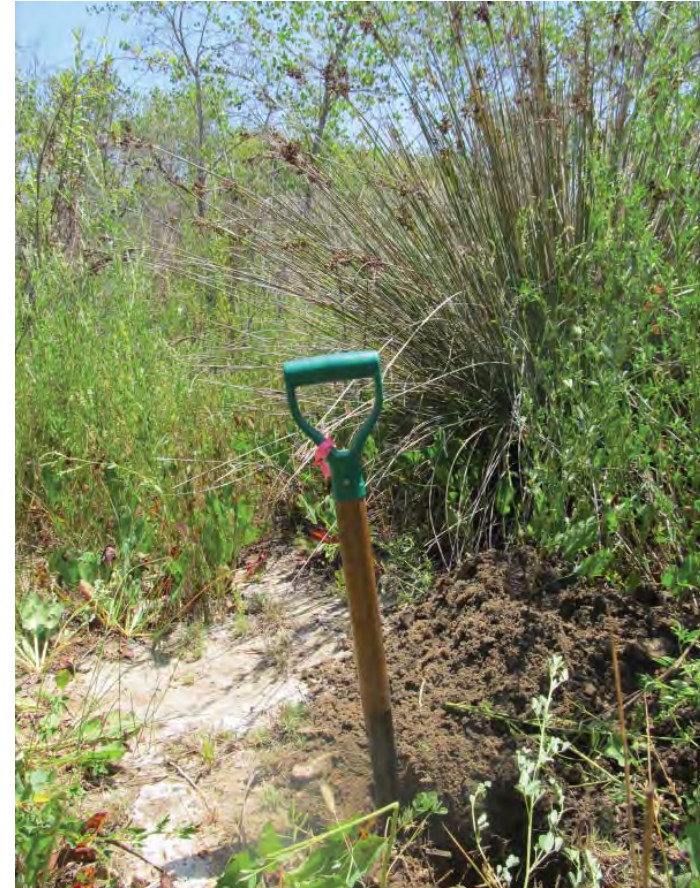
Sampling Point 6. Looking north at southern riparian forest in the eastern portion of the study area. Sampling point is within CDFW jurisdictional habitat.

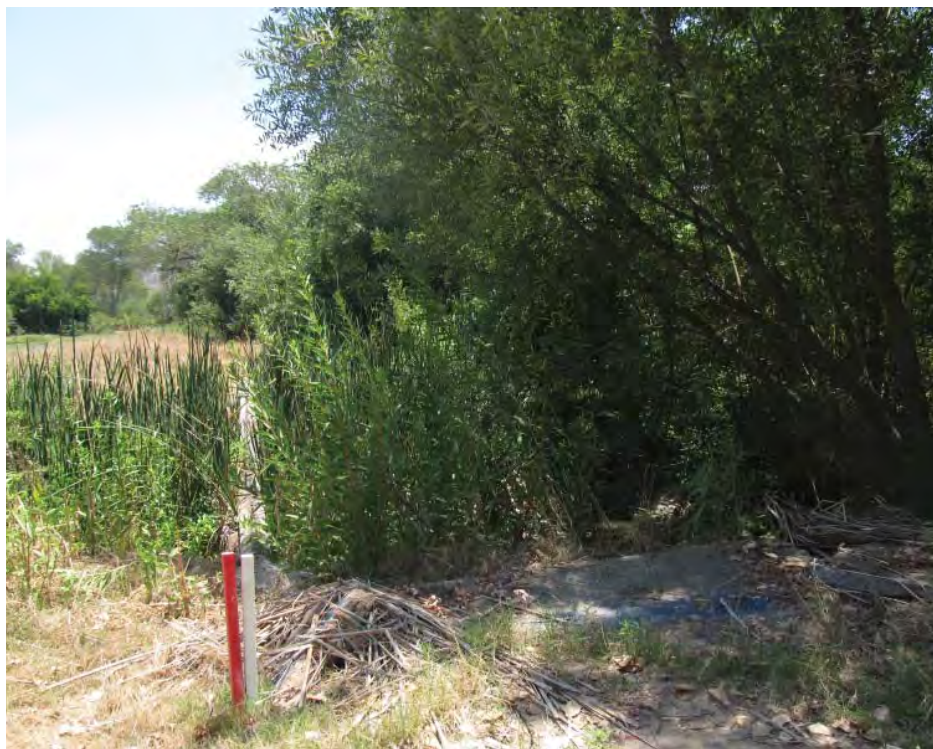
Photo 1. Looking south at freshwater marsh and southern willow scrub along Sycamore Creek in the western portion of the study area.

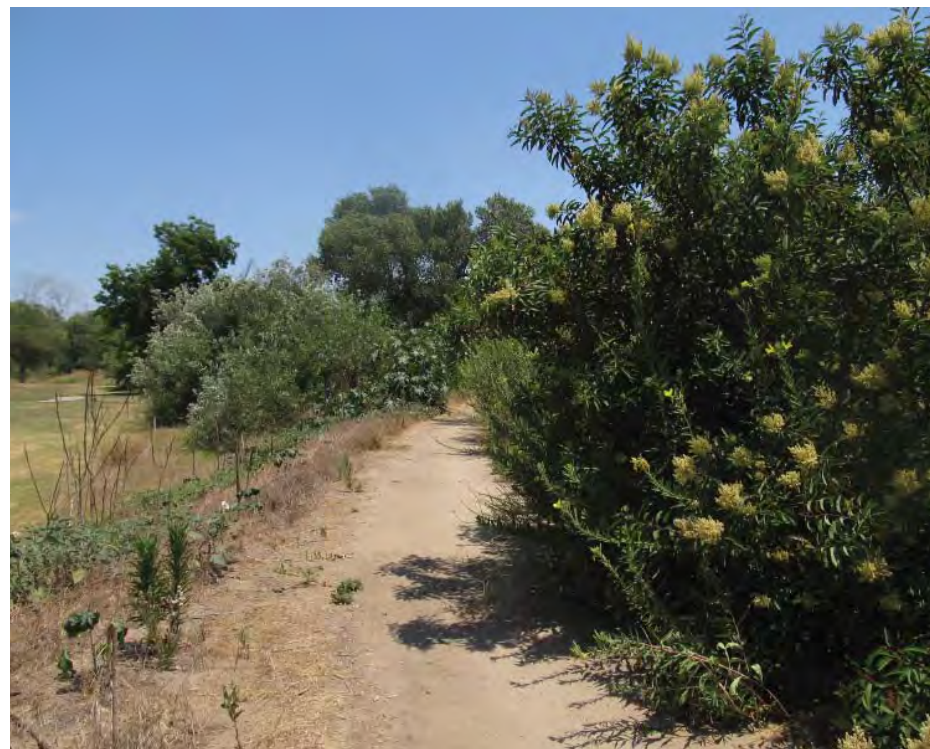
Photo 2. Looking east at the existing dirt trail on top of the berm in the western portion of the study area.

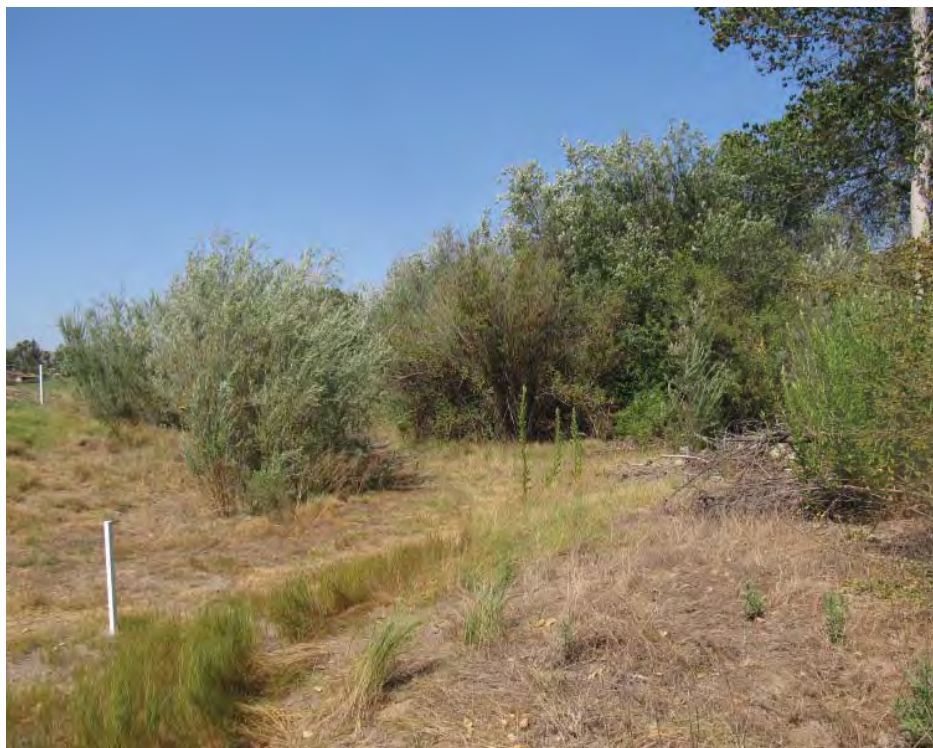
Photo 3. Looking east at southern willow scrub in the central portion of the study area. This habitat is north of the berm that abuts the San Diego River.

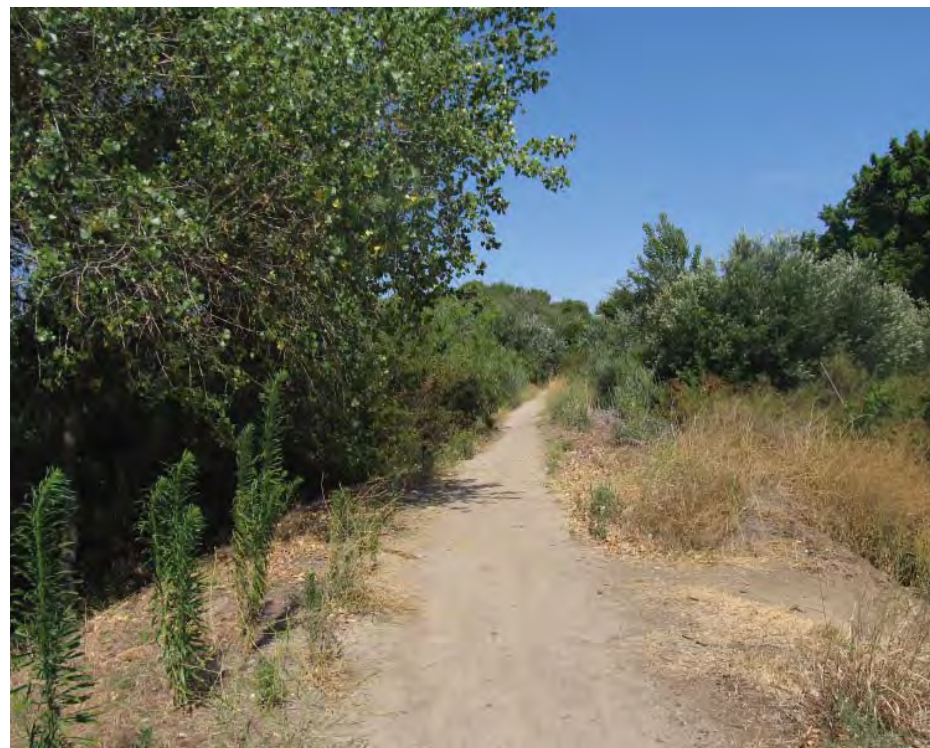
Photo 4. Looking east at the existing dirt trail on top of the berm in the central portion of the study area.

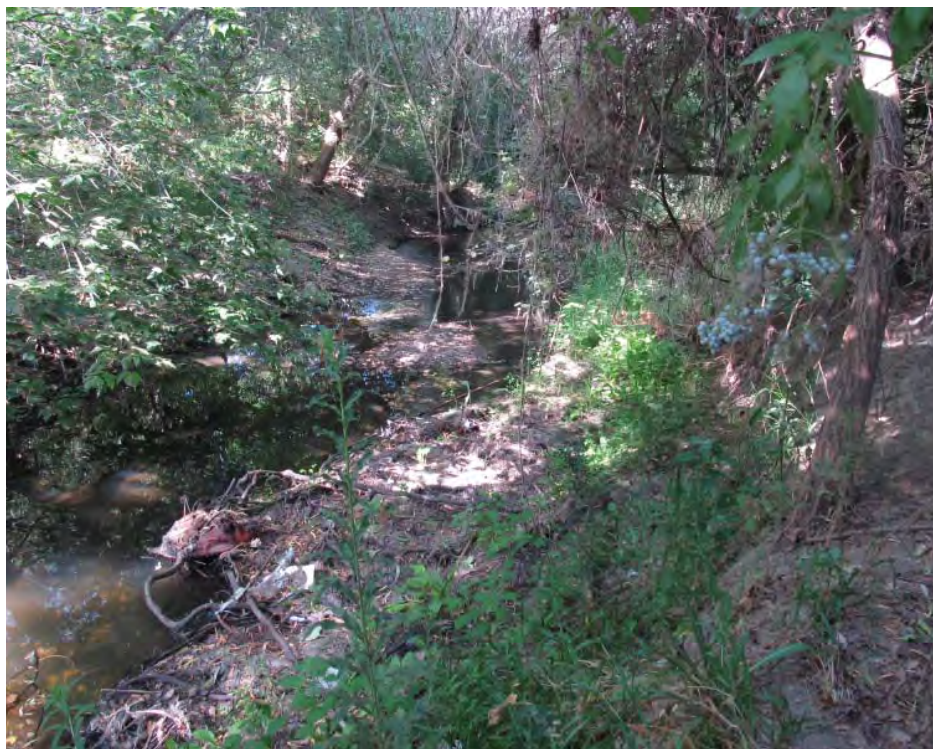
Photo 5. Looking west at the San Diego River channel and associated riparian forest habitat in the central portion of the study area.
