# **JURISDICTIONAL DELINEATION REPORT**

## **San Diego River Trail**

### **Carlton Oaks Golf Course Segment Project**

**January 2017**

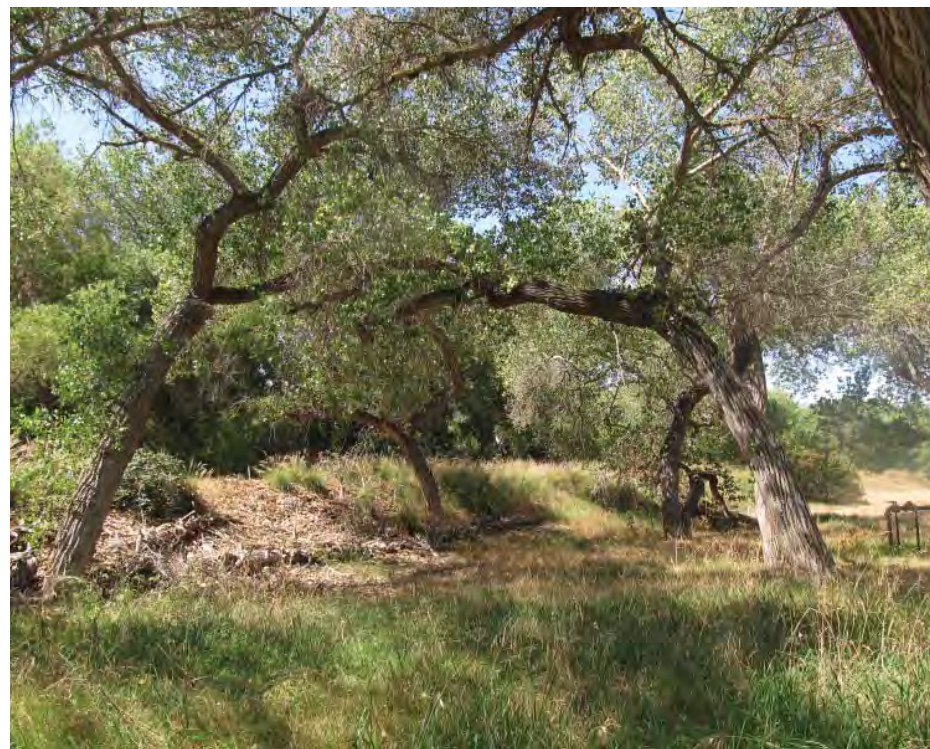
Photo 6. Looking southwest at a stand of southern riparian forest adjacent to the golf course in the eastern portion of the study area.

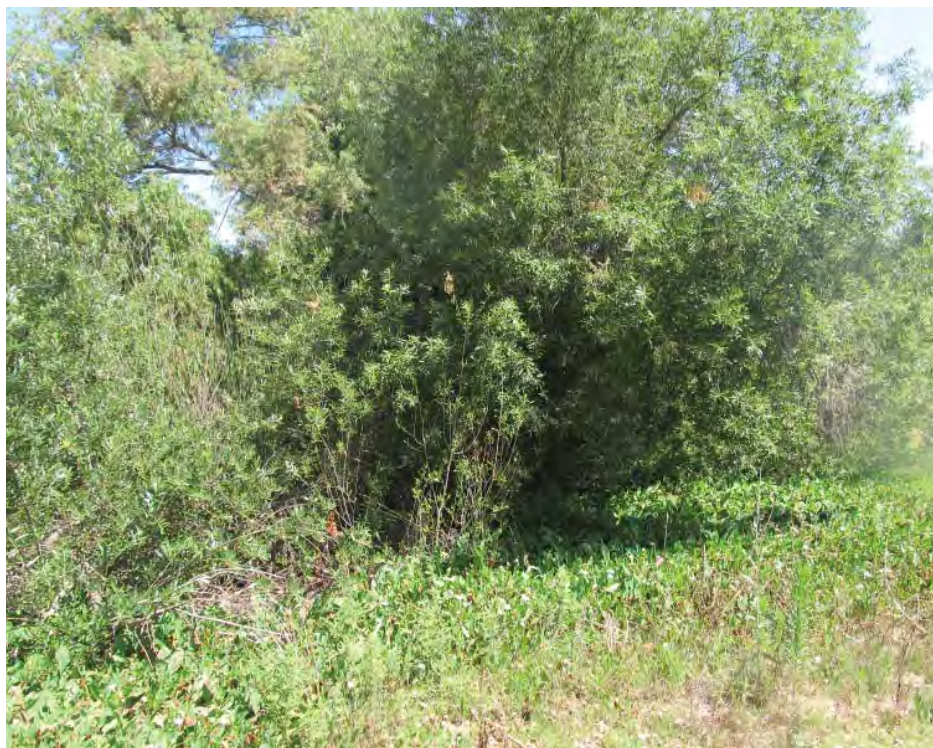
Photo 7. Looking north at a small stand of southern riparian forest east of the golf course maintenance building in the eastern portion of the study area.

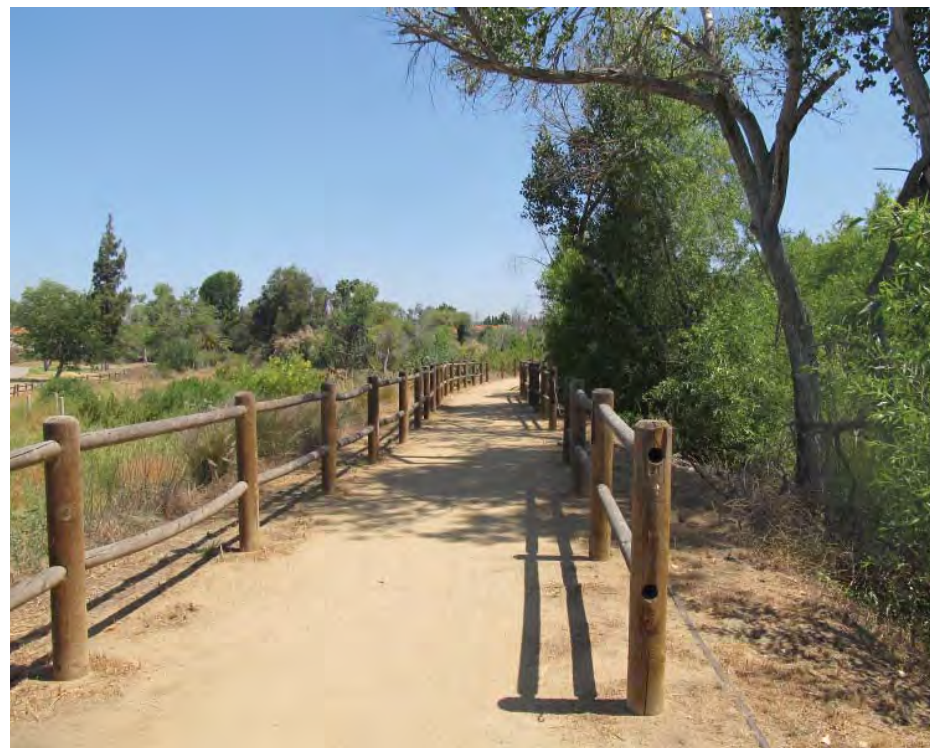
Photo 8. Looking north at the existing San Diego River Trail just east of the golf course.

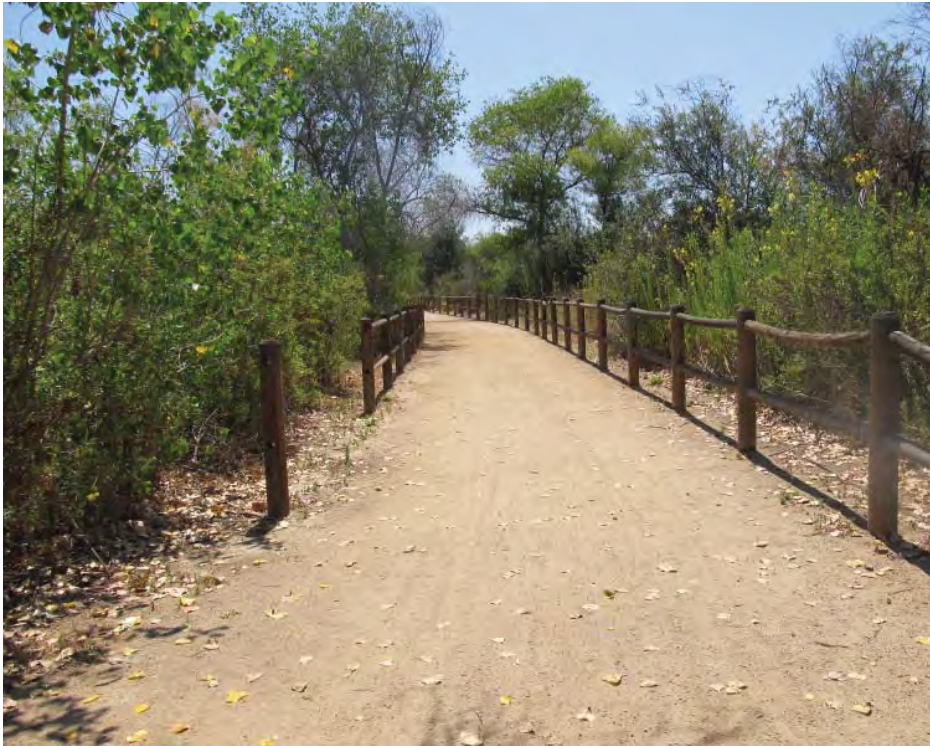
Photo 9. Looking east at the existing San Diego River Trail just east of the golf course.

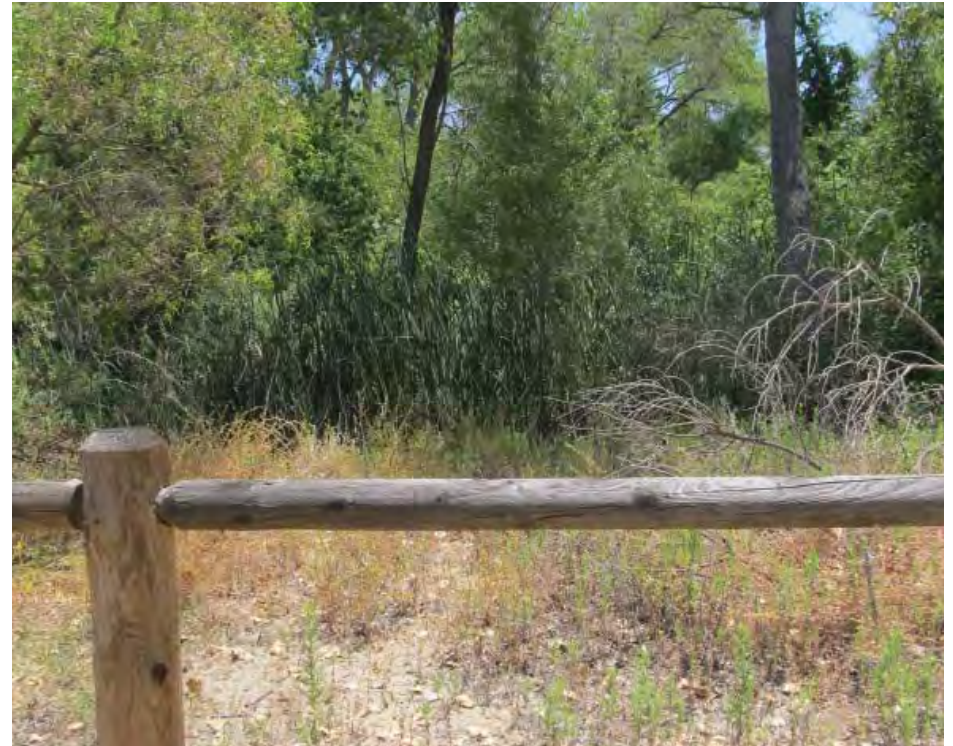
Photo 10. Looking south at riparian forest along the existing San Diego River Trail in the eastern portion of the study area.

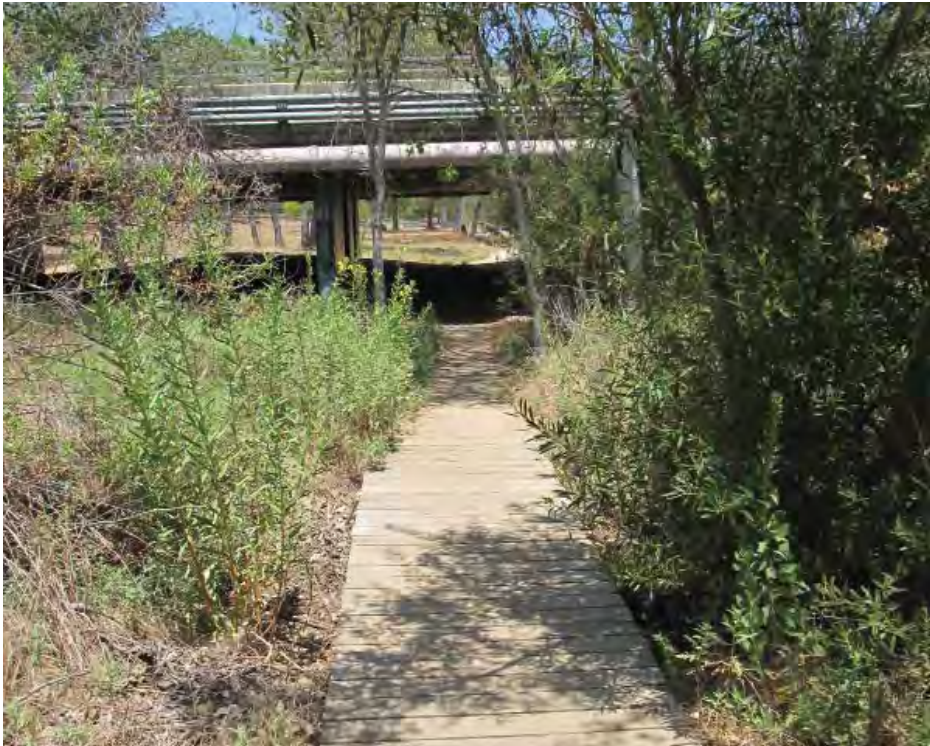
Photo 11. Looking east at a small bridge crossing of non-wetland Waters of the U.S. and CDFW riparian habitat in the eastern portion of the study area.

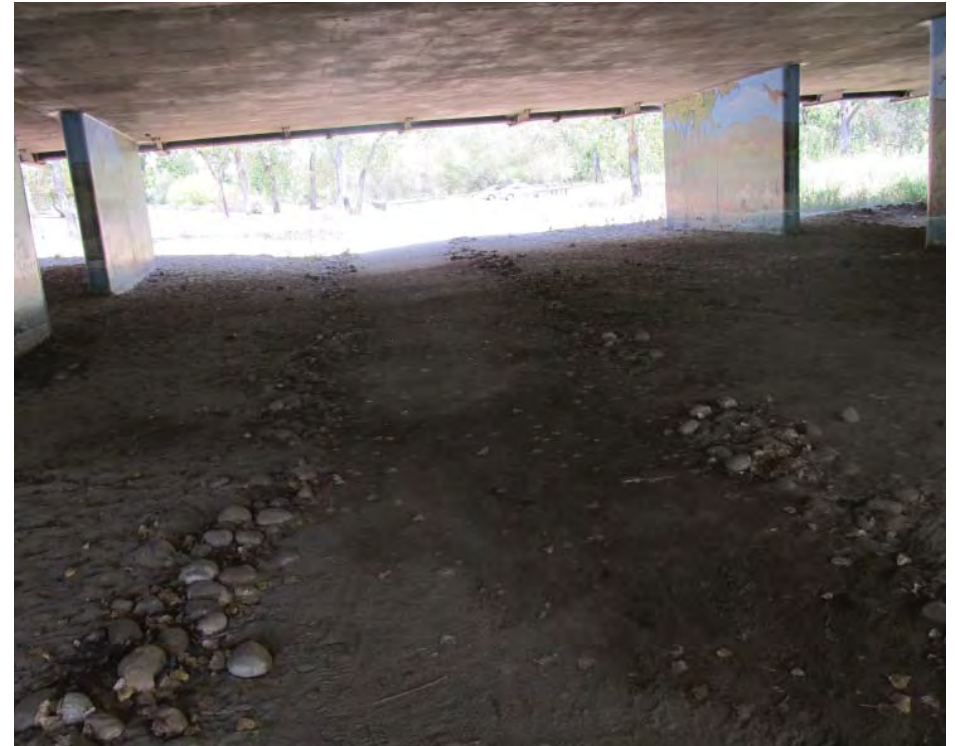
Photo 12. Looking east at the undeveloped trail below the Carlton Hills Boulevard bridge in the eastern portion of the study area.

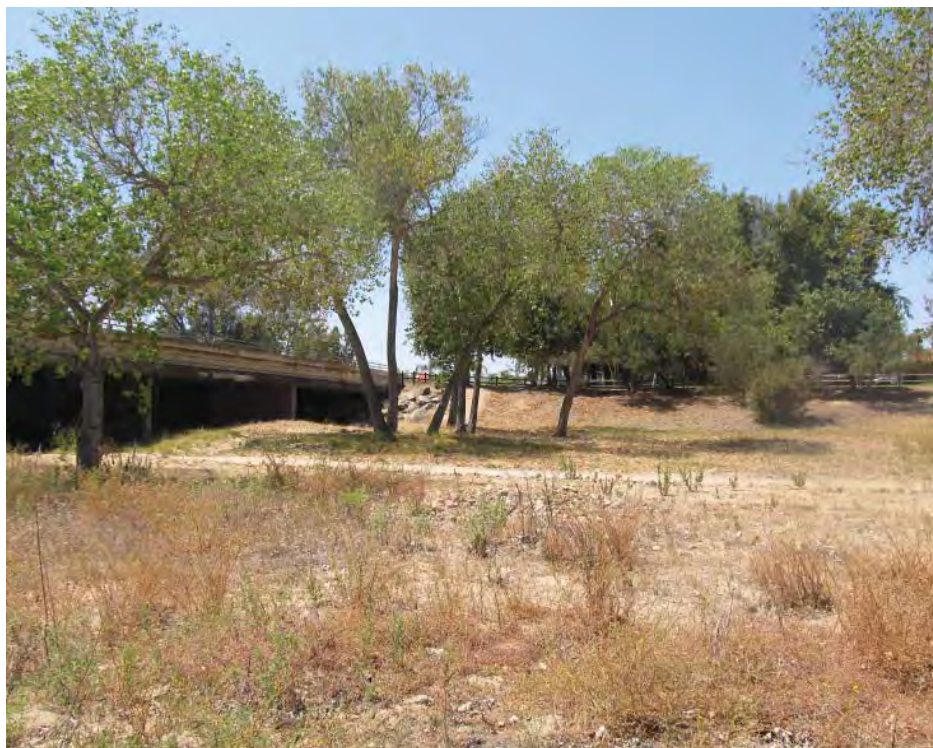
Photo 13. Looking northwest at disturbed southern riparian forest in Mast Park, just east of Carlton Hills Boulevard.

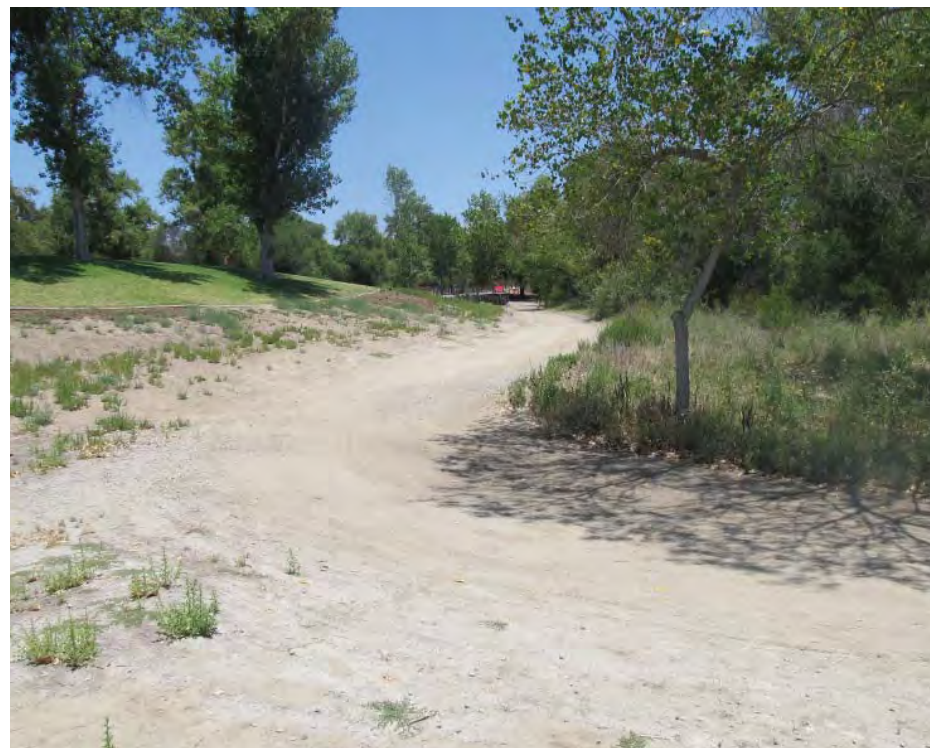
Photo 14. Looking east at an existing dirt trail in Mast Park in the eastern portion of the study area.
