**Phase I Environmental Site Assessment**  
**San Diego River Trail – Carlton Oaks Segment**  
**Santee, San Diego, California**

13 January 2017  
AGE Project No. 16-3919

San Diego Association of Governments (SANDAG)  
and  
Nasland Engineering

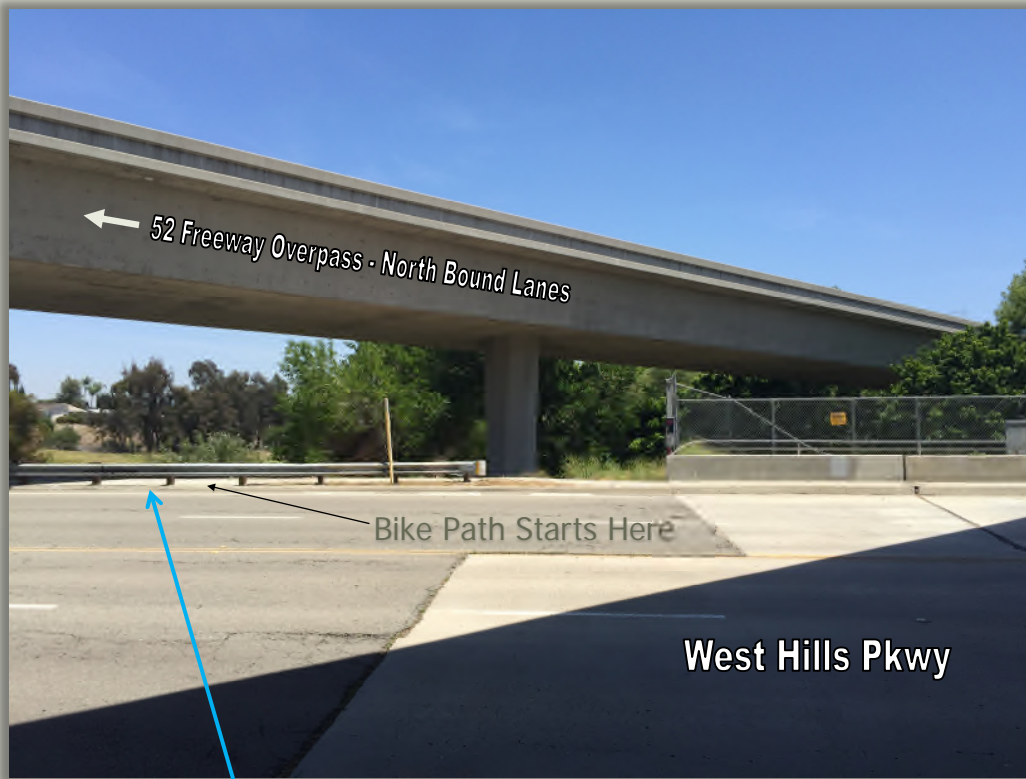
Photograph 1: Viewing east at the west entrance of the bikeway route located on West Hills Pkwy.

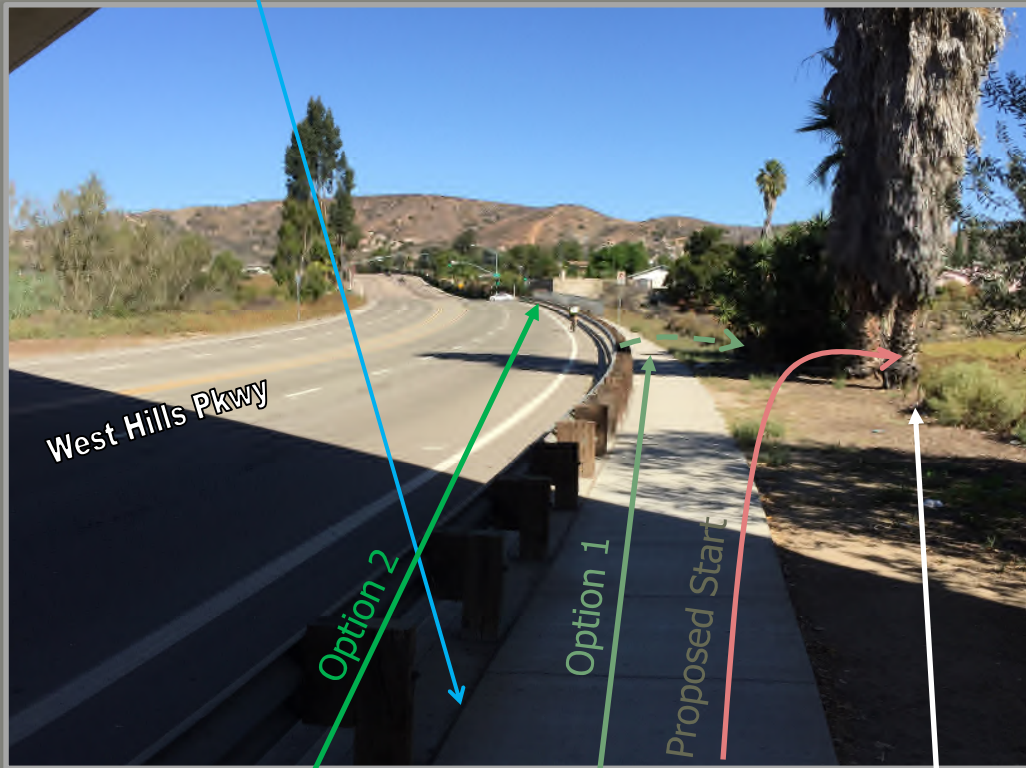
Photograph 2: Viewing north at the west entrance and start to the bikeway. Option 1 entrance of the bikeway will start here. Option 2 entrance of the bikeway will start here next to the residential area. **Note**, arrows on picture are showing approximate trail locations and start points.

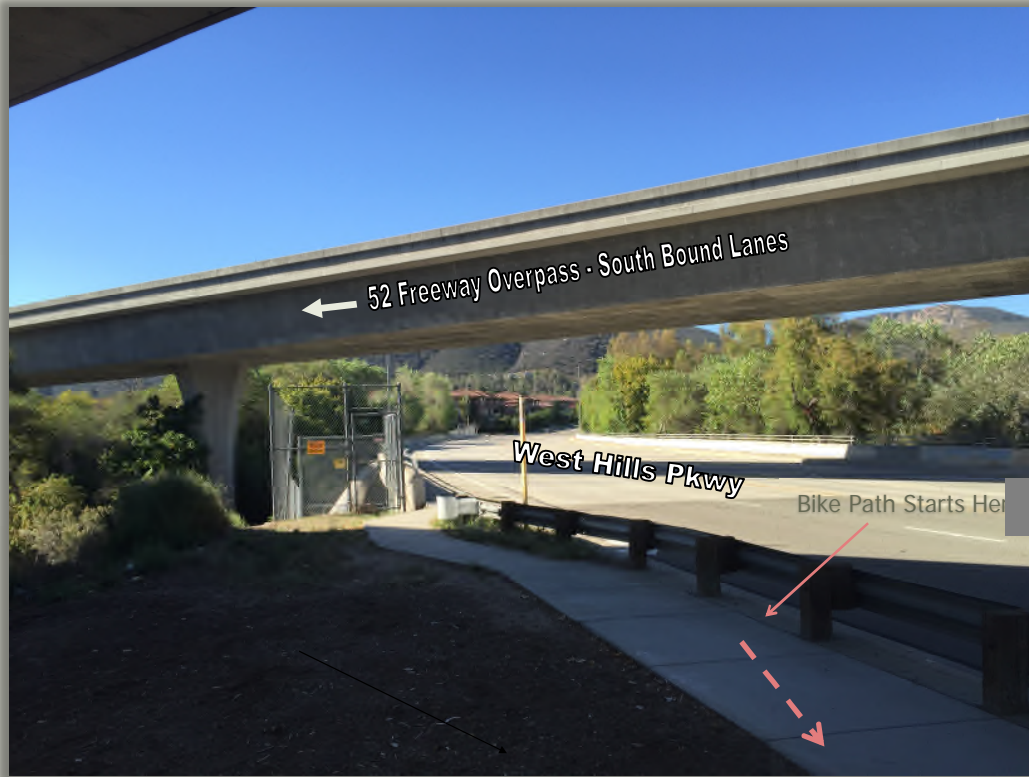
Photograph 3: Viewing south at the west entrance of the bikeway as identified on photographs 1 and 2 of the proceeding page.

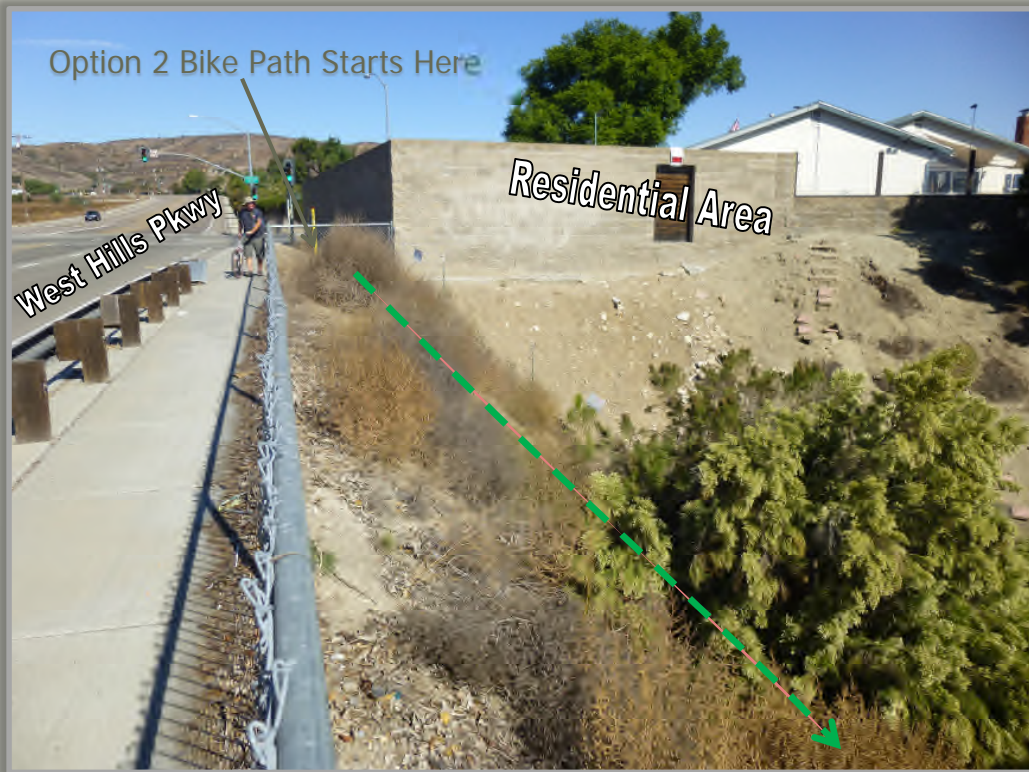
Photograph 4: Viewing north at Option 2 entrance of the bikeway as identified on photograph 2 of the proceeding page. This optional starting location is located approximately 100 feet south of Carlton Oaks Drive and adjacent the home pictured above.

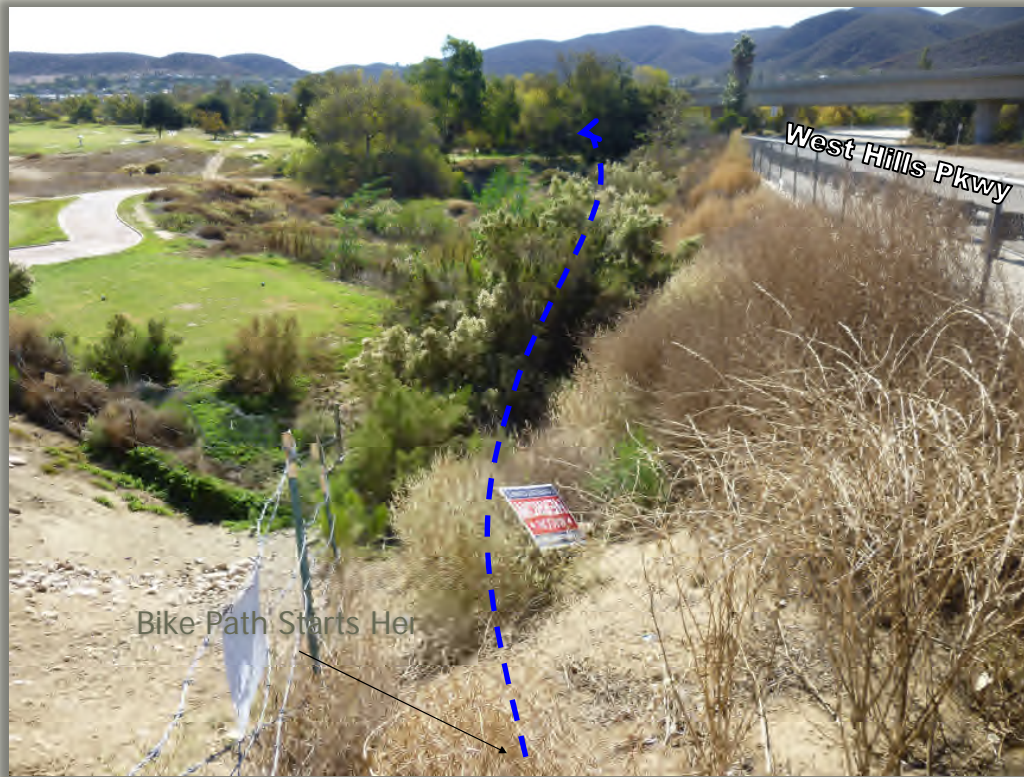
Photograph 5: Viewing south at Option 2 entrance pictured in photographs 2 and 4 in the proceeding pages.

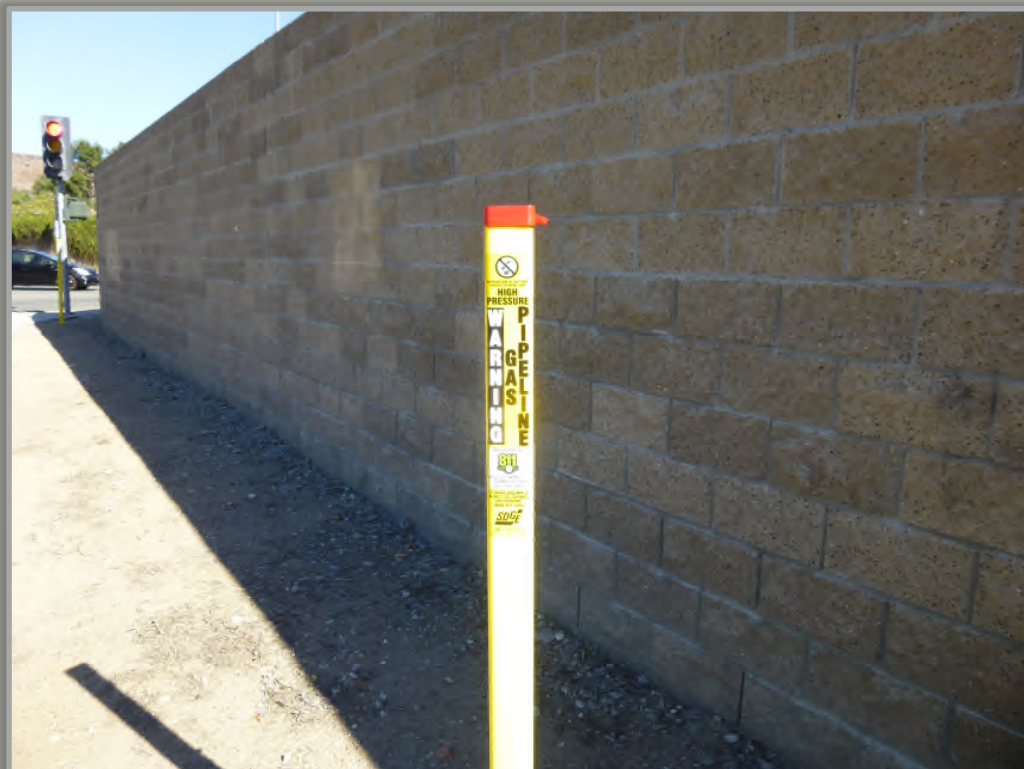
Photograph 6: Viewing north at sign indicating a 24" high pressure gas line is present underground. This line extends along eastern shoulder of West Hills Pkwy near the starting point of the Option 2 bikeway entrance. Unless extensive excavation will take place, it is unlikely this gas line will be disturbed.

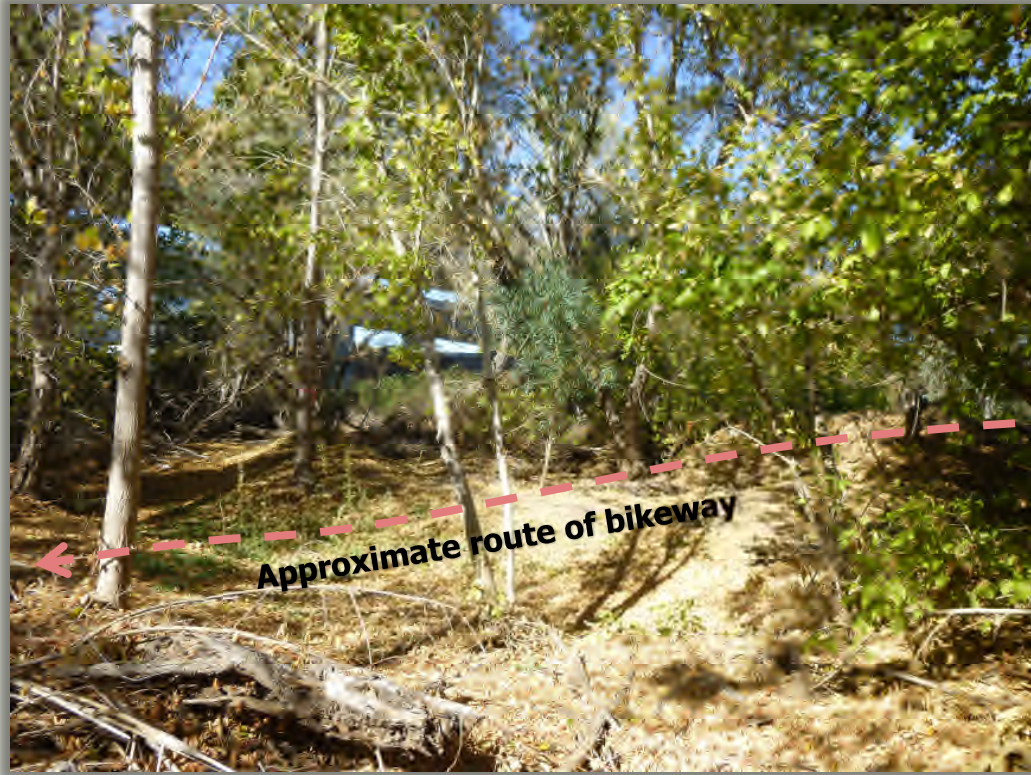
Photograph 7: Viewing west slightly below the west entrance of the bikeway path from West Hills Pkwy. 52 Freeway overpass pictured in background.

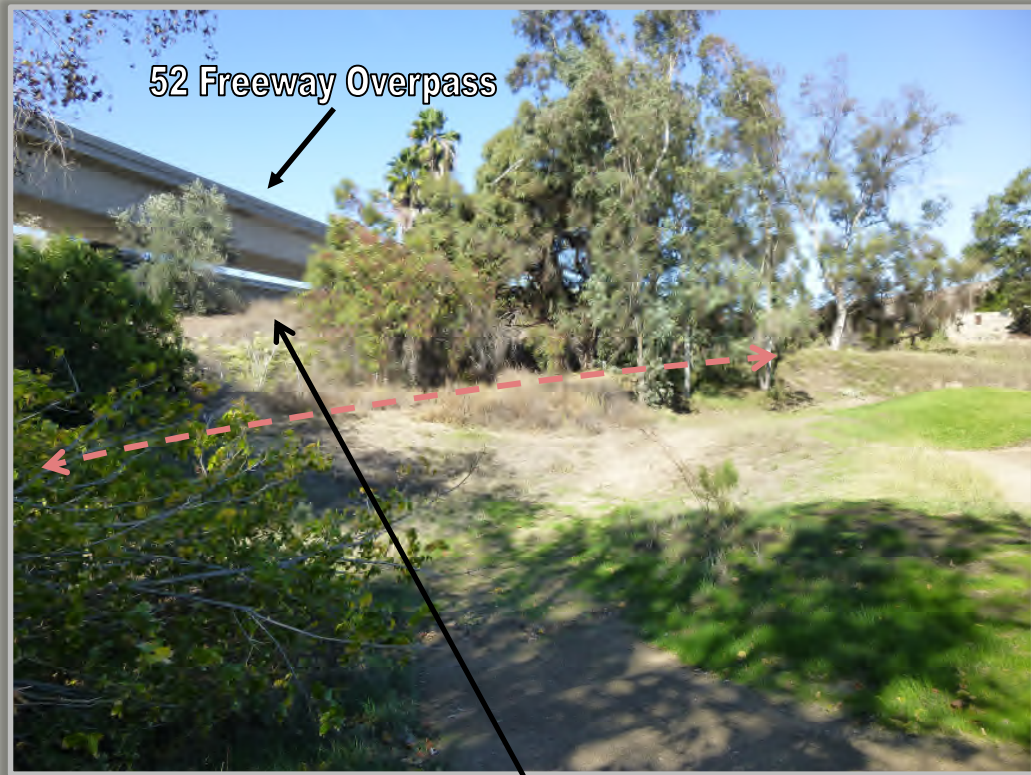
Photograph 8: Viewing west just below West Hills Pkwy at the proposed bikeway path as it extends in a southeasterly direction. All routing options as identified in photographs 2 and 4 of the proceeding pages will follow this path. Golf course green pictured on right.

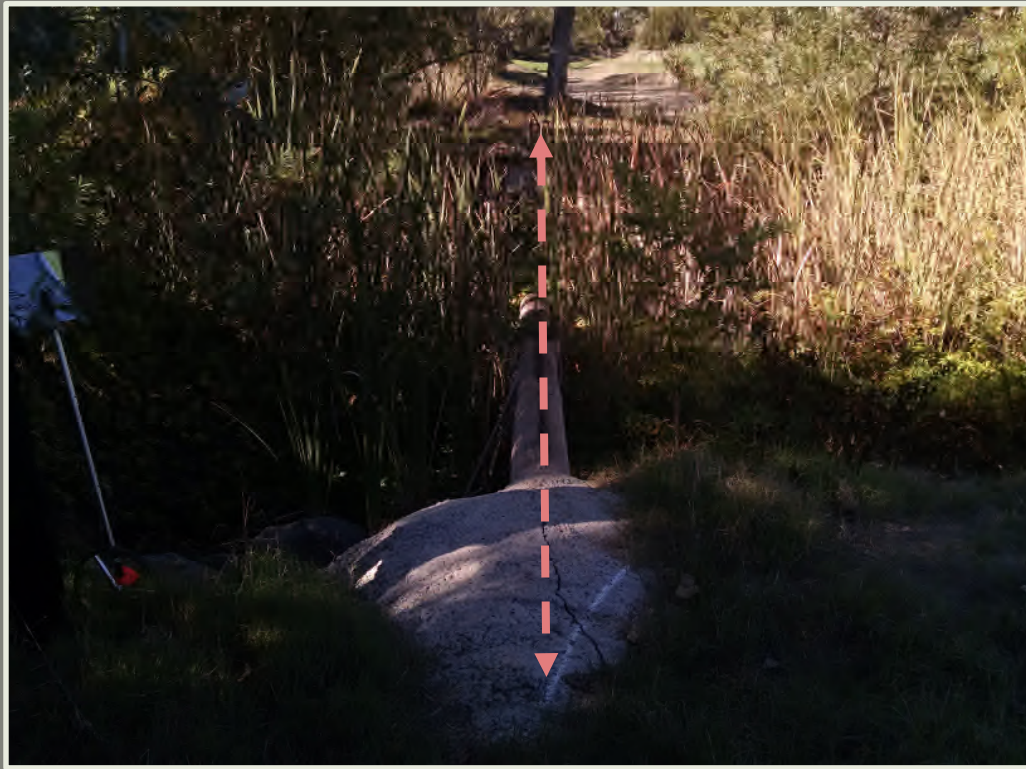
Photograph 9: Viewing west at bikeway route that will cross a section of the San Diego River which extends from the adjacent golf course.

- As the subject property heads in a southeasterly direction it will transverse a small creek (photograph 9), originating from the golf course and referred to as the San Diego River. At the time of our inspection there was a small amount of

standing water in this creek (6" to 8"). There was no indication of any discolorations, odors or sheen in this water. From the small creek, the subject property will be constructed along a narrow dirt pathway bordering the golf course (photograph 10). The subject property will continue east following the route of the existing dirt path (photograph 11 and 12).

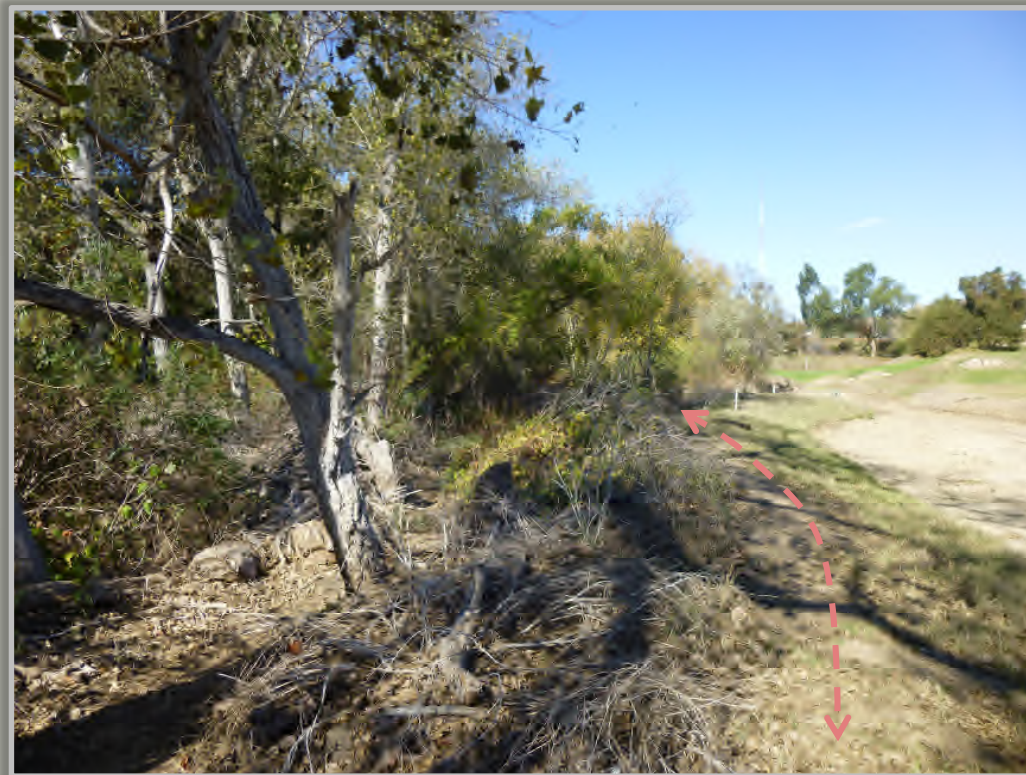
Photograph 10: Viewing west at bikeway path located in the western portion of the project area. The route of the bikeway follows a narrow strip of land that separates the golf course and San Diego River in the western portion of the project area.

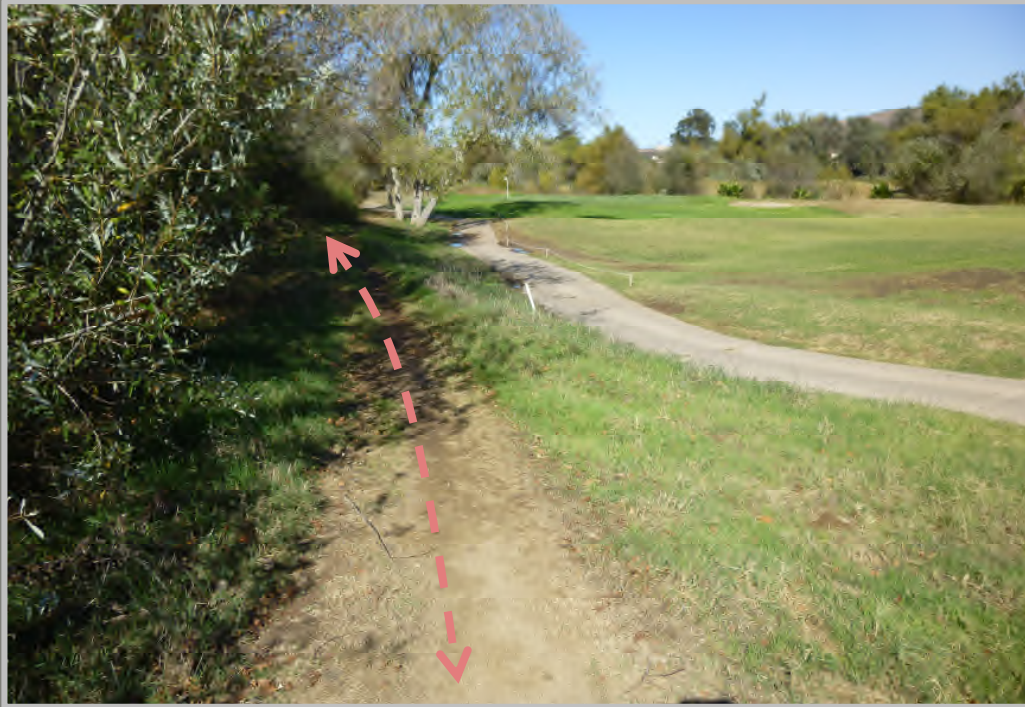
Photograph 11: Viewing west where the bikeway path parallels a cart path extending along the southern border of the golf course.

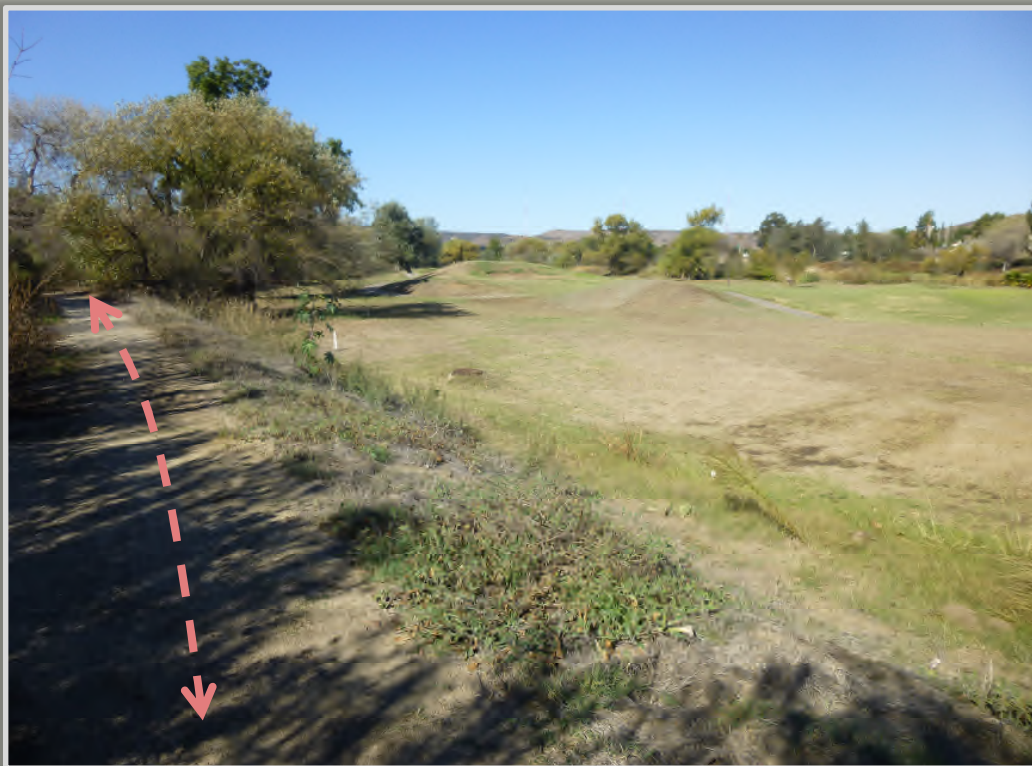
Photograph 12: Viewing west along a dirt path proposed for the bikeway route. This portion of the path parallels a fairway portion of the golf course pictured on right.

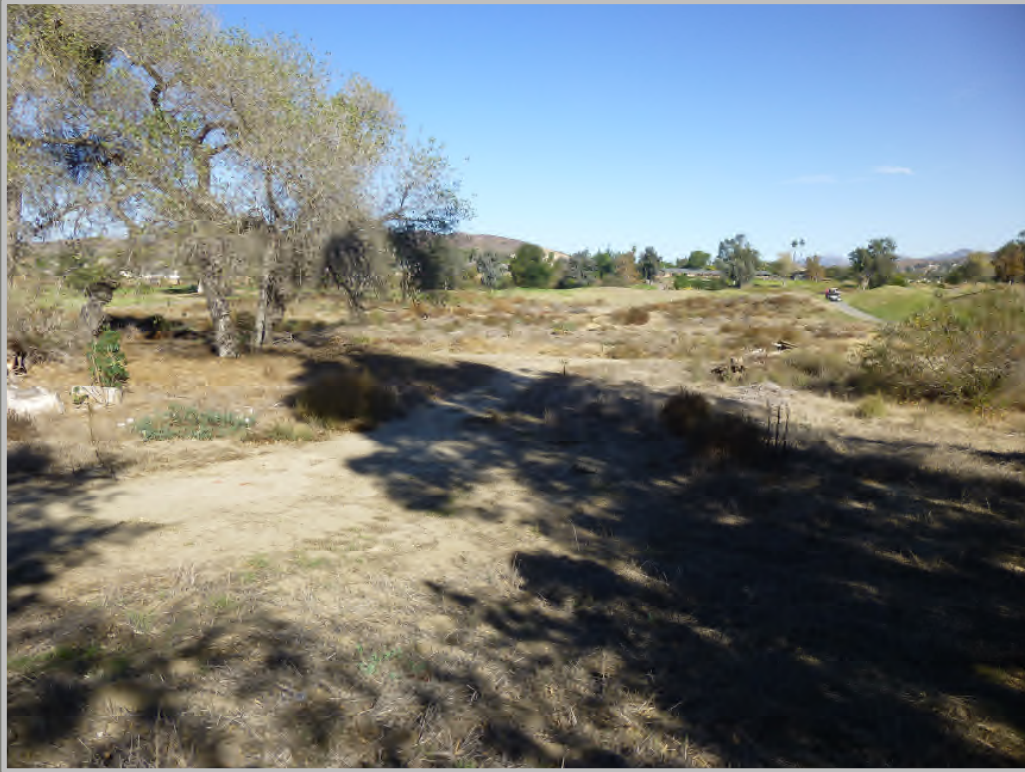
Photograph 13: Viewing north from the bikeway trail at an area of the golf course in which the project boundaries will extend approximately 250 feet from the proposed bikeway trail.

- Approximately 0.92 miles from the western starting point at West Hills Parkway a section of the property will extend out to the north approximately 200 feet from the subject property (photograph 13 and 14). This is an area of the golf course used to dump golf course debris (grass clipping, shrub clippings, etc.). There was no evidence of hazardous materials, stained soil or illegal dumping of hazardous materials in this area.

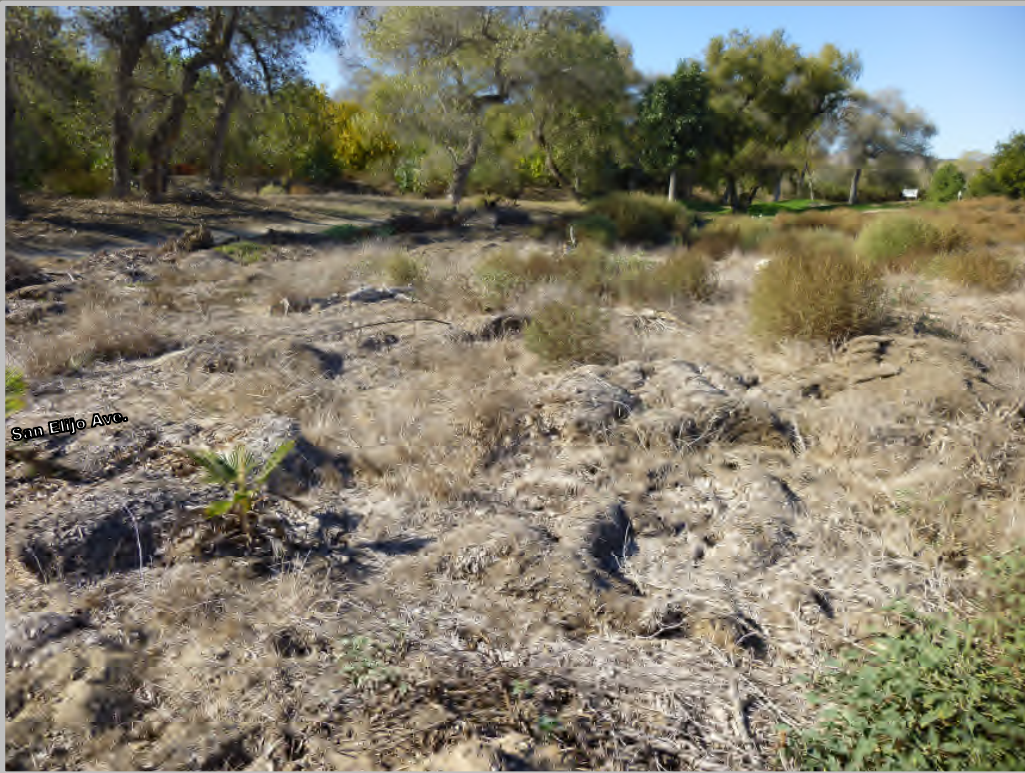
Photograph 14: Viewing west at an area pictured in photograph 13 above where the boundaries of the project will extend. Miscellaneous golf course debris is dumped (lawn clippings, tree branches, etc.) in this area. There was no visual indication of any hazardous debris dumping in this area.

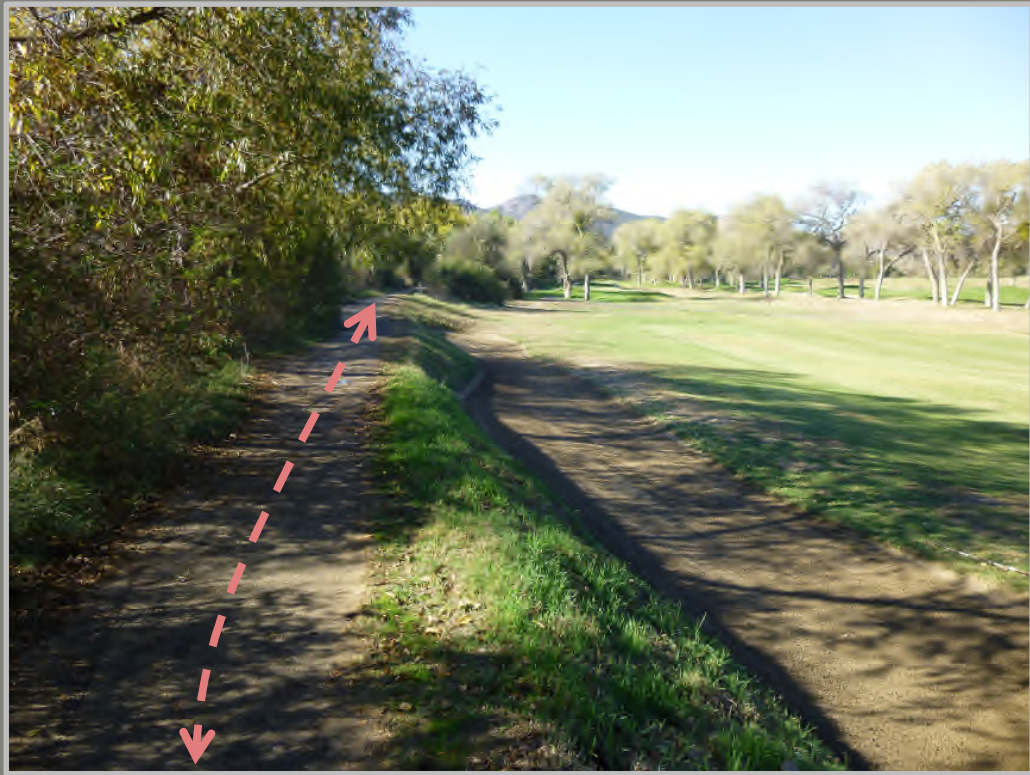
Photograph 15: Viewing west along a portion of the proposed bikeway fronting the golf course pictured on the right.

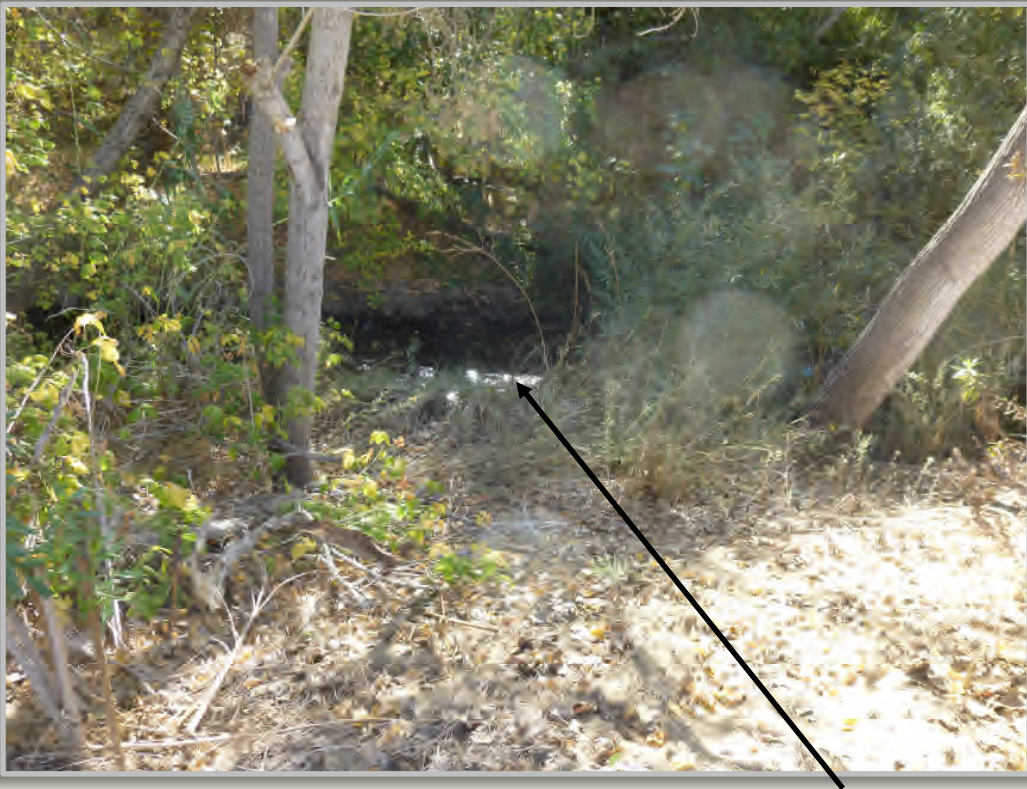
Photograph 16: Viewing south from the bikeway path at the Forester Creek which borders sections of the bikeway route along the western portion of the project area.

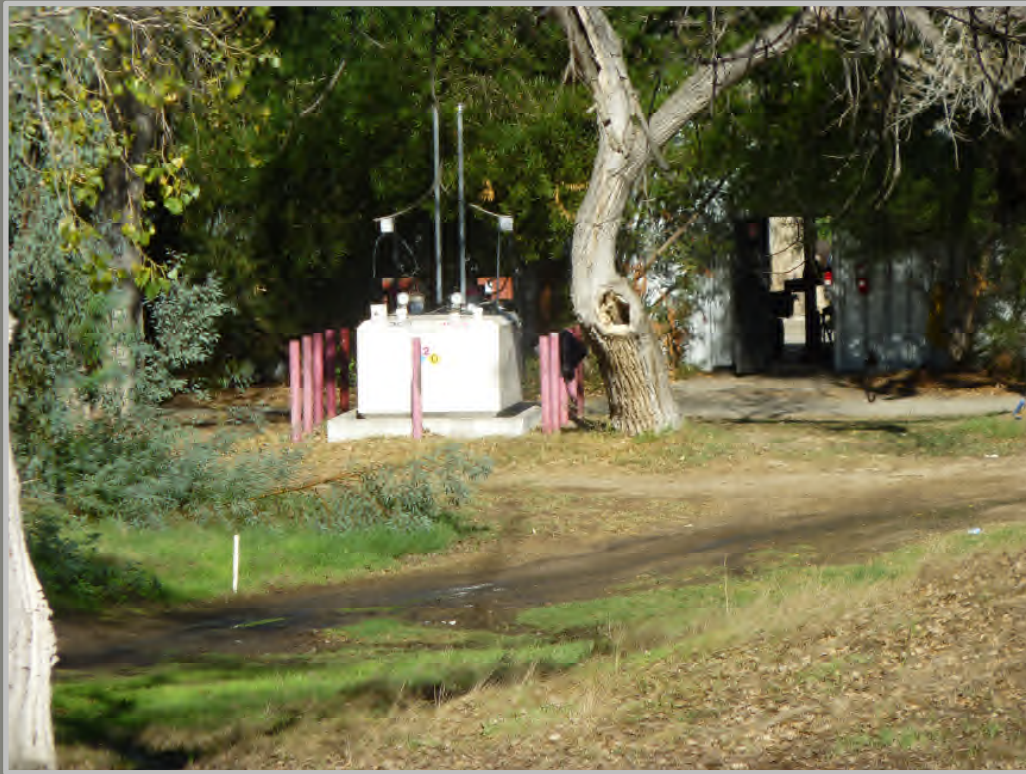
Photograph 17: Viewing north from bikeway trail at an above ground fuel storage tank located next to the golf course maintenance building. The tank is located approximately 400 feet north of the bikeway trail.

- In the eastern section of the subject property, as the property starts to curve in a northeasterly direction, the Carlton Oaks Golf Course maintenance building is located approximately 300 feet from the property. An above ground fuel tank is located on the south side of this building (Photograph 17). The observation of this tank was made from the project area using binoculars. The tank appeared in good condition with no apparent leaks or staining around the base of the tank. AGE believes the location of this tank was the former location of an underground fuel storage tank (UST) which was removed in 1991 from the golf course. The former UST leaked gasoline into the soil. Ground water was not impacted. The contaminated soil was removed and the regulatory agency granted closure to the site in 1992. (See Section 3.4.1. of this report for details of this former UST).

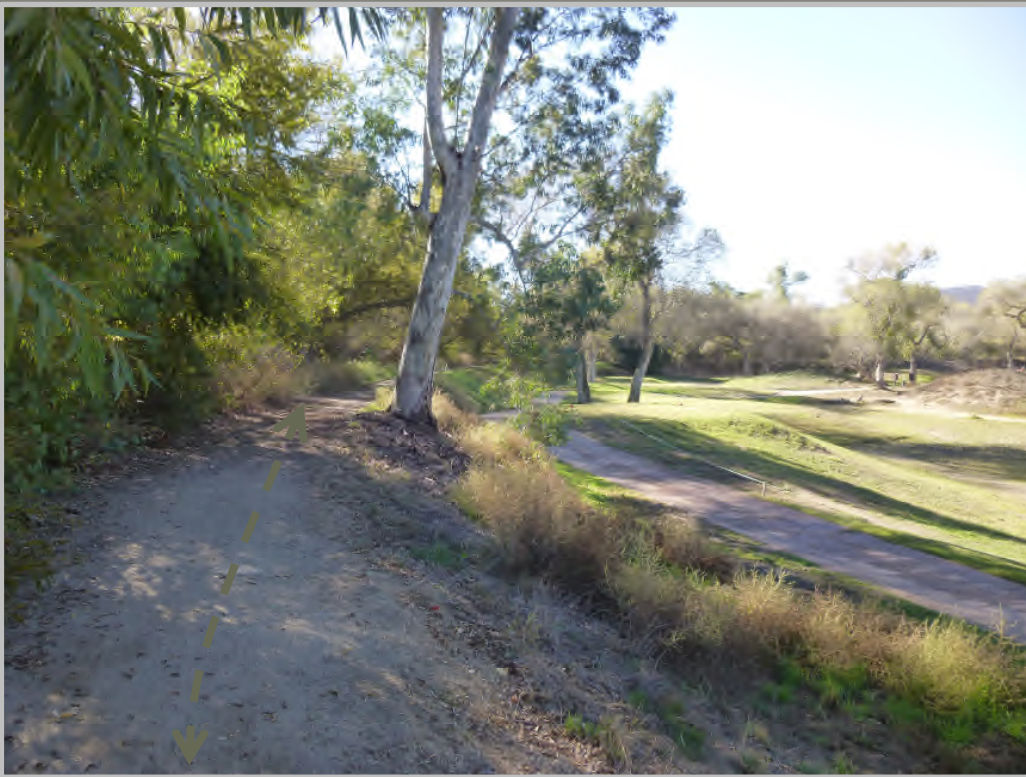
Photograph 18: Viewing southwest at a section of the bikeway trail extending along the eastern portion of the golf course just south of the end of the Mast Park trail pictured in photograph 19.

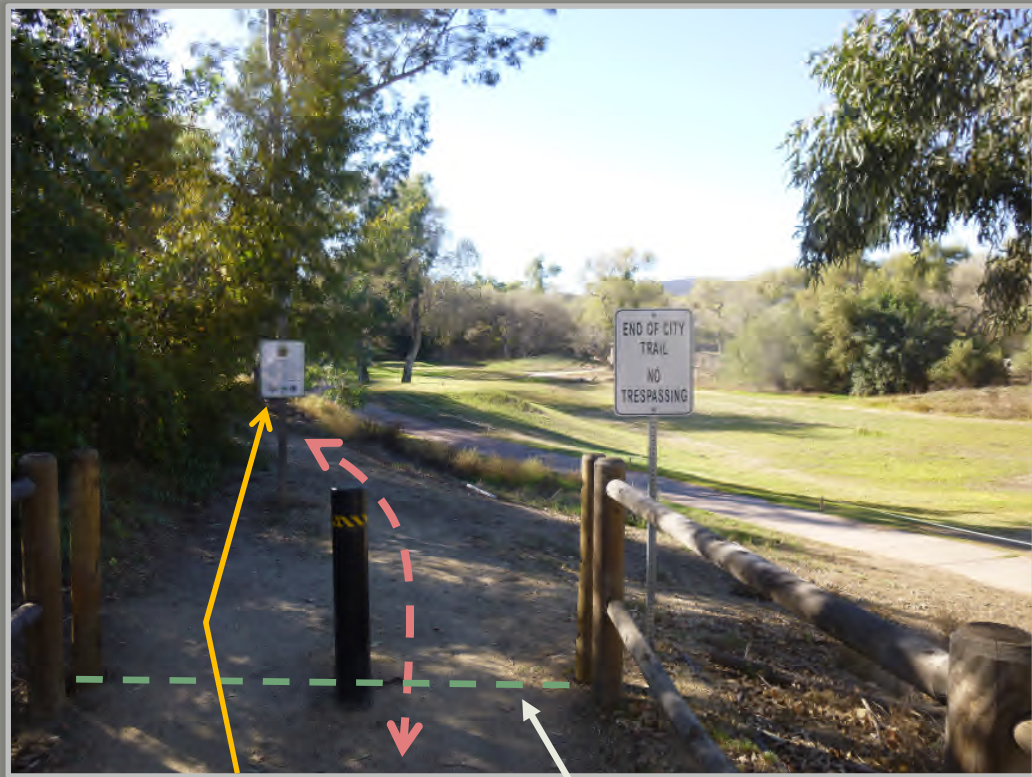
Photograph 19: Viewing southwest at the end of the existing Mast Park dirt trail and the location of where the bikeway will continue.

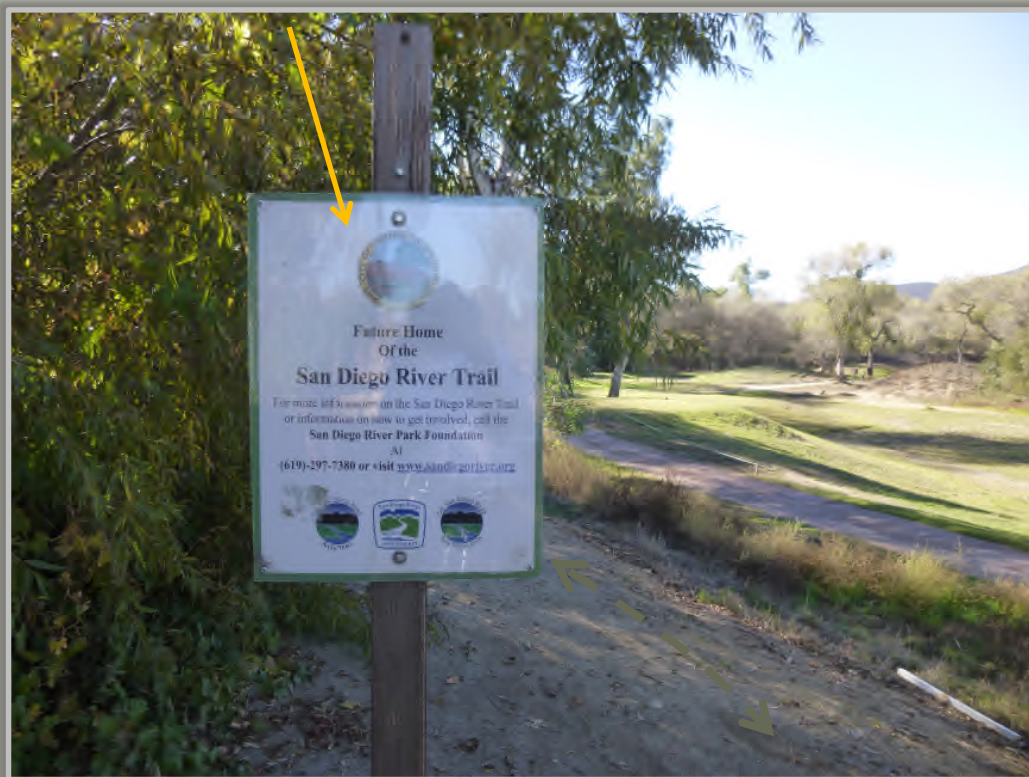
Photograph 20: Viewing southwest at sign indicating the “future home of the San Diego River Trail” bikeway path.

- At approximately 1.50 miles from the starting point at West Hills Parkway the subject property joins up with an existing dirt trail in Mast Park (Photograph 19 and 20). From this point the property will follow a dirt trail in Mast Park in a northerly direction for approximately 0.15 miles at which point the property will turn east onto another dirt trail (Photograph 21 and 22). As the property heads east it will run parallel with Mast Park Lake (Photograph 23).

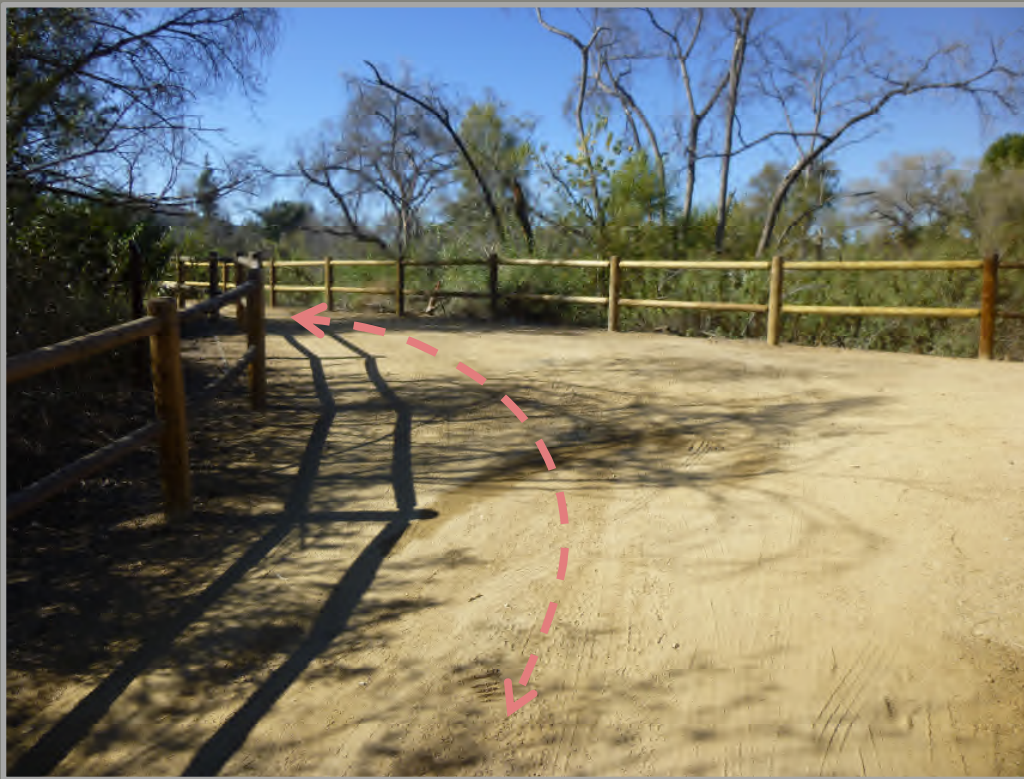
Photograph 21: Viewing west where the bikeway path follows the existing dirt trail in the west portion of Mast Park.

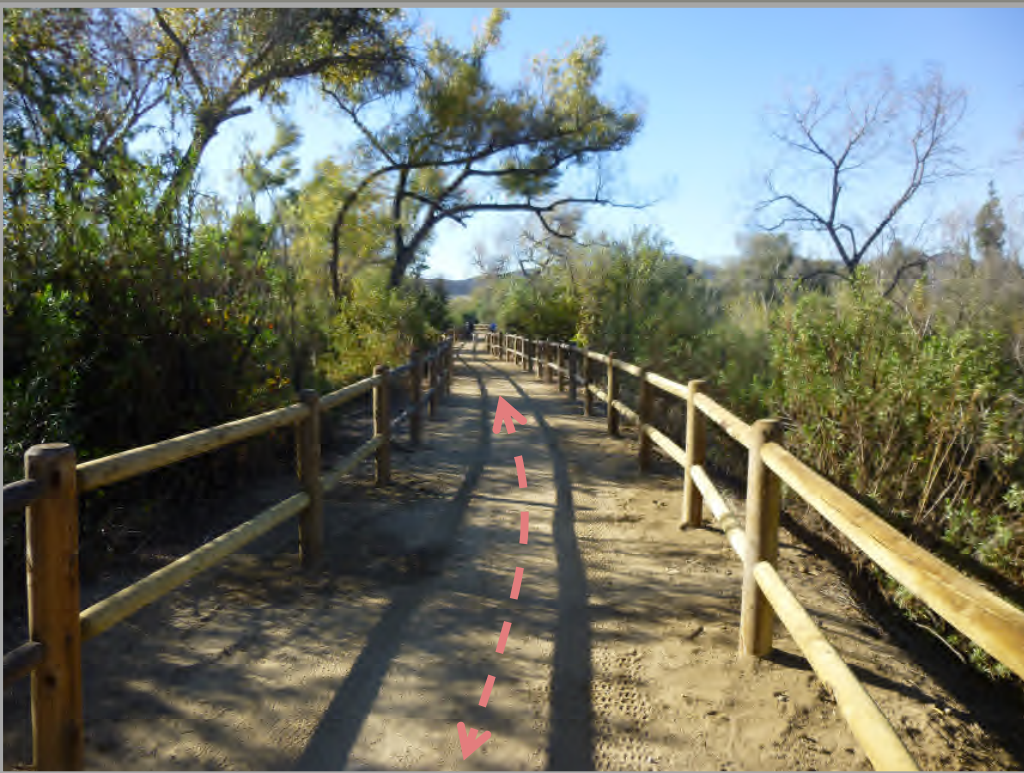
Photograph 22: Viewing east from photograph 21 above as the dirt trail in Mast Park extends east.

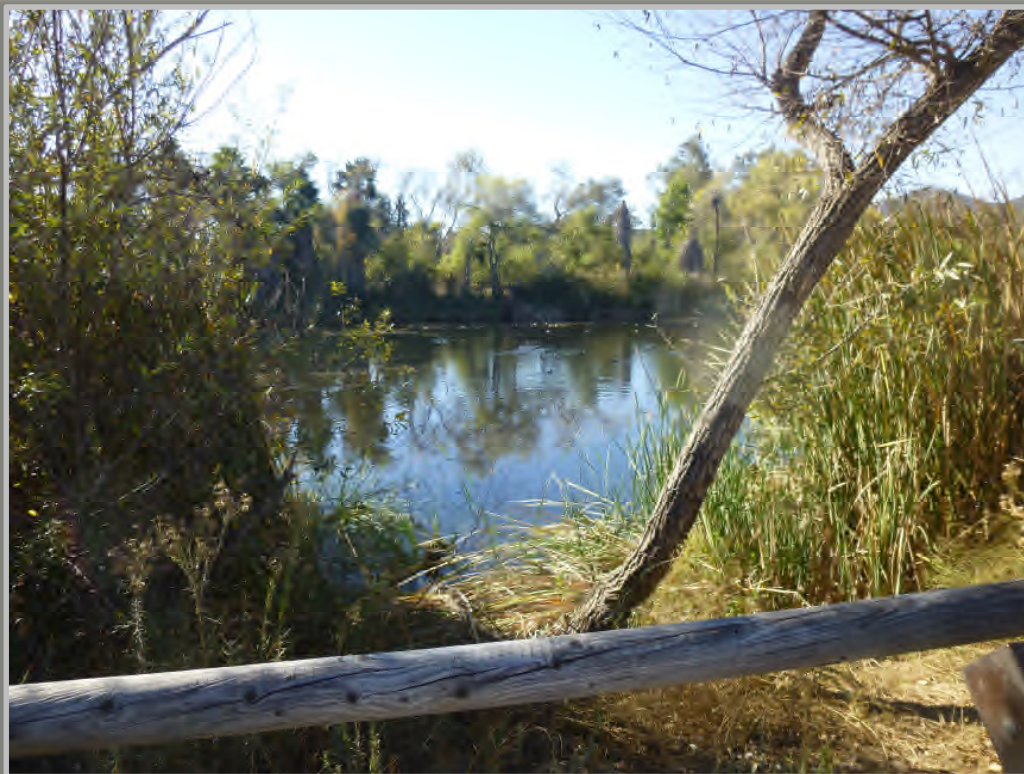
Photograph 23: Viewing south at Mast Park Lake which extends along a section of the proposed bikeway in the eastern portion of Mast Park.

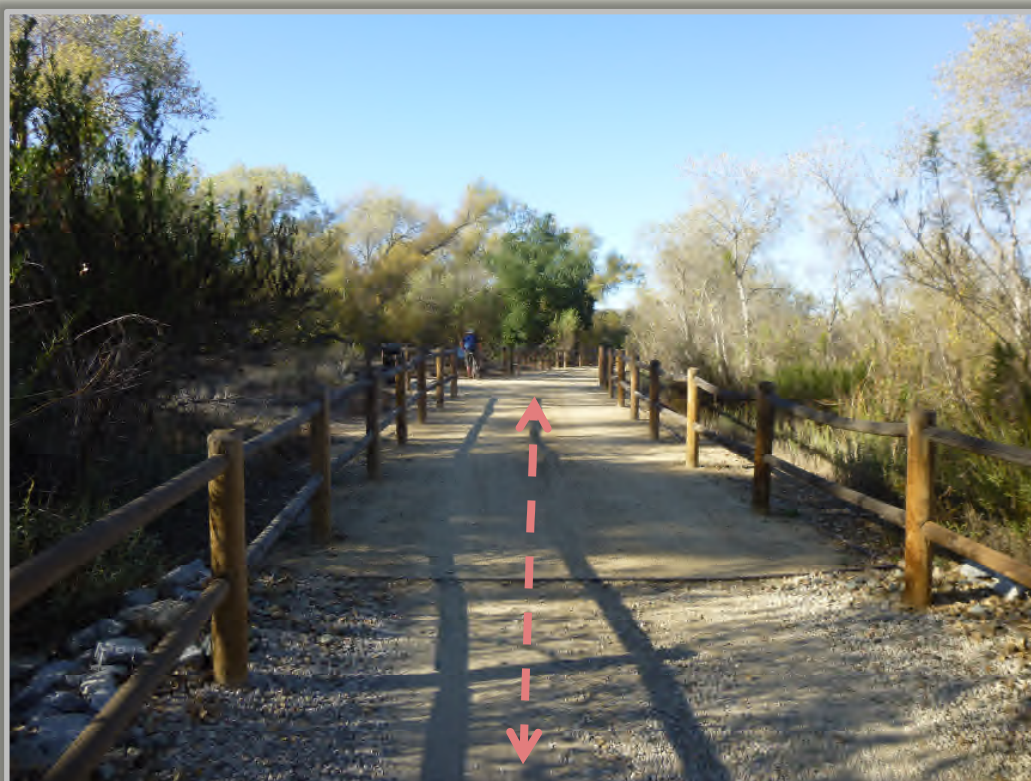
Photograph 24: Viewing east as the dirt trail in Mast Park from photograph 21 above.

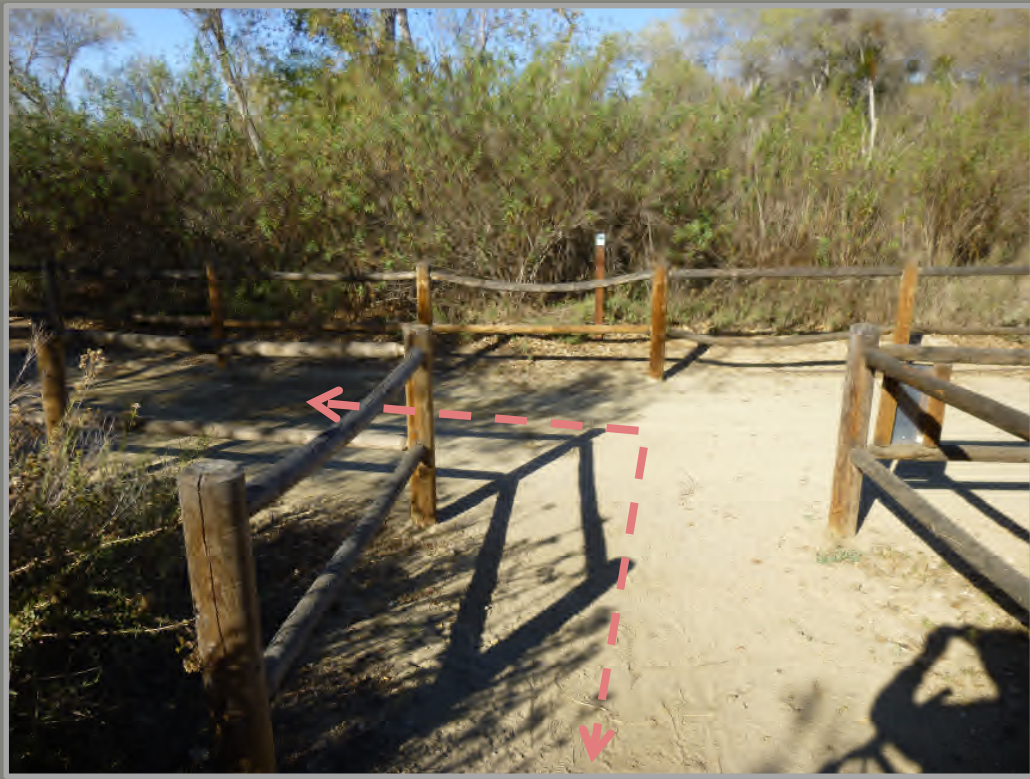
Photograph 25: Viewing west where the bikeway trail makes a right turn in the eastern portion of Mast Park to head east.

- Continuing east, the property will turn right (Photographs 25 and 26) where it crosses a small wooden bridge extending over a small drainage channel and continues under Carlton Hills Boulevard (Photograph 27). The subject property

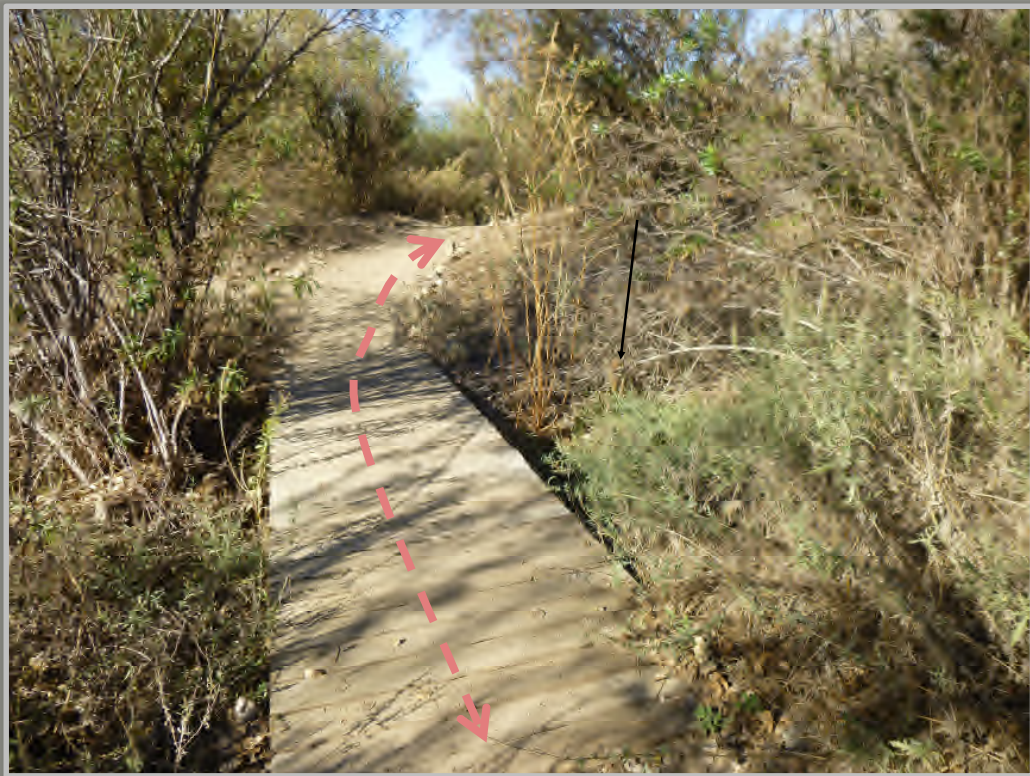
Photograph 26: Viewing west a small wood access bridge the bikeway path will follow in the eastern portion of Mast Park.
