**Phase I Environmental Site Assessment**  
**San Diego River Trail – Carlton Oaks Segment**  
**Santee, San Diego, California**

13 January 2017  
AGE Project No. 16-3919

San Diego Association of Governments (SANDAG)  
and  
Nasland Engineering

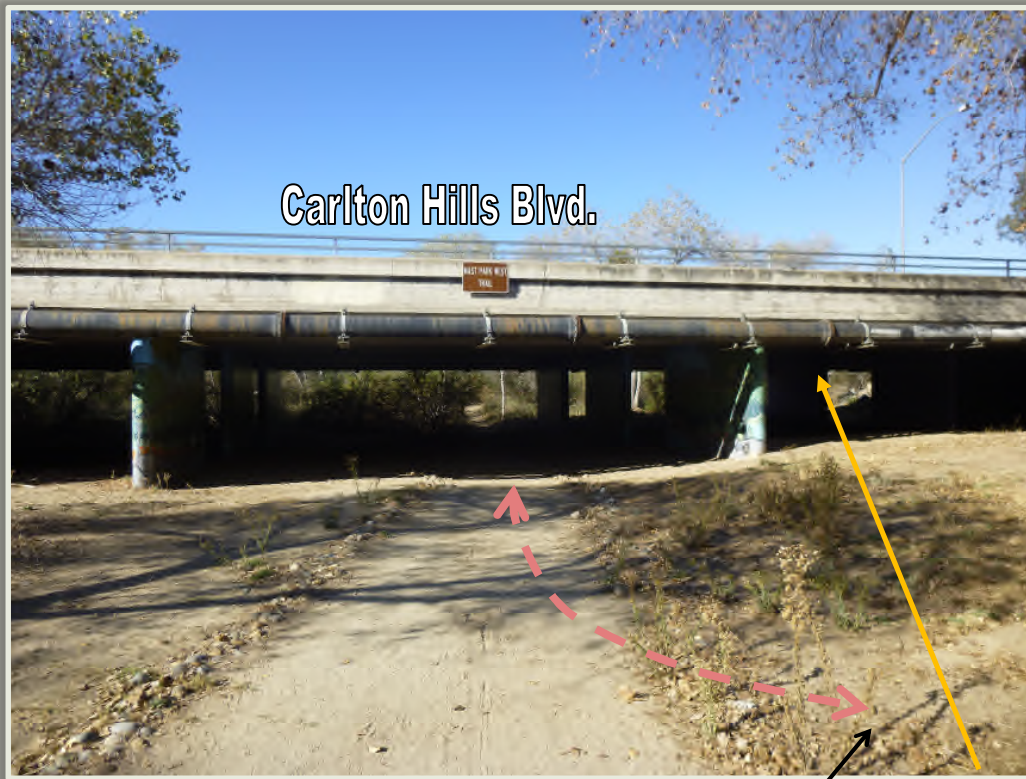
Photograph 27: Viewing west where the bikeway path will extend under Carlton Hills Boulevard.

- Continuing east, the property will turn right (Photographs 25 and 26) where it crosses a small wooden bridge extending over a small drainage channel and continues under Carlton Hills Boulevard (Photograph 27). The subject property

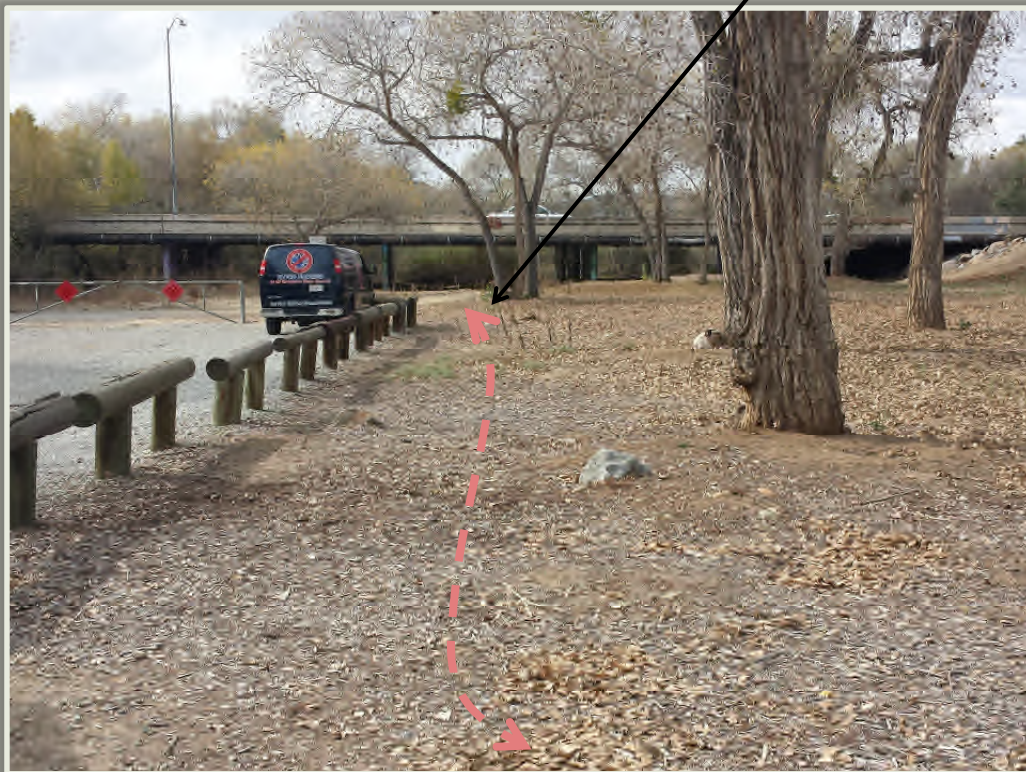
Photograph 28: Viewing west from the continuation of photograph 27 above as the bikeway path swings slightly north of a vehicle access way pictured on the left.

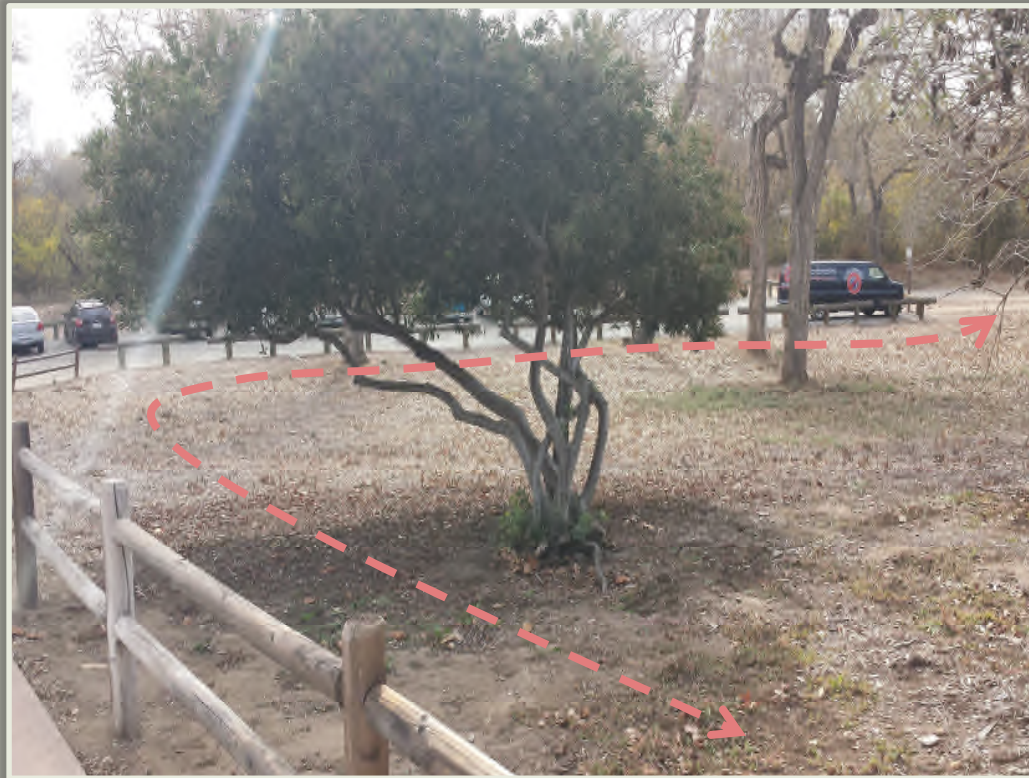
Photograph 29: Viewing south as the bikeway path turns north to its termination point of the Mast Park vehicle parking lot pictured below.

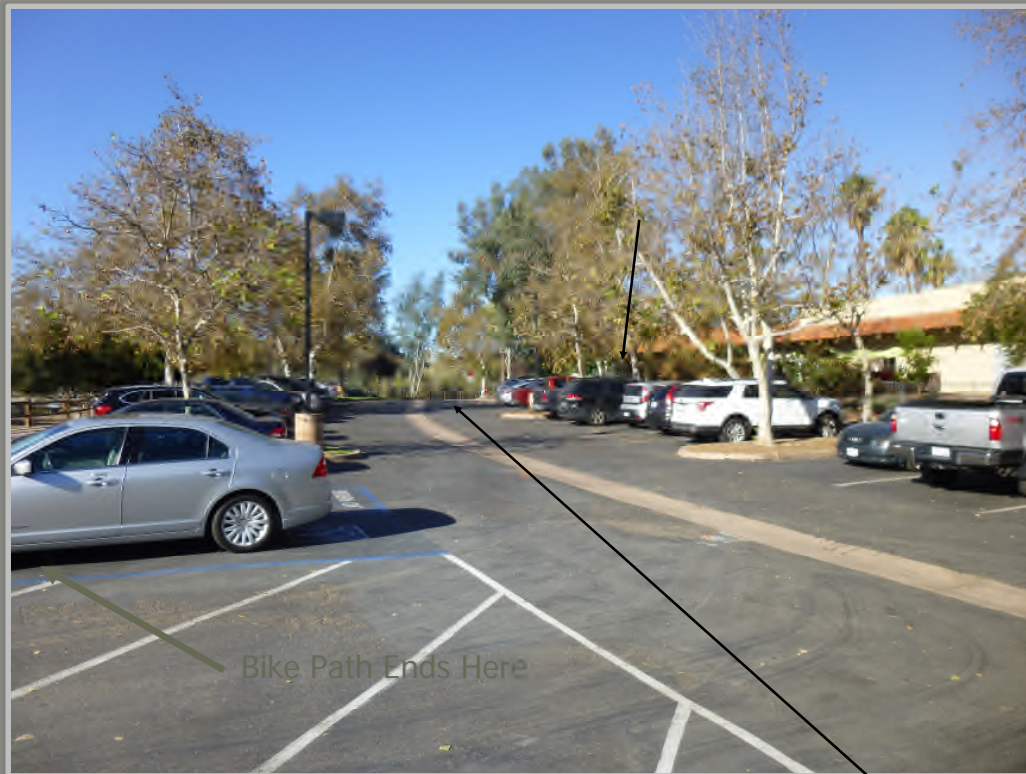
Photograph 30: Viewing west at vehicle parking lot located at the east end of the bikeway path project area. Entrance to this parking area is from Carlton Hills Boulevard.

will terminate at the vehicle parking area located east of Carlton Hills Boulevard (Photograph 30). AGE found no evidence of any former structures (e.g. concrete or wood foundations) along or near the subject property. AGE also did not observe any containers containing hazardous materials, stained soil or evidence of illegal dumping of hazardous materials on or near the project area.

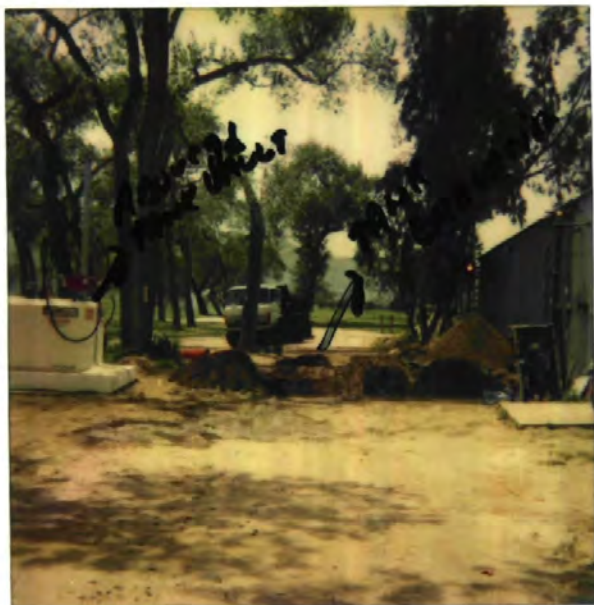
H20821

TANK 4

CARLEW OAKS  
 LOOKING COUNTRY CLUB  
 9200 JENNIFER DR.  
 SANTEE CA 4/23/72

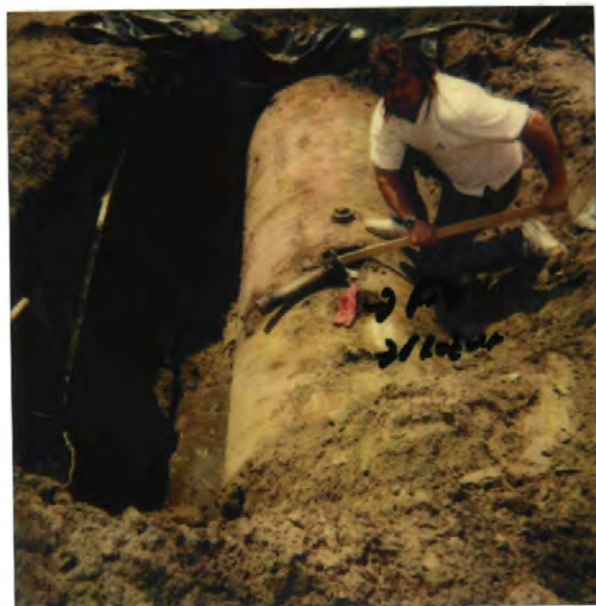
H20821

CARLEW OAKS  
 LOOKING COUNTRY CLUB  
 9200 JENNIFER DR.  
 SANTEE CA 4/23/72

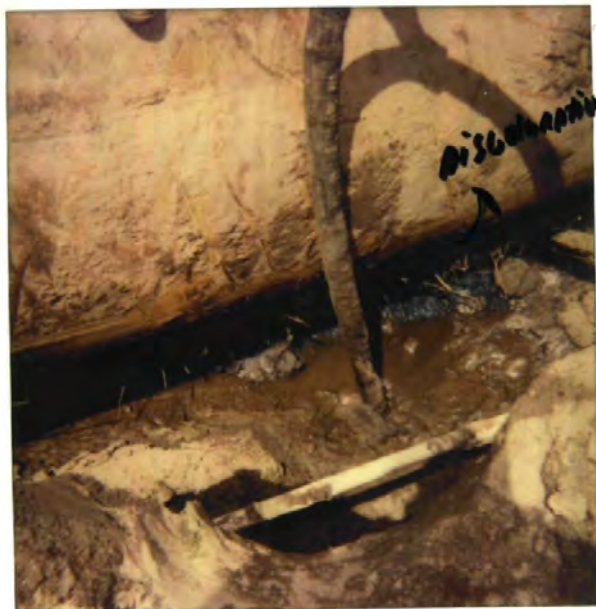
H20821

CARLEW OAKS  
 LOOKING COUNTRY CLUB  
 9200 JENNIFER DR.  
 SANTEE CA 4/23/72

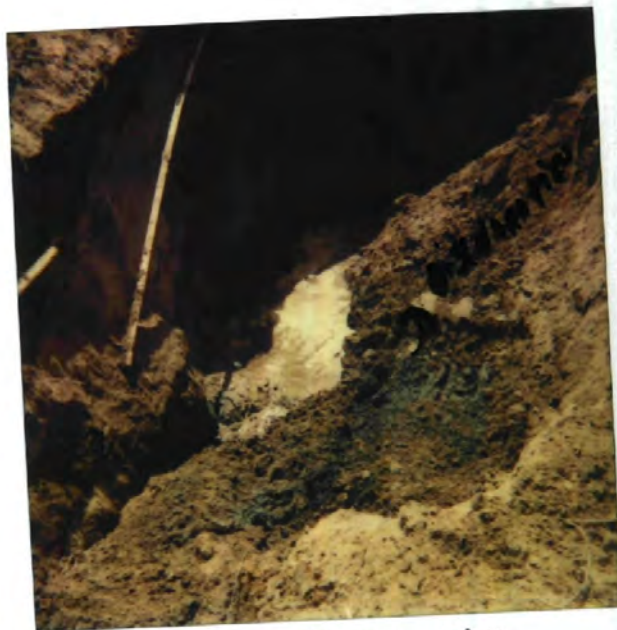
H20821

CARLEW OAKS  
 LOOKING COUNTRY CLUB  
 9200 JENNIFER DR.  
 SANTEE CA 4/23/72

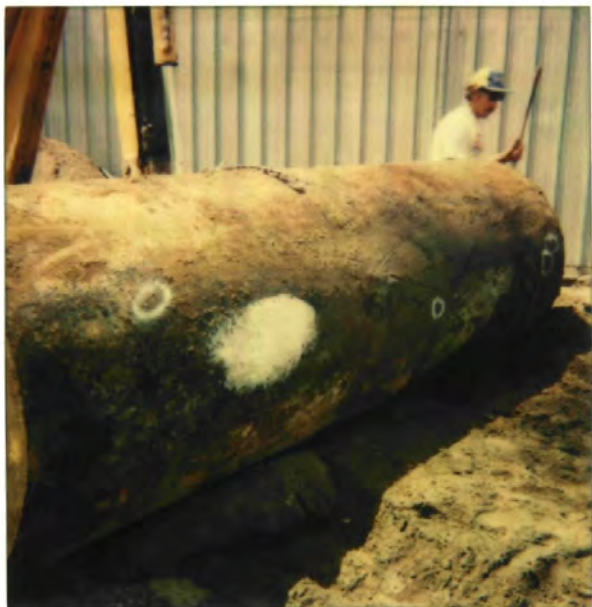
H2082  
CARLTON OAKS  
200M + COUNTRY CLUB  
9200 JENNIFER DR.  
SANTEE CA 91220/92

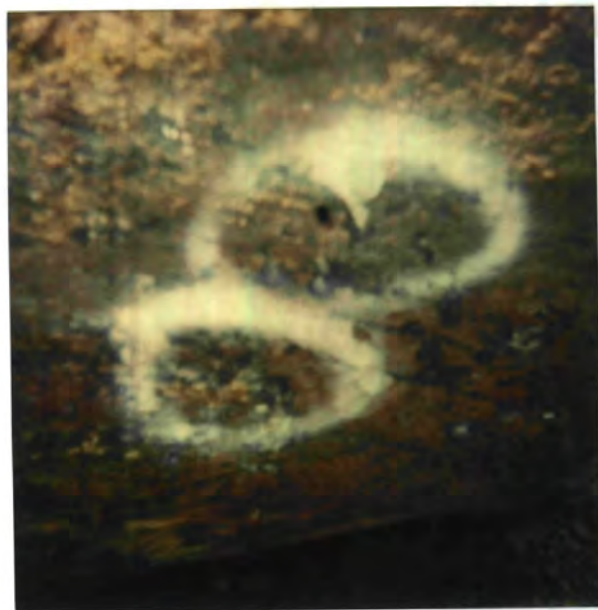
H2082  
CARLTON OAKS  
200M + COUNTRY CLUB  
9200 JENNIFER DR.  
SANTEE CA 91220/92

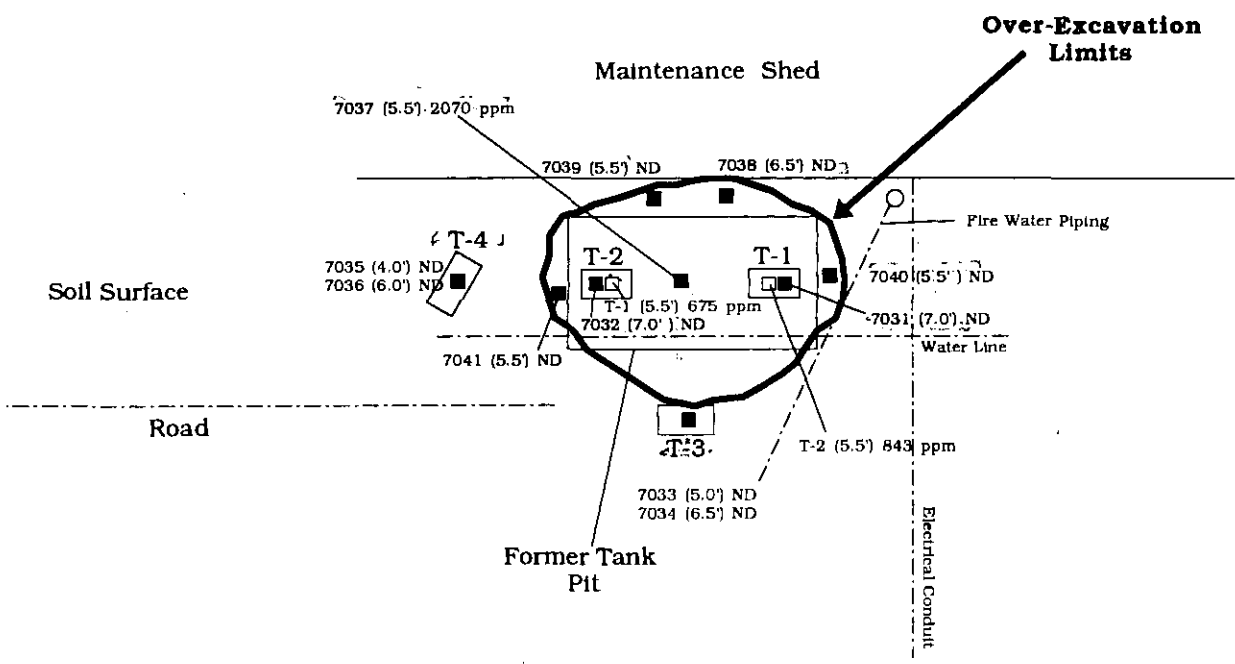
T-4 Trench Location

□ T-1 (5.5') 675 ppm Soil Sample collected by Angus Asphalt Inc. under HMMD direction on April 23, 1992 and analyzed by certified laboratory. (Depth below grade) TPH in ppm.
