Subject: Biological Resources Letter Report for the Del Mar Bluffs Stabilization Project 5

This letter presents the results of a focused biological resources technical study performed by HELIX Environmental Planning, Inc. (HELIX) for the Del Mar Bluffs Stabilization Project 5 (proposed project) located within the City of Del Mar, San Diego County, California (Figure 1, *Regional Location*). The project is located along a portion of the existing North County Transit District (NCTD) railroad right-of-way (ROW) and consists of a continuation of the previous phases of the Del Mar Bluffs Stabilization Project to stabilize the coastal bluffs and preserve track bed support in order to maintain the use of the existing railroad track.

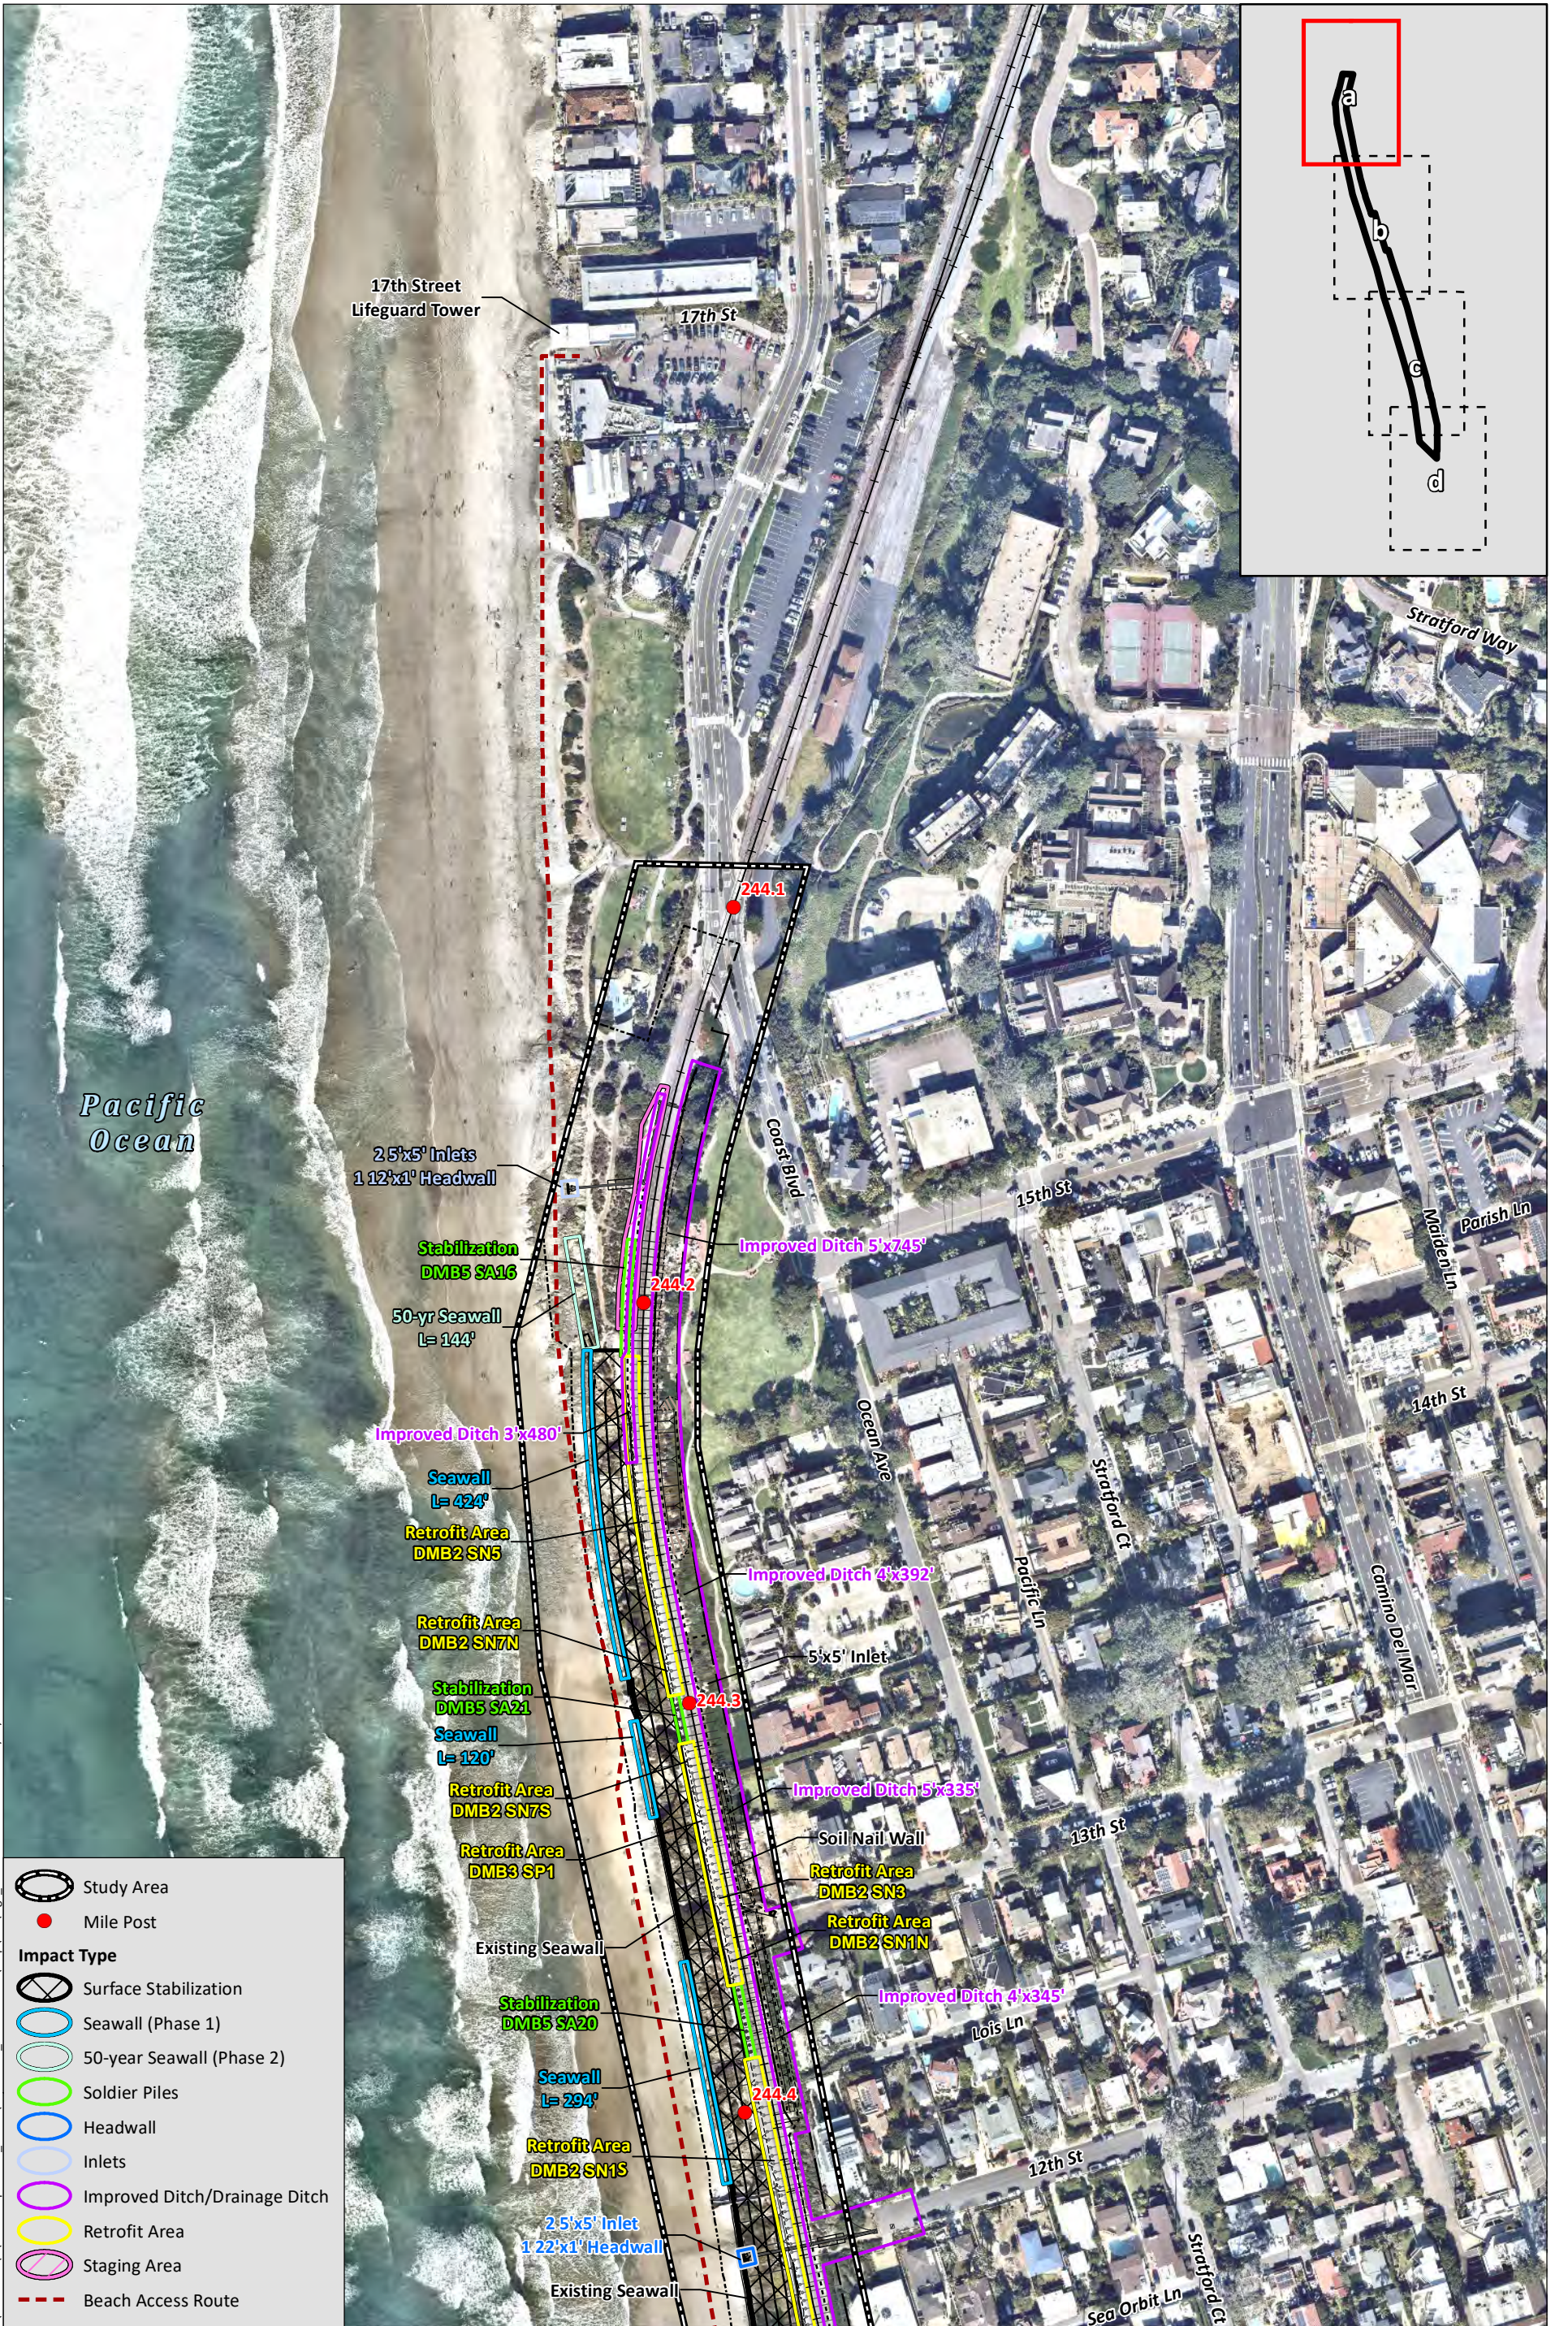
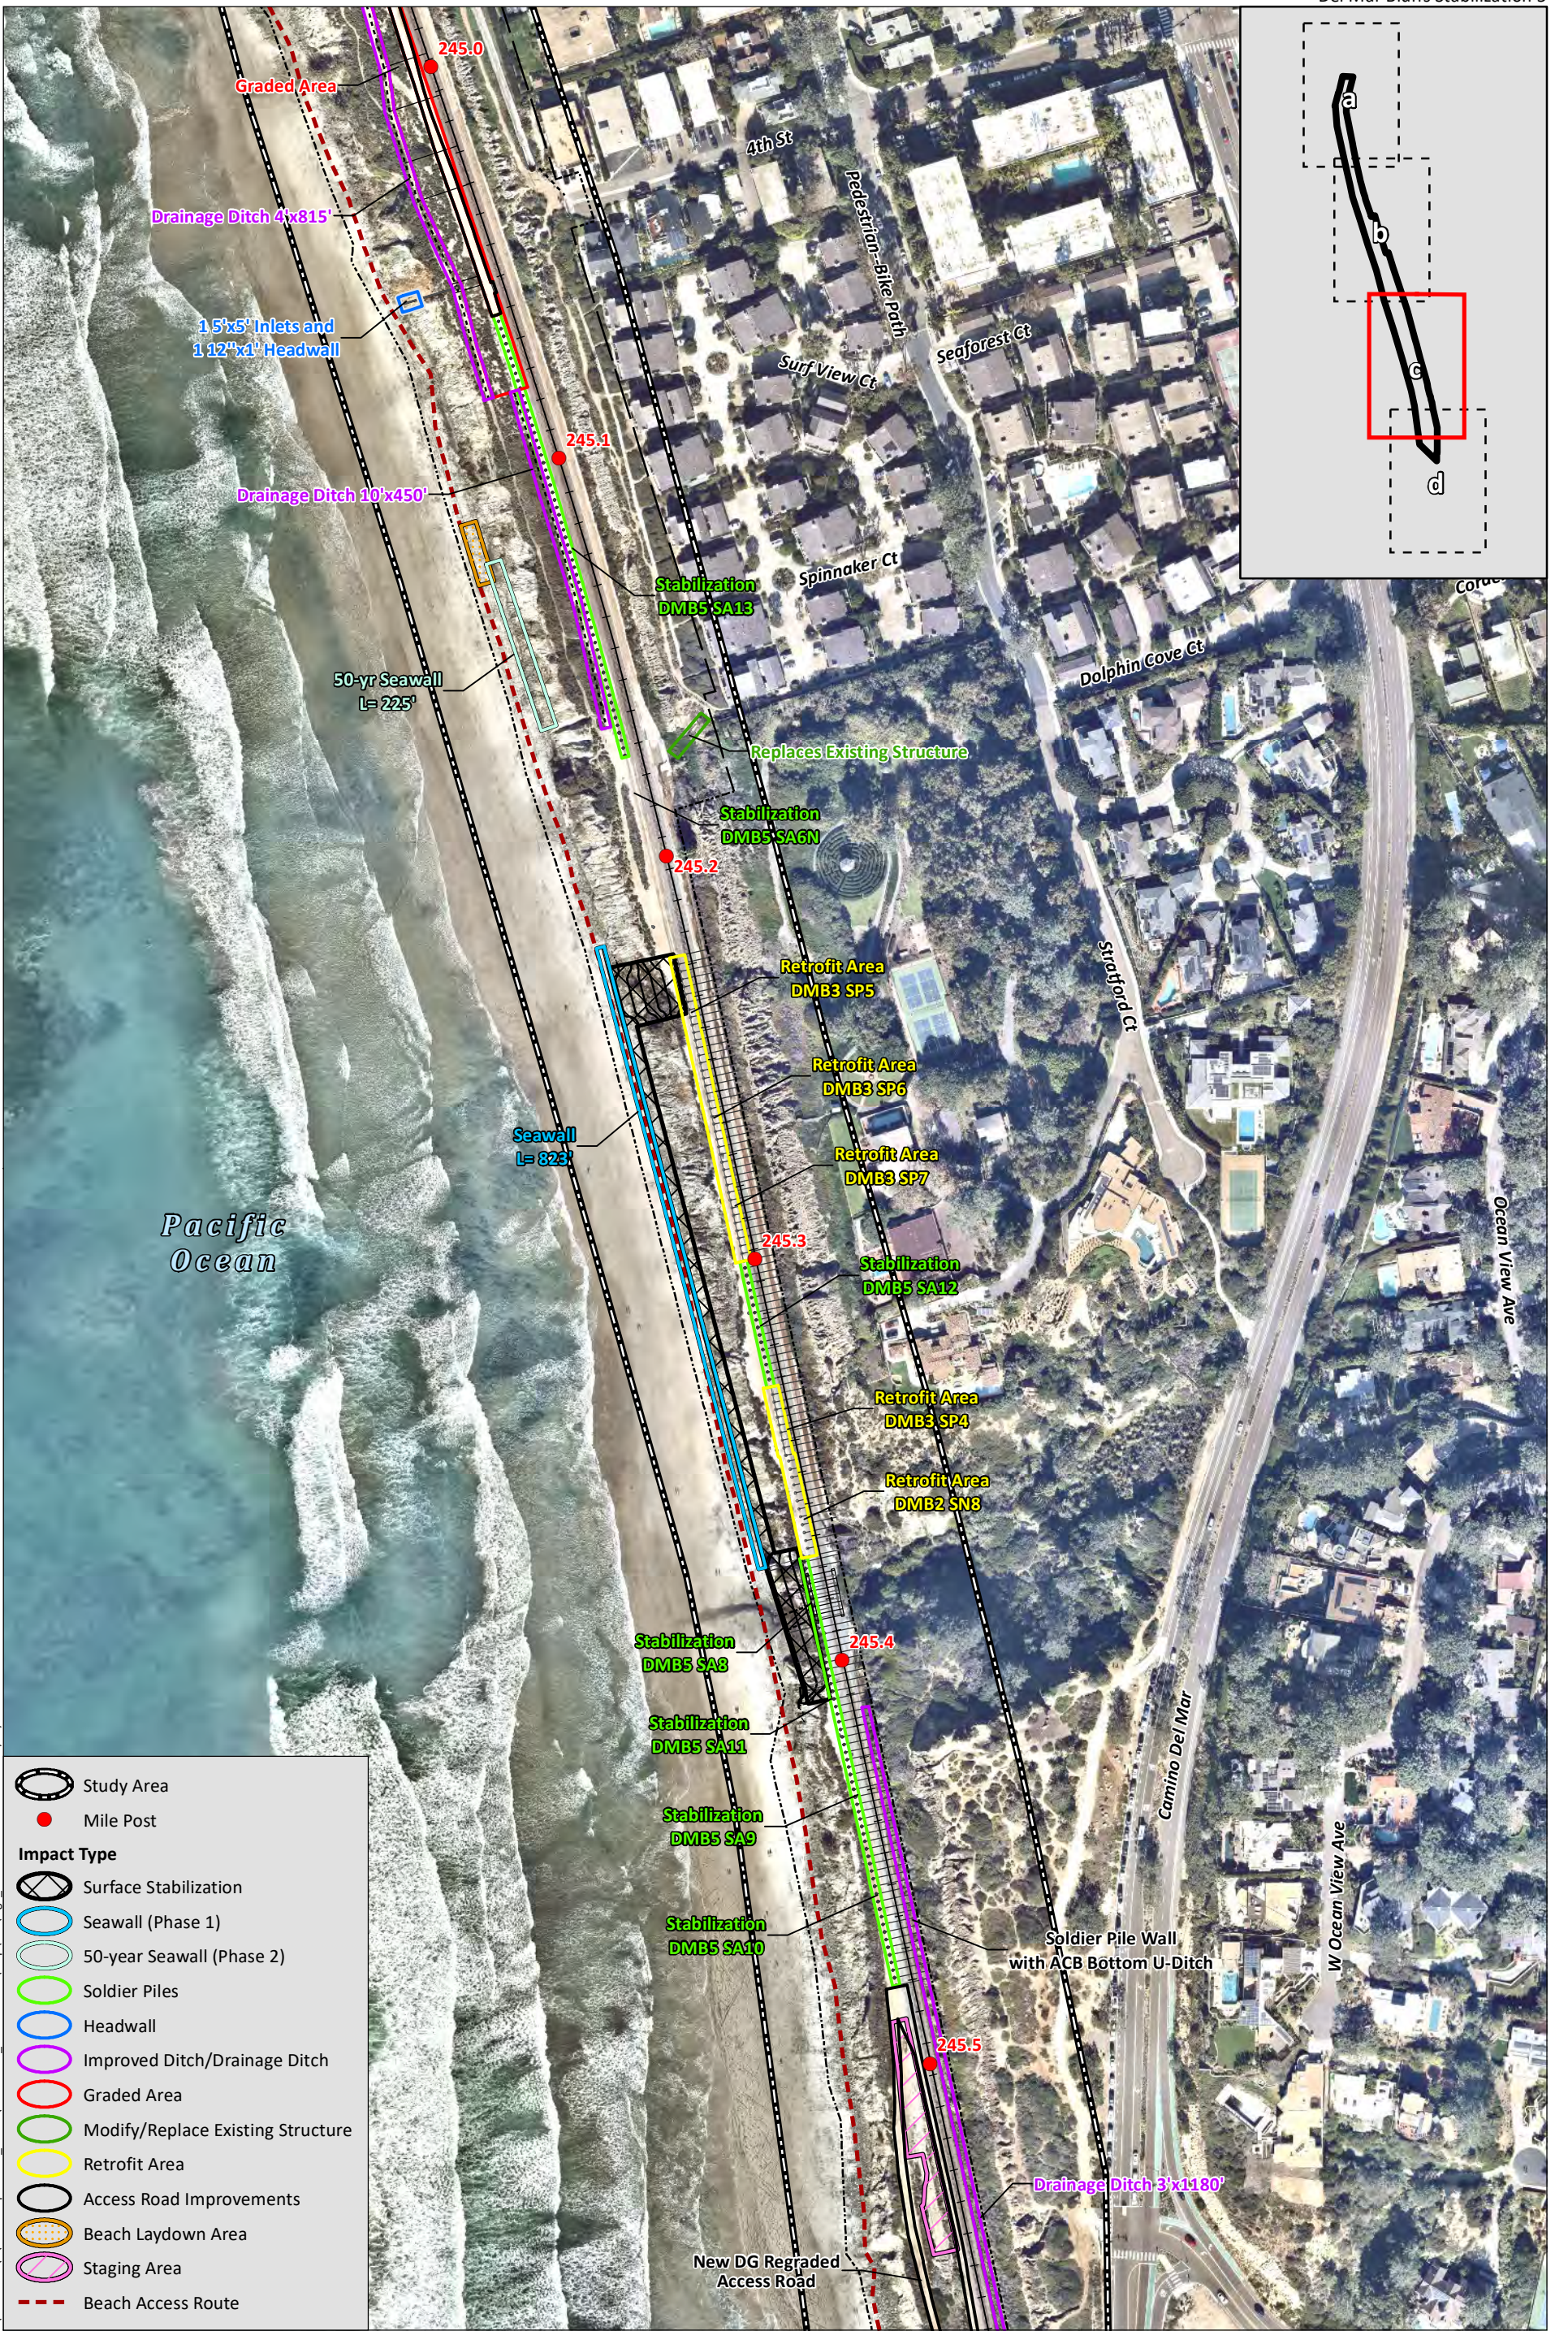
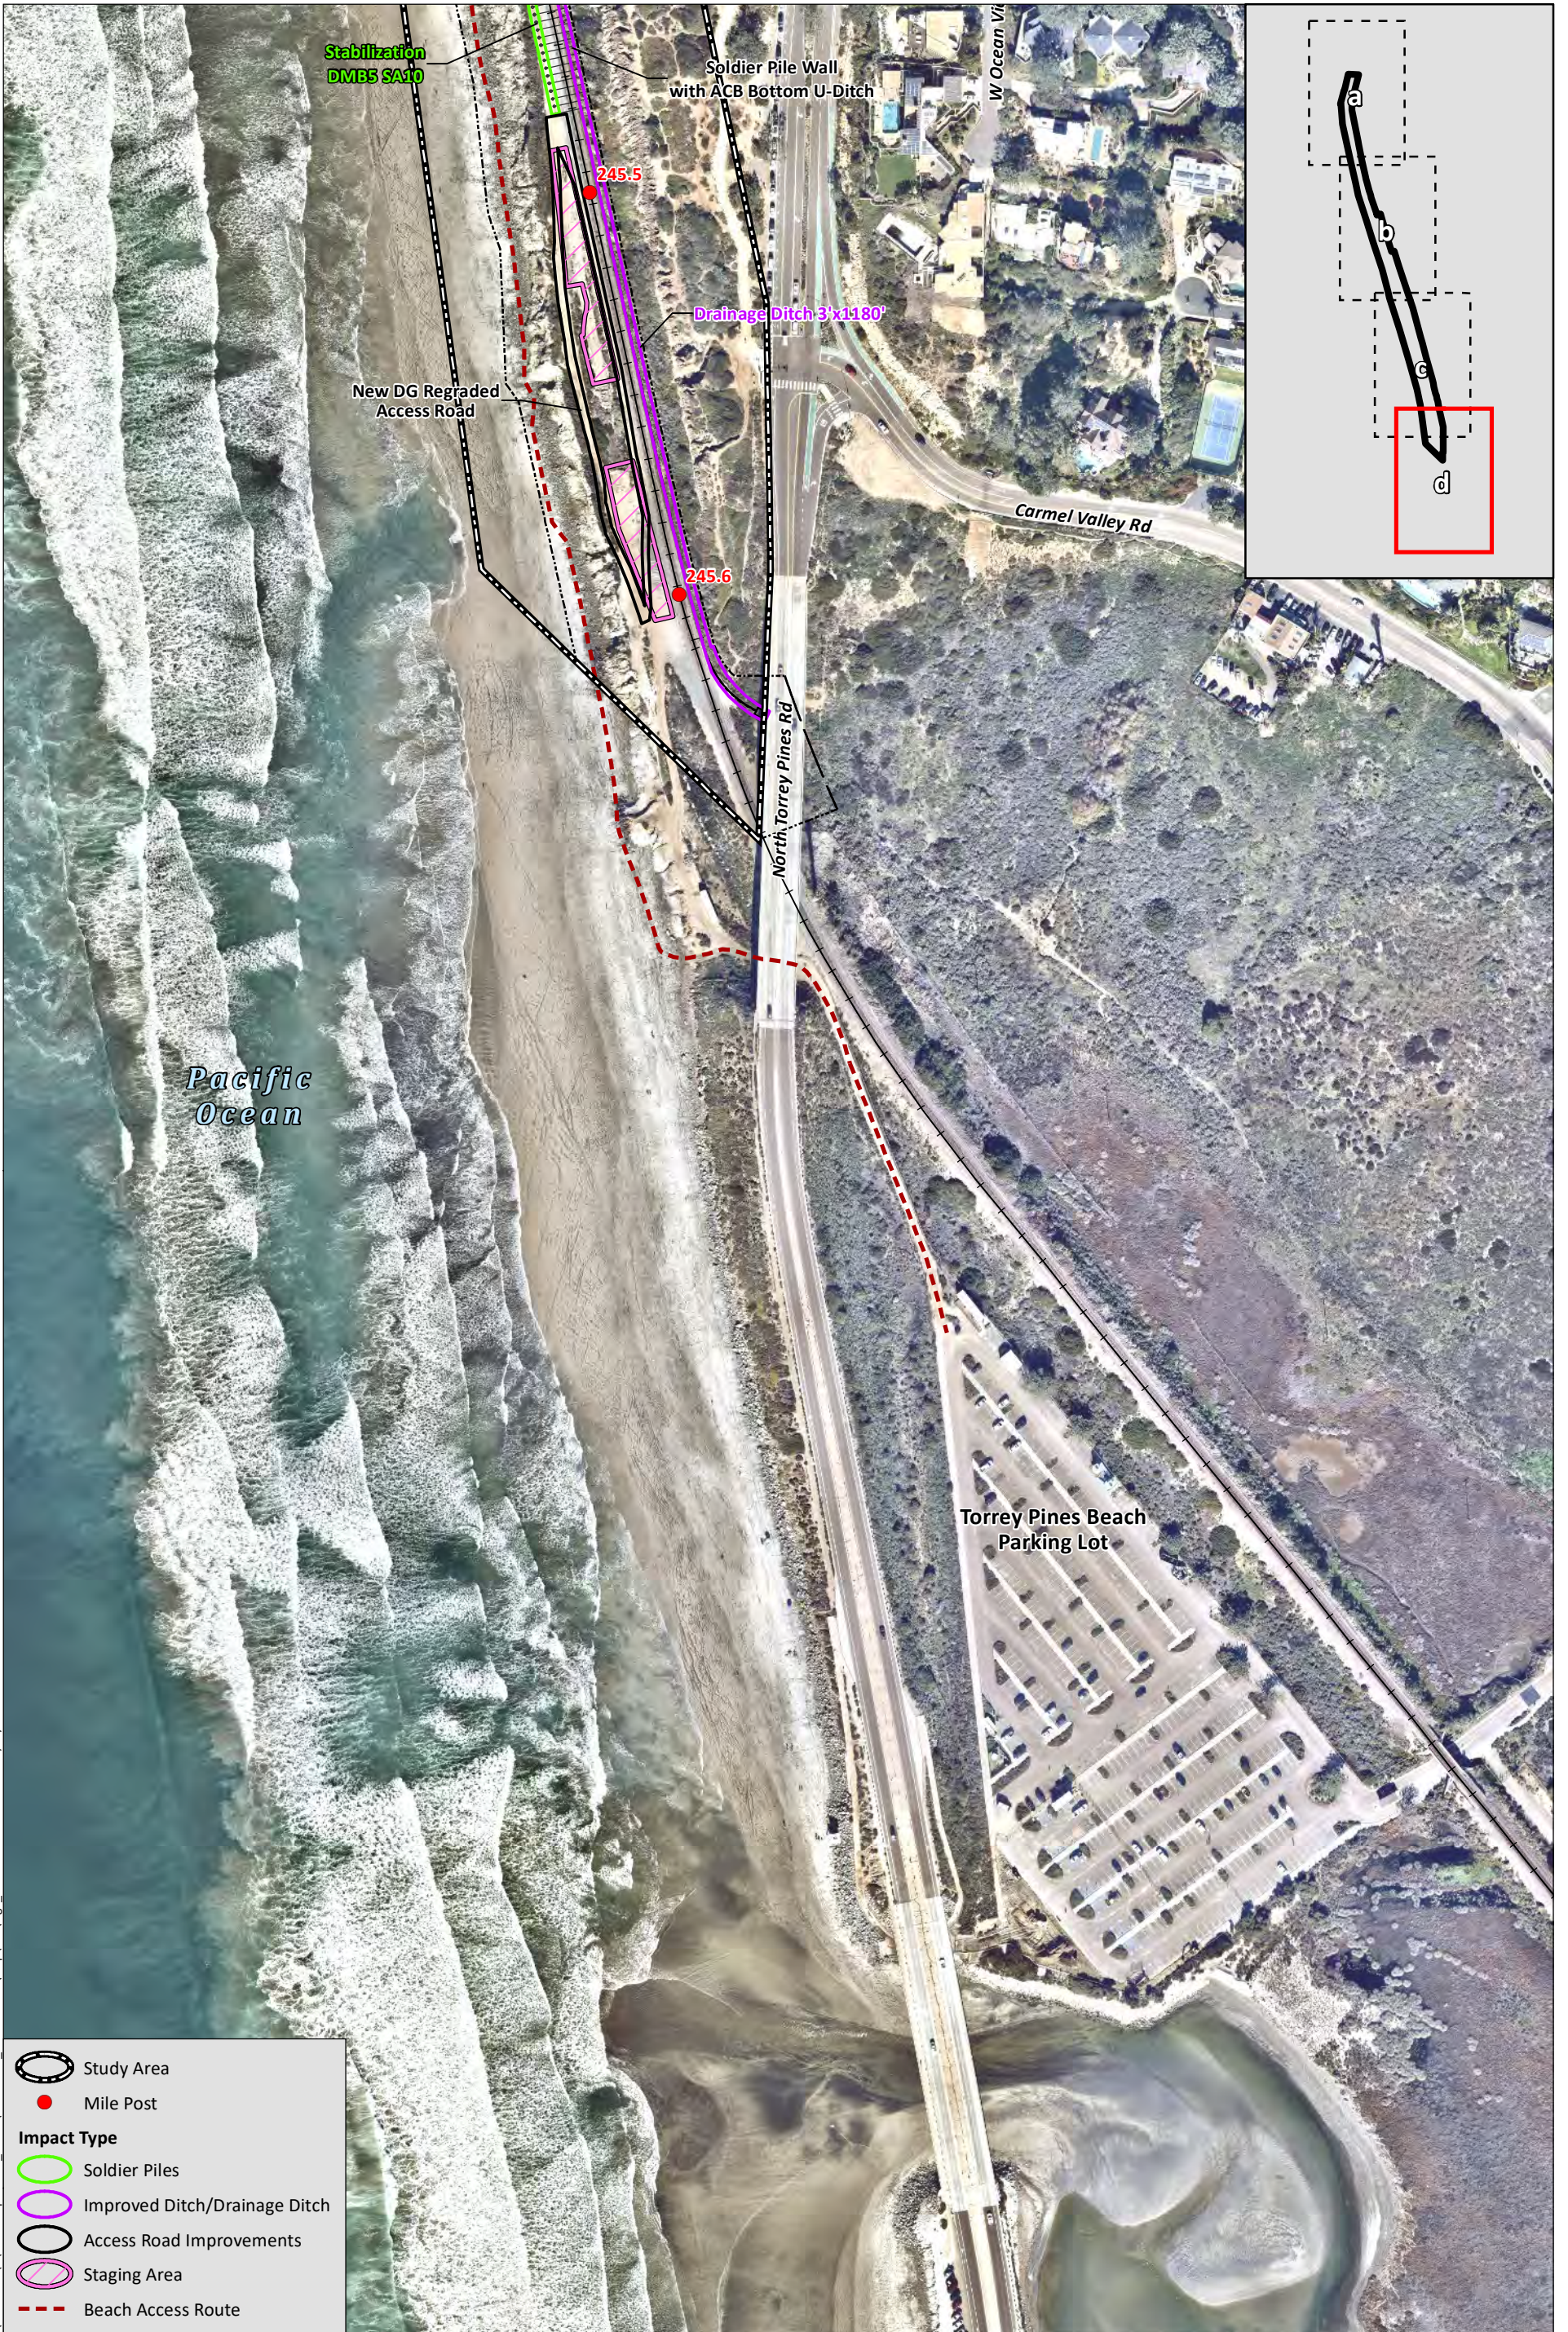
- Study Area
- Mile Post
- Impact Type**
- Surface Stabilization
- Seawall (Phase 1)
- 50-year Seawall (Phase 2)
- Soldier Piles
- Headwall
- Inlets
- Improved Ditch/Drainage Ditch
- Graded Area
- Modify/Replace Existing Structure
- Retrofit Area
- Access Road Improvements
- Staging Area
- Beach Access Route

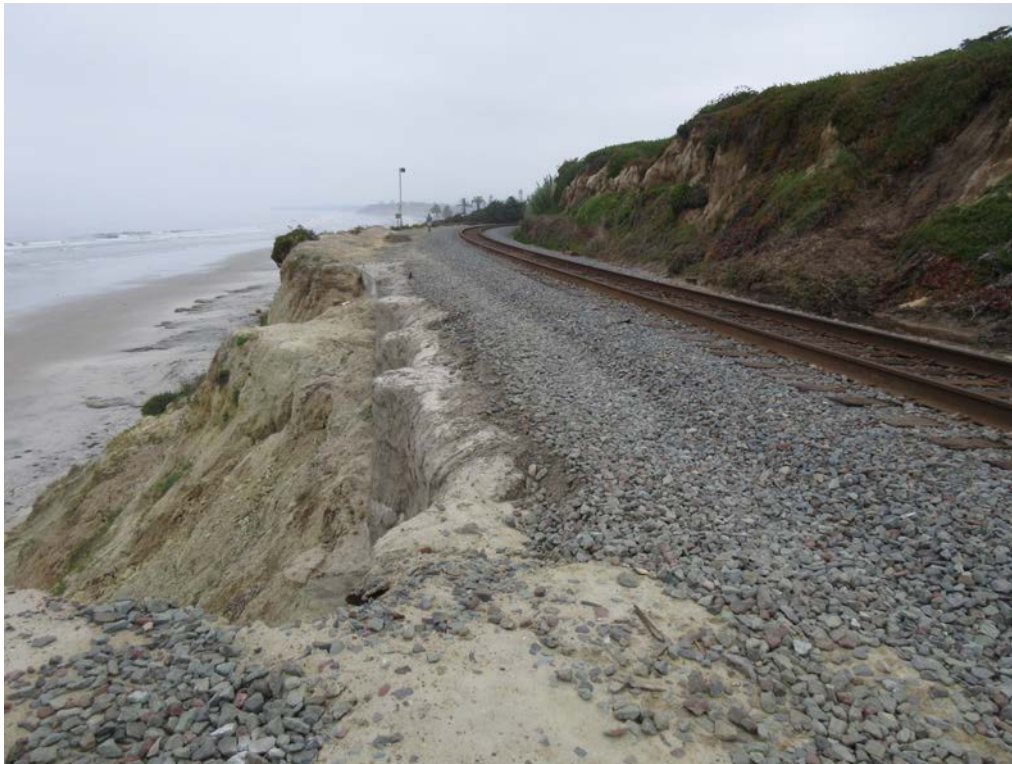
Photo 1. Looking north at eroded, unvegetated bluff adjacent to railroad in the northern part of the study area.

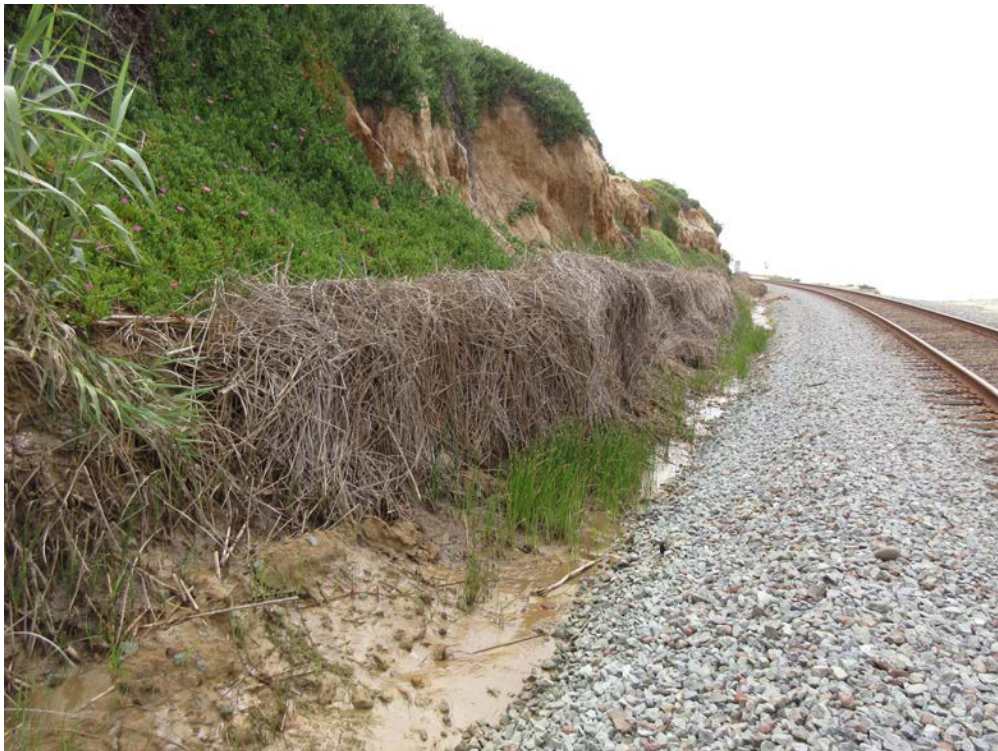
Photo 2. Looking south at freshwater marsh within an upland-constructed swale adjacent to the railroad in the northern part of the study area.

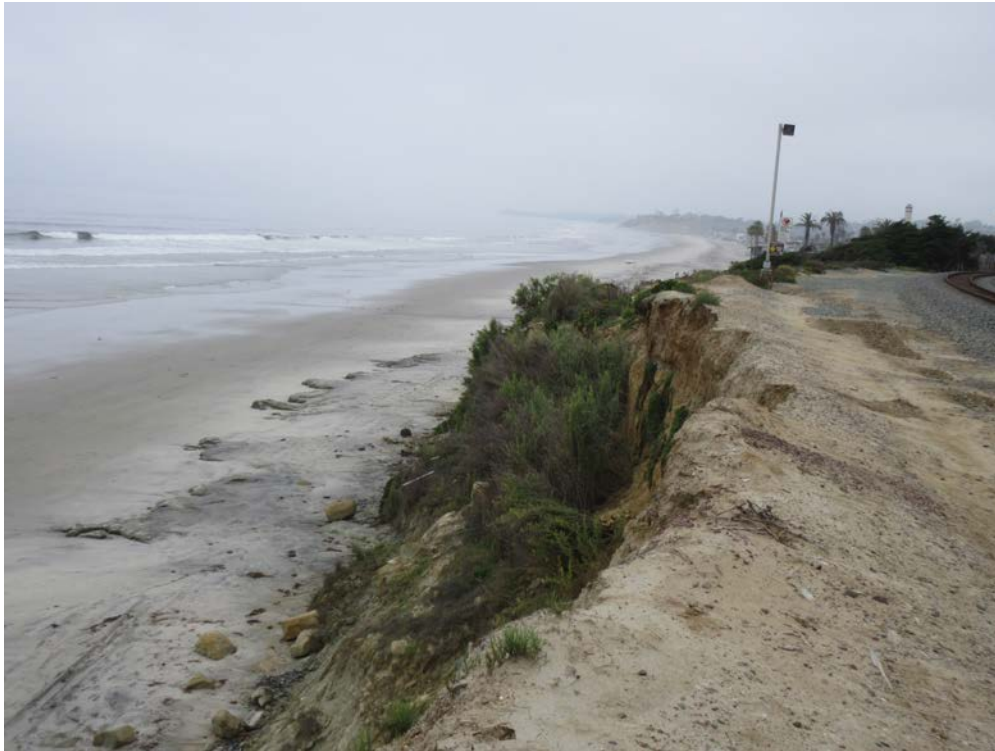
Photo 3. Looking north at a small stand of arrow weed scrub on the eroded bluff face in the northern part of the study area.

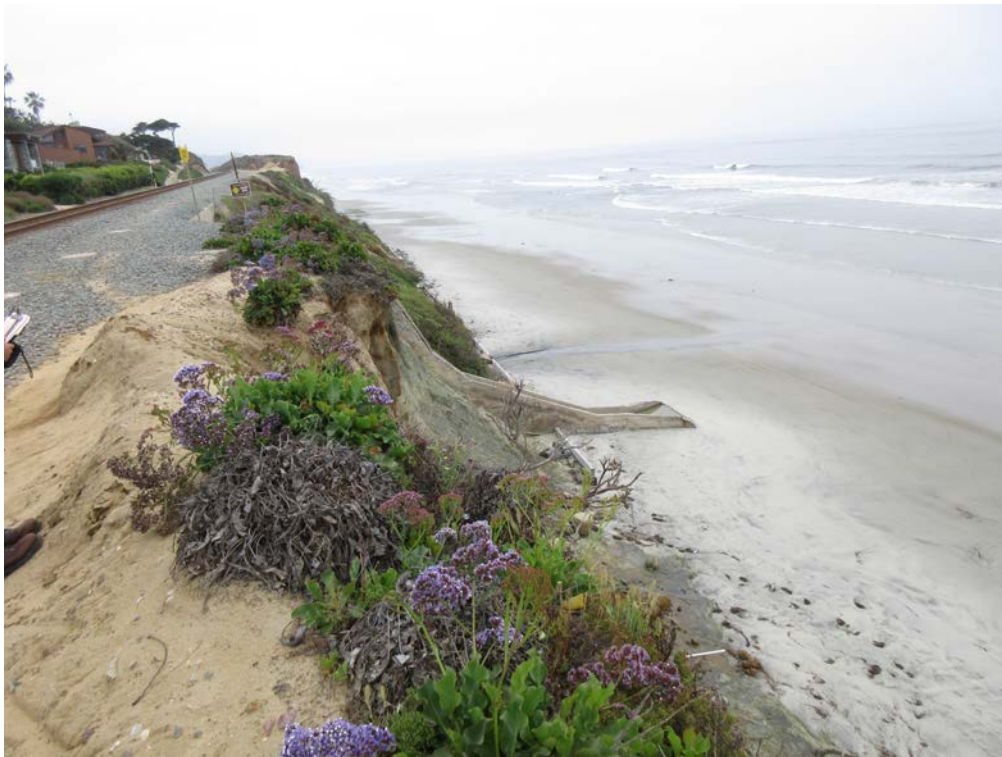
Photo 4. Looking south at disturbed bluff and a concrete storm water outlet onto the beach in the northern part of the study area.

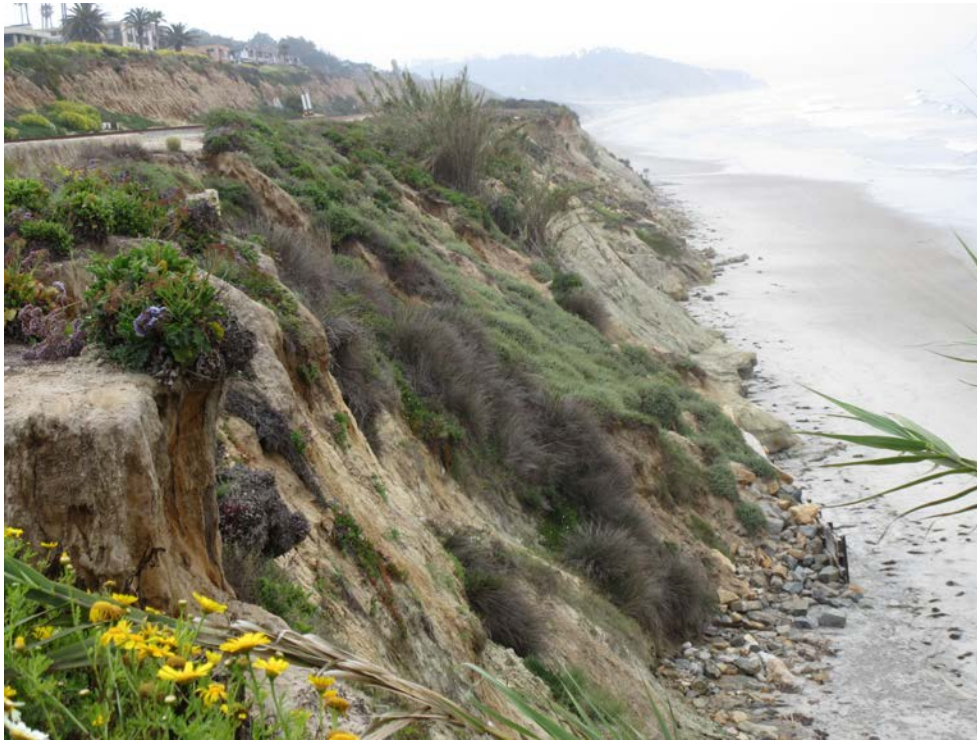
Photo 5. Looking south at the bluff adjacent to the railroad in the central part of the study area. Cismontane alkali marsh is growing on a small portion of the bluff face, with coastal bluff scrub immediately to the south.

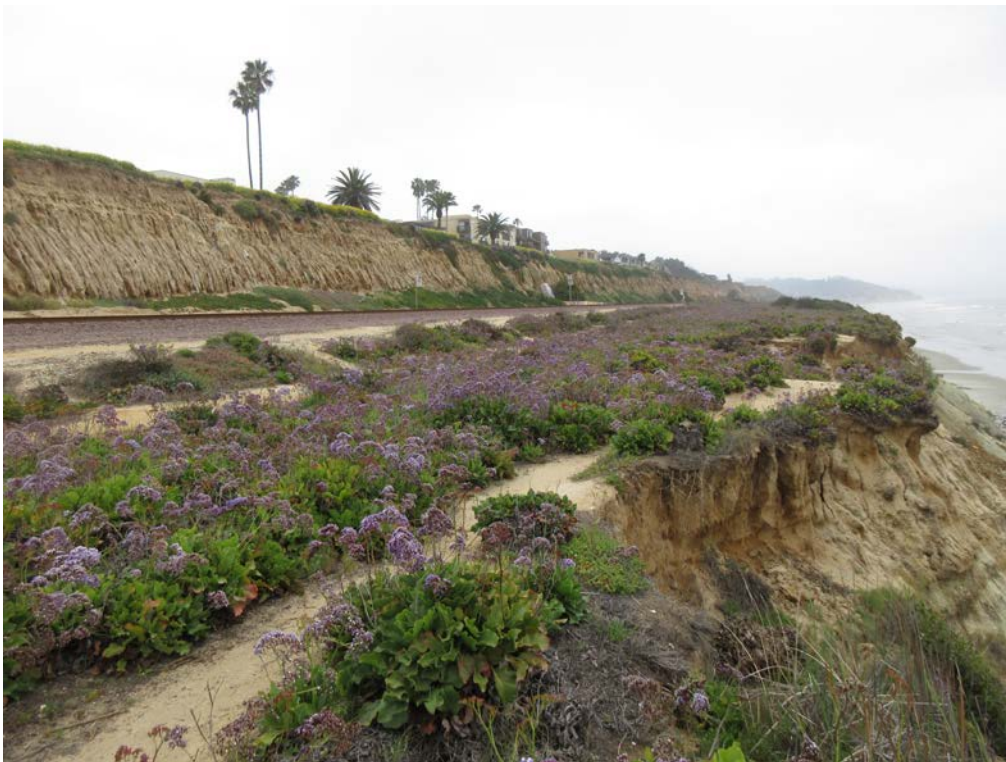
Photo 6. Looking south at non-native vegetation along the railroad and adjacent unvegetated, eroding bluff in the central part of the study area.

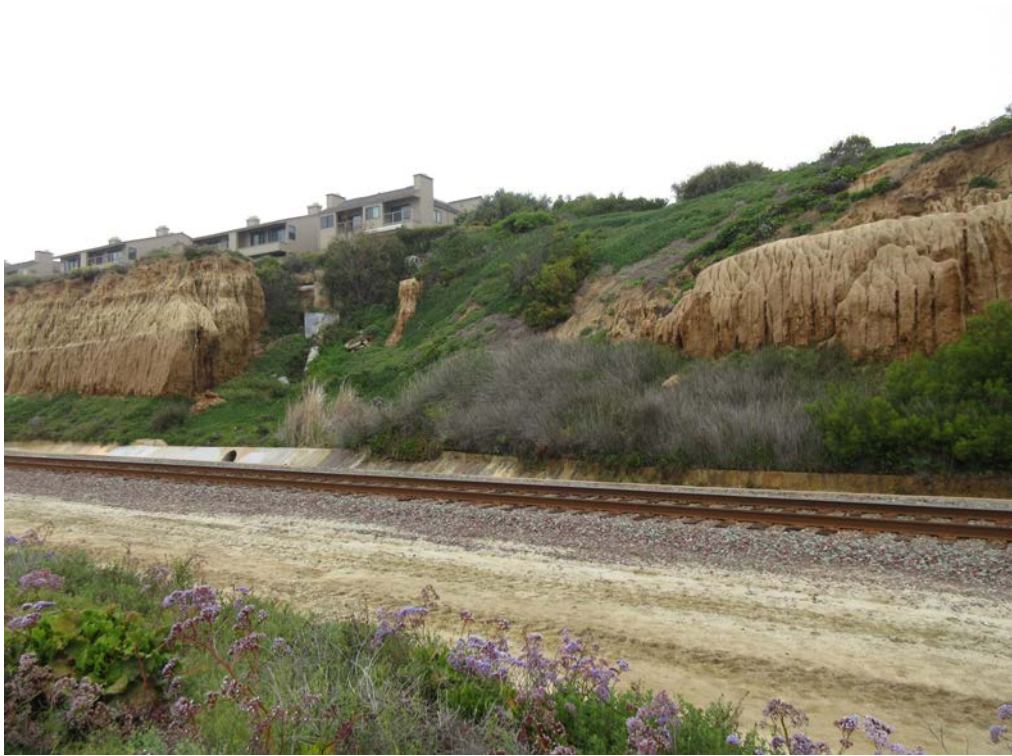
Photo 7. Looking northeast at cismontane alkali marsh and a small stand of freshwater marsh near the base of the bluff east of the railroad in the southern part of the study area. A concrete-lined ditch parallels the railroad in this location. Non-native vegetation is present on the slopes and in the foreground.

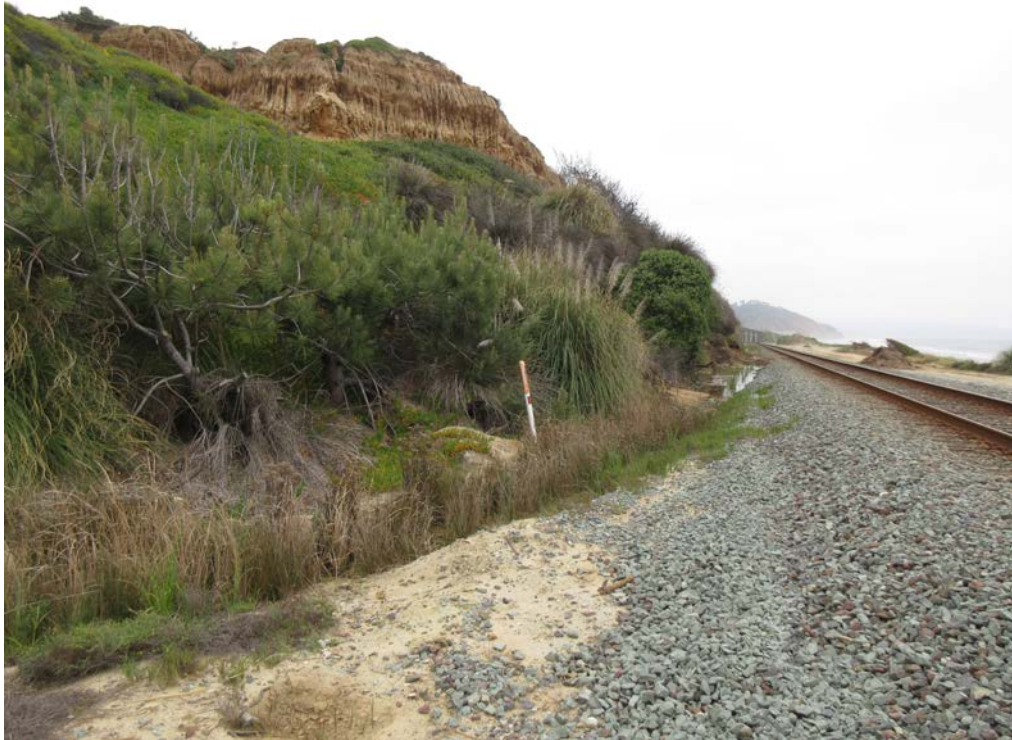
Photo 8. Looking south at the railroad in the southern part of the study area. An upland-constructed swale vegetated with freshwater marsh parallels the railroad, and cismontane alkali marsh is present along portions of the adjacent bluff.

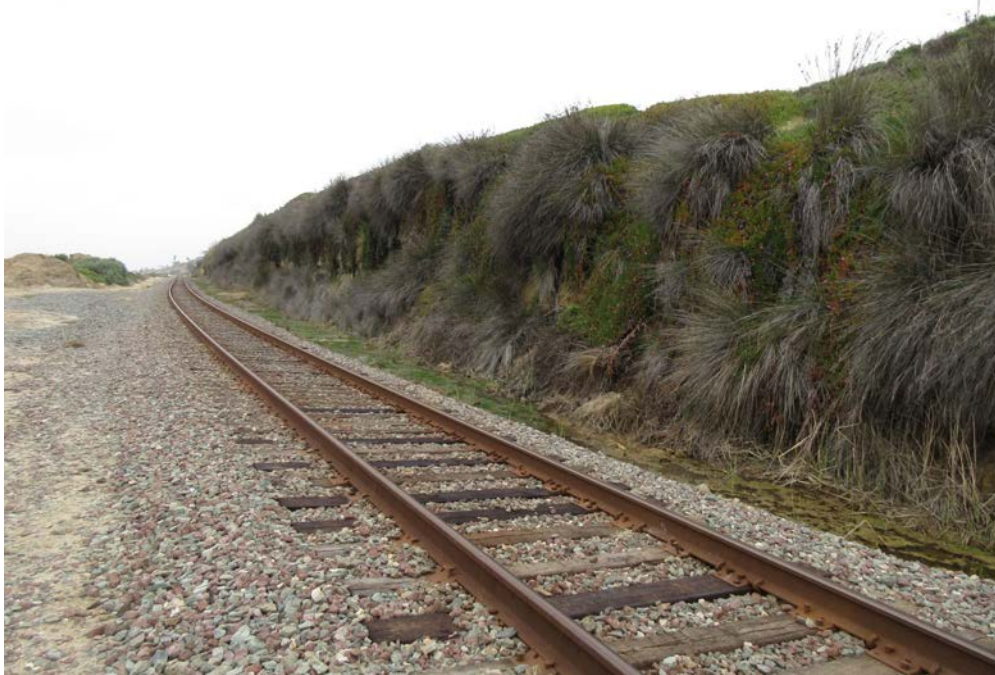
Photo 9. Looking north at the railroad in the southern part of the study area. Cismontane alkali marsh is present on the bluff face east of the railroad where seepage from irrigation and urban runoff provides a source of hydrology. Disturbed freshwater marsh occurs in the upland-constructed swale at the base of the bluff, paralleling the railroad.

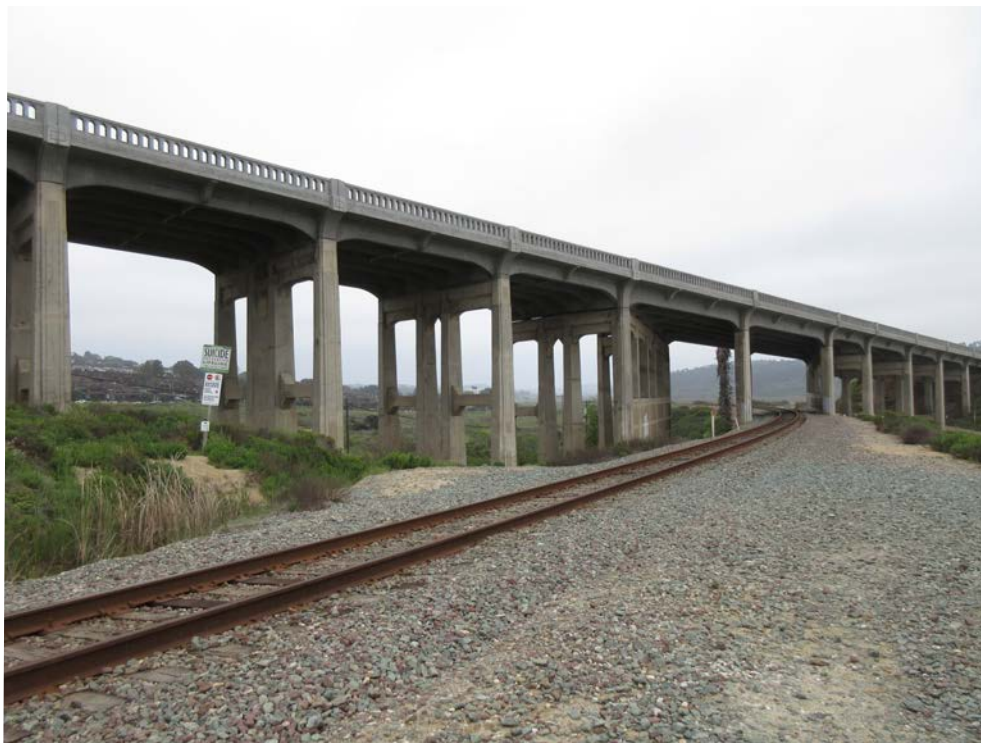
Photo 10. Looking southeast at the southern end of the study area. Disturbed freshwater marsh occurs in the upland-constructed swale paralleling the railroad and Diegan coastal sage scrub is adjacent, extending offsite to the east below the North Torrey Pines Road bridge.
