# **Del Mar Bluffs Stabilization Project 2 – Preserving Trackbed Support**

## **Evaluation of Existing Seawalls**

Submitted to:  
**North County Transit District**  
810 Mission Avenue  
Oceanside, CA 92054

June 18, 2004

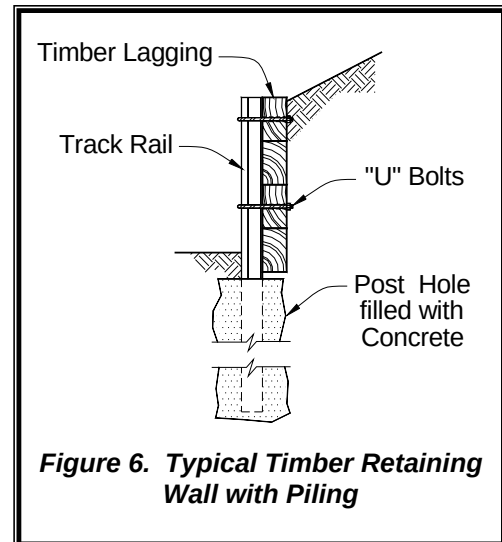
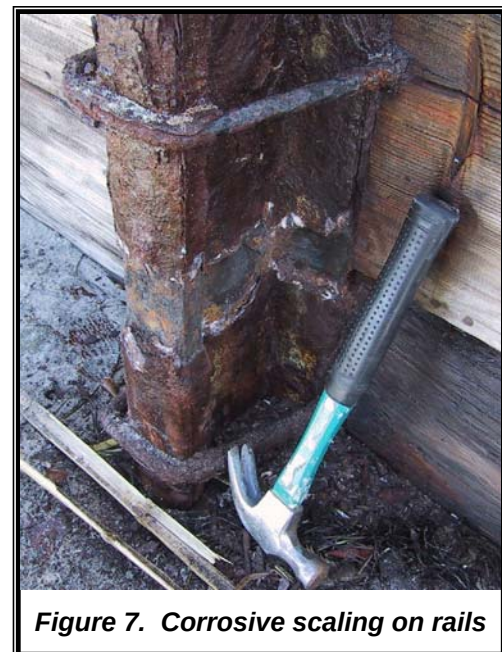
## B. STATION 1514

Between 7<sup>th</sup> and 8<sup>th</sup> Street a 70-foot timber wall stands at the base of a pedestrian trail. The height is a constant 5.5 feet from top of wall to top of concrete post hole. From historical records the build date on the wall appears to be 1977. Landslides during the winter months necessitated a seawall at this location to keep surf activity from attacking the toe of slope and destabilizing the slide area further.

About one foot of sand exists above the top of the concrete post hole at present, however this height varies seasonally. One concern is the possibility of soil eroding and compromising the foundation. However, formational material underlies the base of this wall; therefore the foundation should remain intact though the top sand may shift. The depth of the concrete piles is estimated to be at least four feet deep, similar to the timber wall at Twelfth Street.

As the rails have corroded their strength capacity has decreased. Assuming that the load demand on the rails will be constant for the next few decades, a chart of safety factor versus time has been created (see Appendix B). From this analysis a failure date in 2049 is projected for the rails, which demonstrates they will likely remain intact for at least the next 20 years.

The condition of the wood timber is good when compared to the older timber wall built in 1964 between 11<sup>th</sup> and 12<sup>th</sup> Street. Based on the 13-year difference between these walls, the projected condition of the timber in 20 years will probably be poor, but intact.
