DEL MAR BLUFFS STABILIZATION
PROJECT 2 – PRESERVING TRACKBED SUPPORT

**SUPPLEMENTAL GEOTECHNICAL EVALUATION
AND
DETERMINATION OF SITE SPECIFIC CONCEPTUAL REPAIR ALTERNATIVES**

Project No. 040151-009

June 2, 2003
(Revised November 5, 2003)

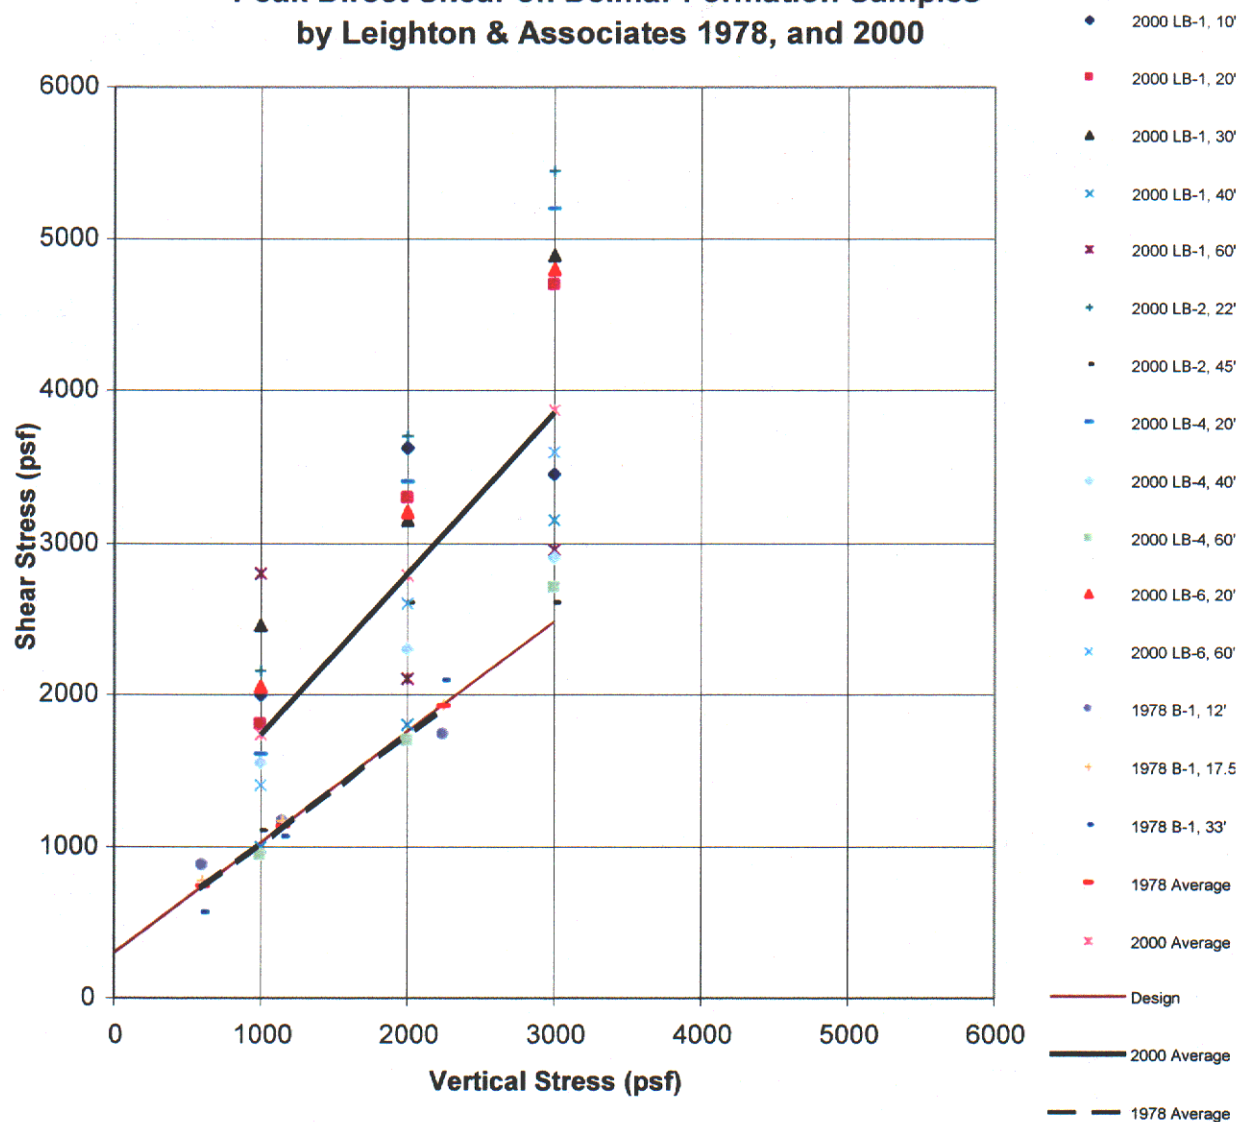
Figure No. 4

The overall stability of the slope is significantly affected by the strength of the Delmar Formation. While testing an intact block of the Delmar Formation would yield relatively higher strength parameters, the use of such a strength in the slope stability analysis would show no failures occurring on the bluff. As a majority of the bluff has experienced numerous failures, the use of intact strength values is not appropriate. As presented on Figures 4 through 7, a comparison of the average peak and residual strength data indicates that the Delmar Formation experiences significant strength loss once the cementation between the soil grains is broken. Similarly, when joints and fractures develop within the unit from both weathering and tectonic influences, the loss of contact can greatly reduce or eliminate the strength across the break. In addition, the geometry or steepness of the bluff induces a state of tension behind the crest and at times in the middle of the slope face. When the tensile strength of the materials is exceeded, cracks form. These zones of tension tend to expand during earthquakes, leading to additional areas where reduced strengths and higher water pressures are appropriate for use in the analyses. For these reasons, lower bound strength parameters were assigned to the Delmar Formation (i.e., the strength parameters presented on Figure 4, friction angle of 36 degrees and cohesion

of 300 pounds per square foot, psf). To account for the presence of sheared siltstone and claystone beds, strength parameters similar to the average residual values of fine-grained Delmar Formation samples (i.e., friction angle of 25 degrees and cohesion of 150 psf) were assigned to this material within 5 degrees of horizontal (see Figures 5, 6, and 7).

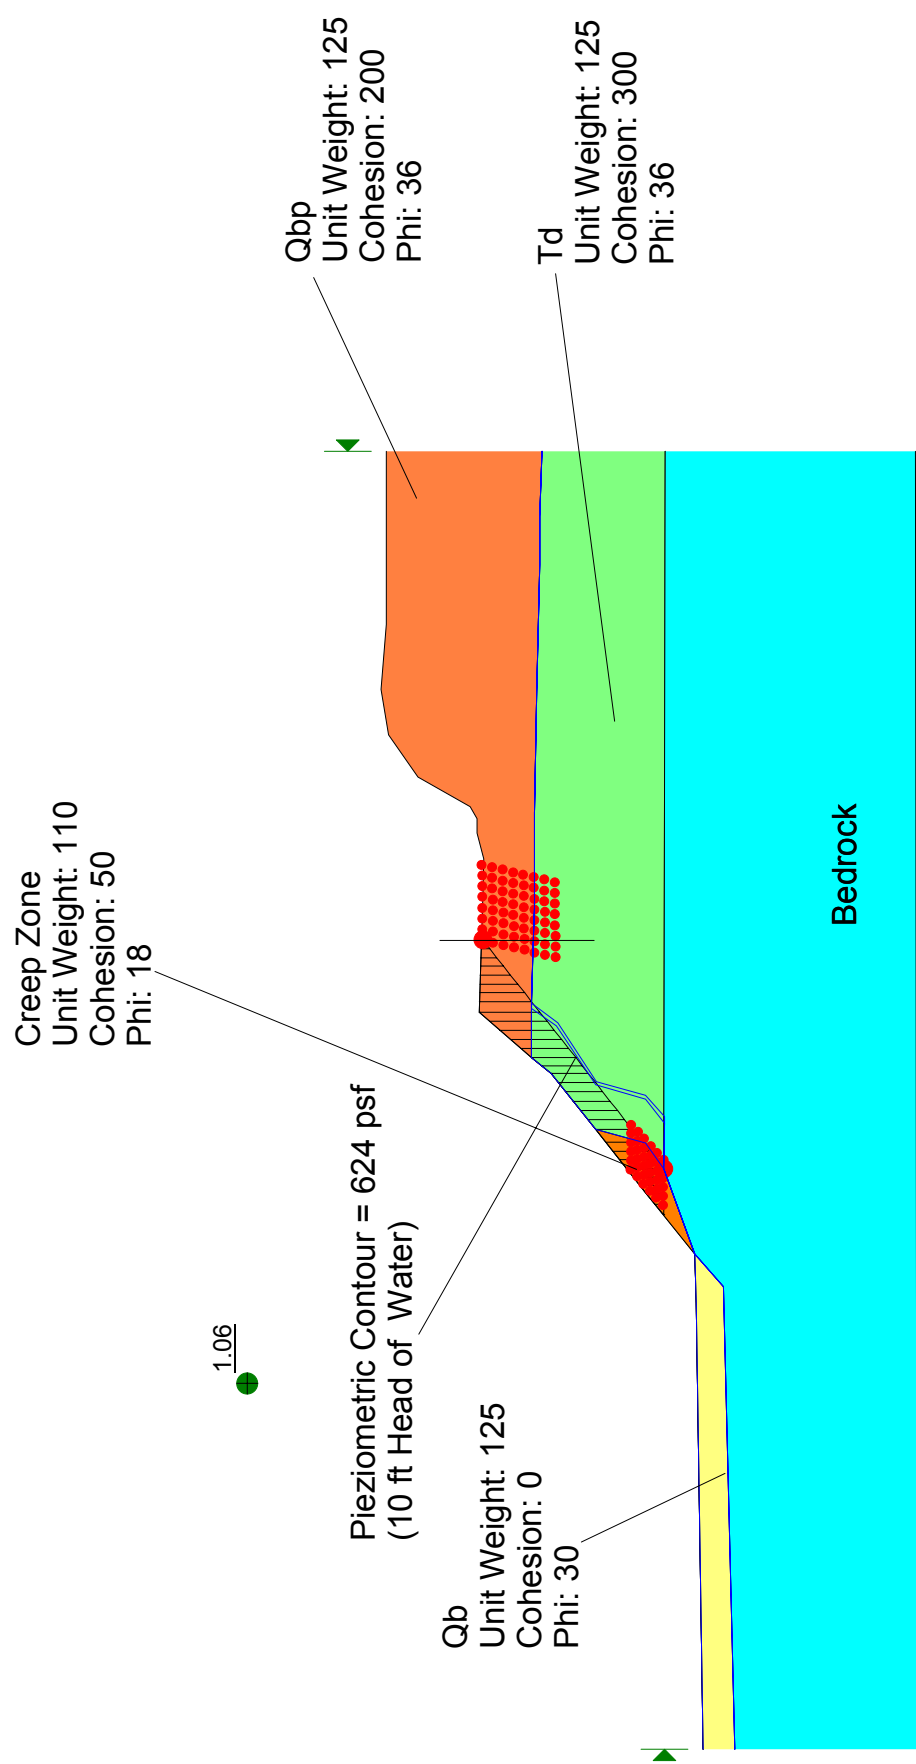
Del Mar Bluffs Cross Section 1-1'
Slope Stability Analysis
File Name: Section 11 Static 1 10ft water.slz
Analysis Method: Spencer
Factor of Safety: 1.06

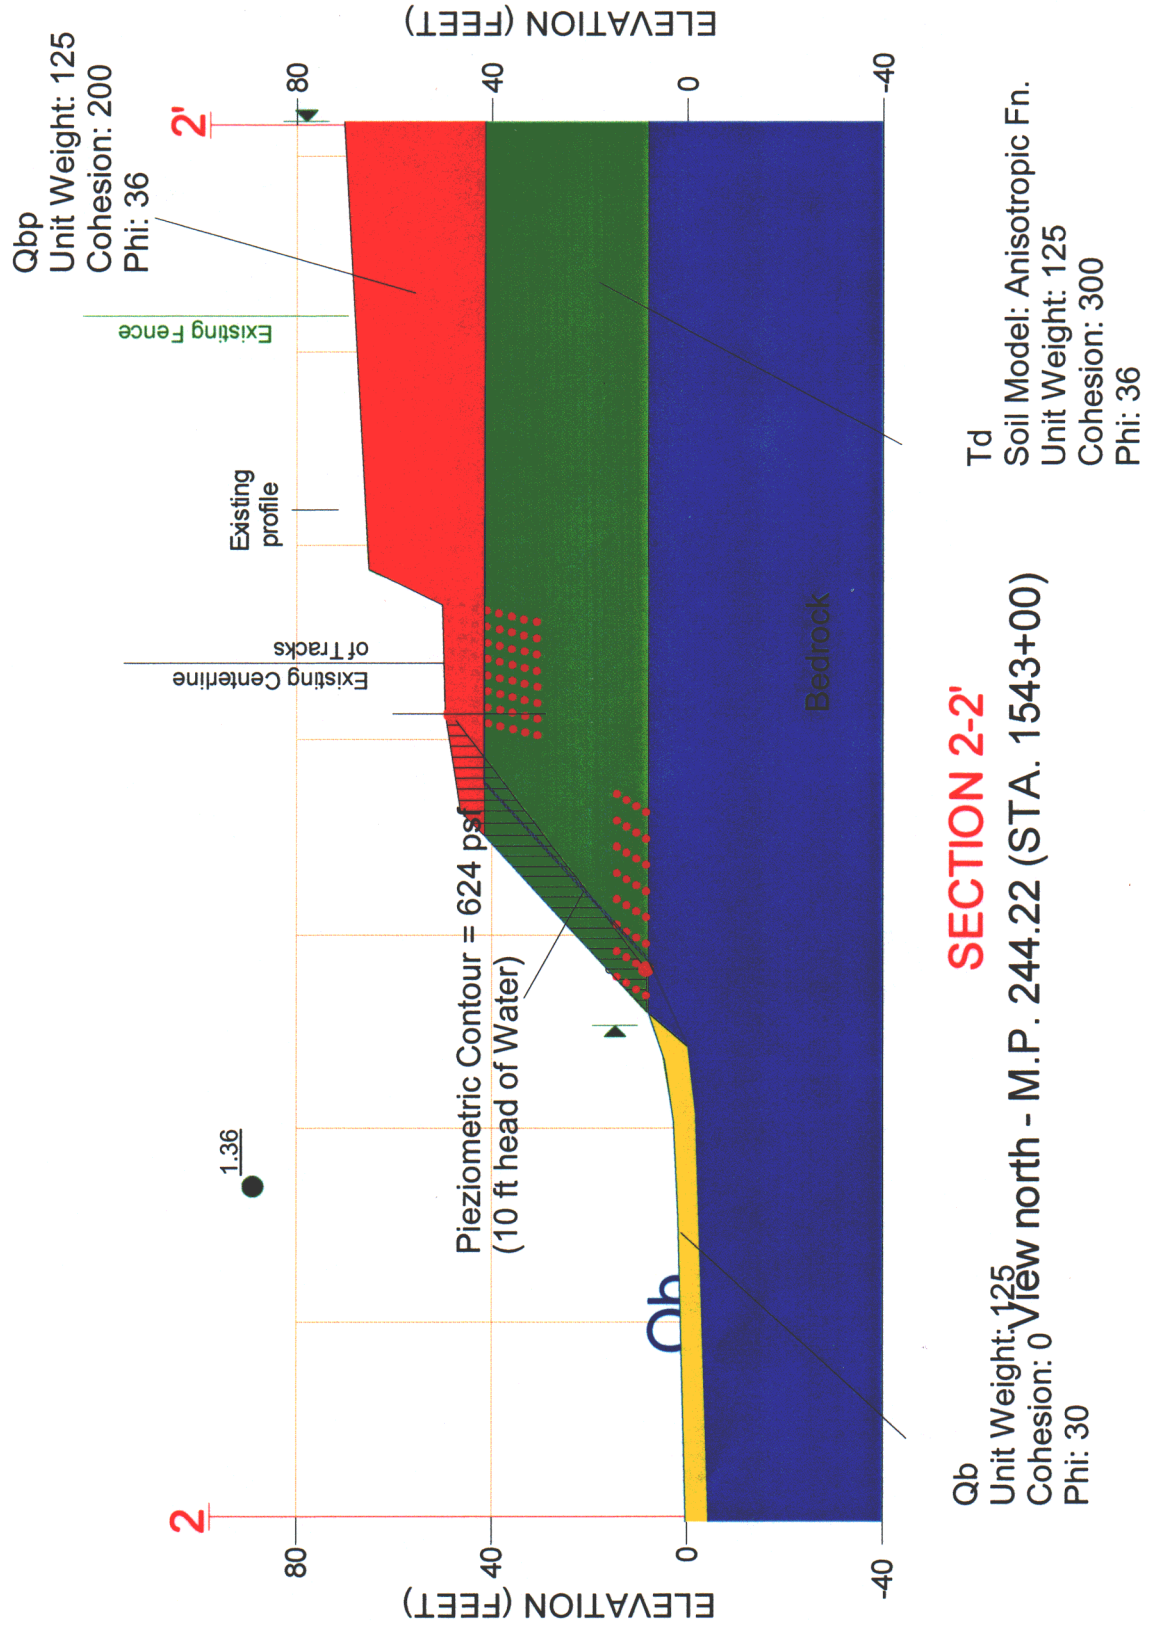
Del Mar Bluffs Cross Section 2-2'
 Slope Stability Analysis
 File Name: Section 22 10ft Water Static 1B.slz
 Analysis Method: Spencer
 Factor of Safety: 1.36

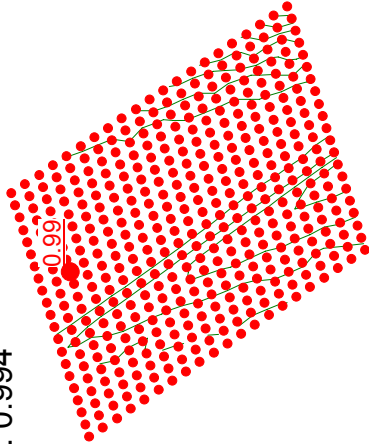
Del Mar Bluffs Section 3-3'

Analysis Method: Bishop

Factor of Safety: 0.994

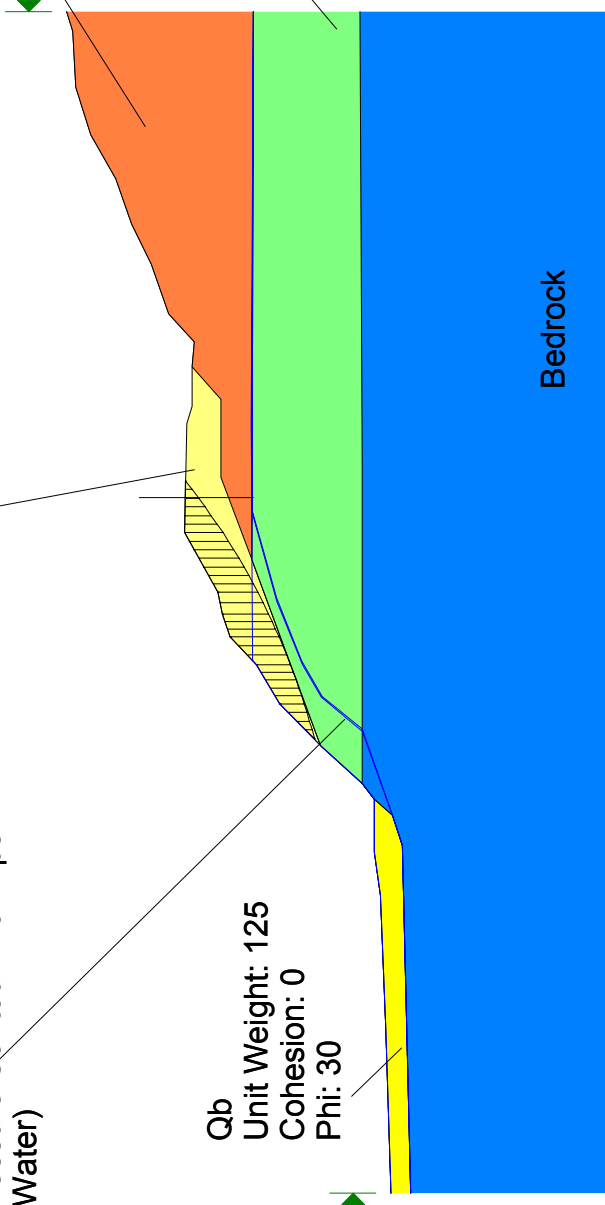
Del Mar Bluffs Cross Section 5-5'
Slope Stability Analysis
File Name: Section 55 10ft Water Static 2.siz
Analysis Method: Spencer
Factor of Safety: 1.39

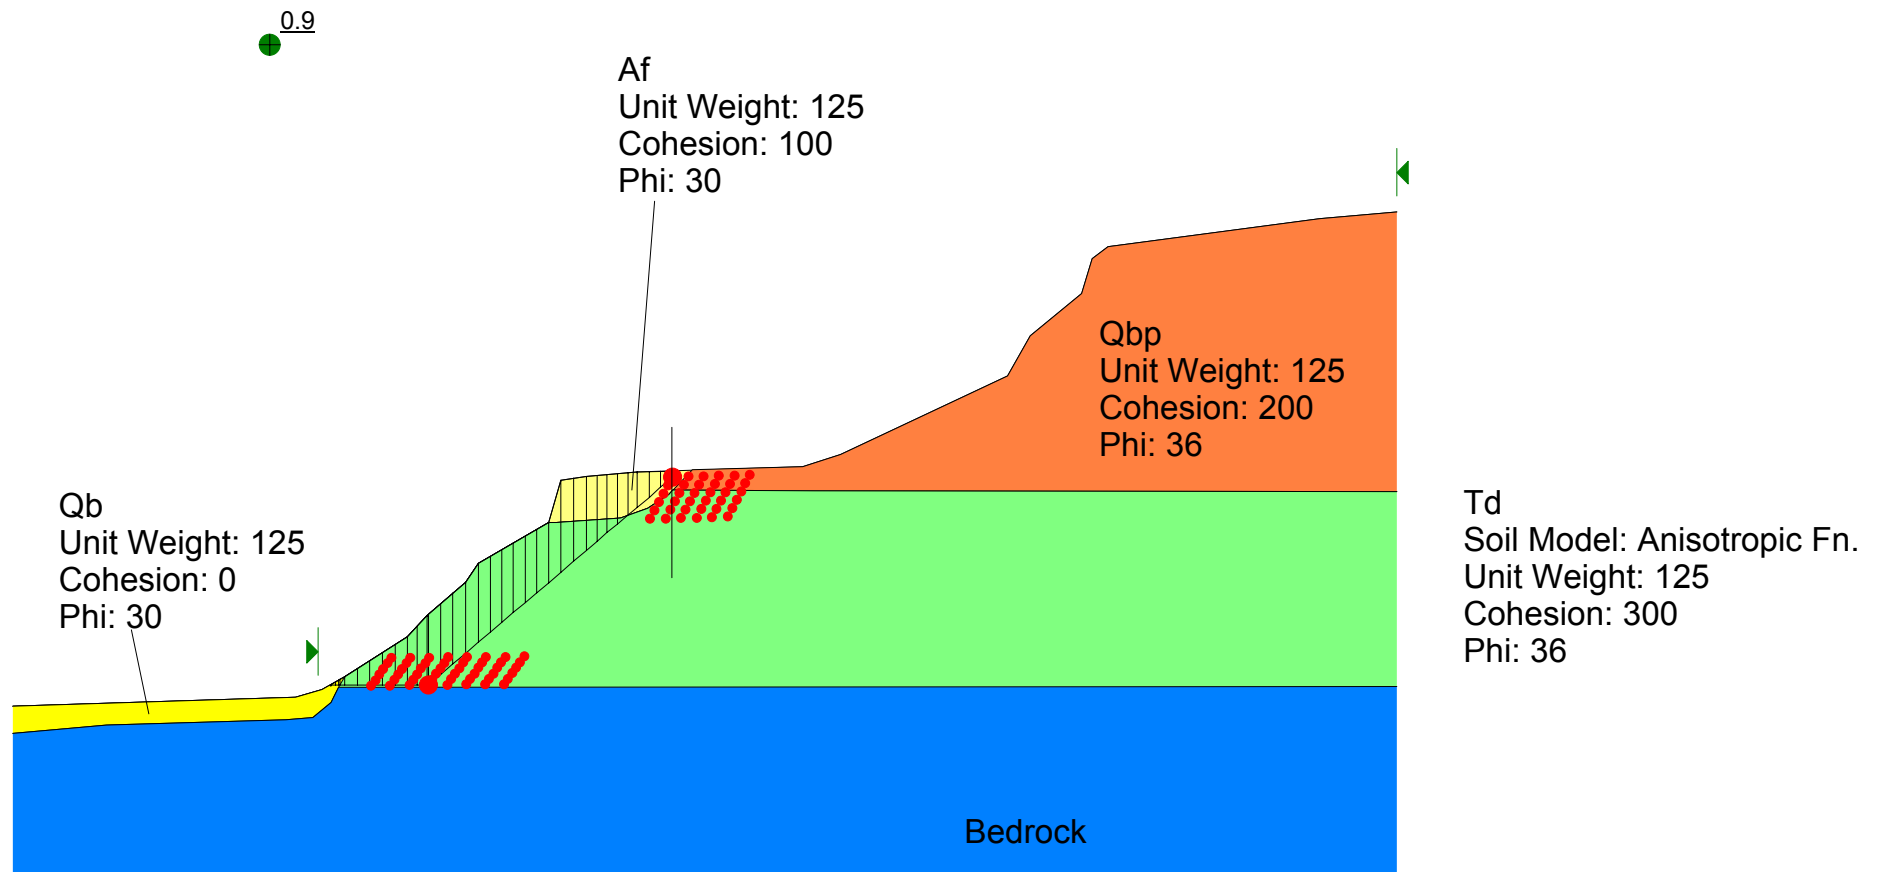
Del Mar Bluffs Cross Section 21-21'

Factor of Safety: 1.43

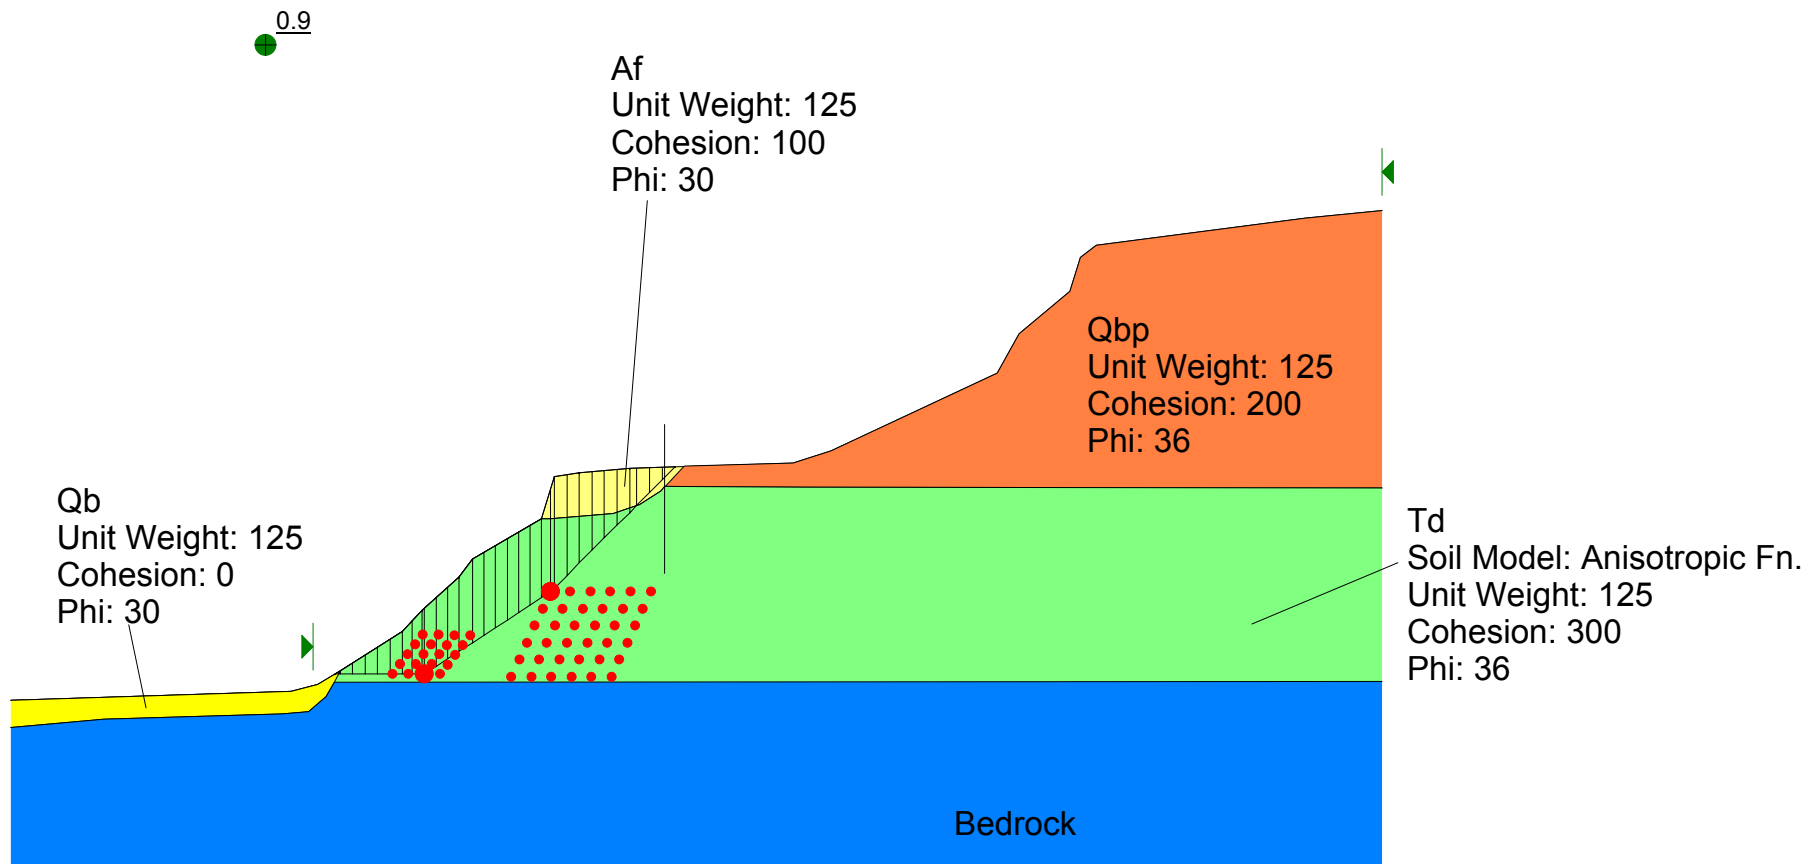
Del Mar Bluffs Cross Section 22-22'
Slope Stability Analysis
File Name: Section 2222 Static 2.slz
Analysis Method: Spencer
Factor of Safety: 1.5

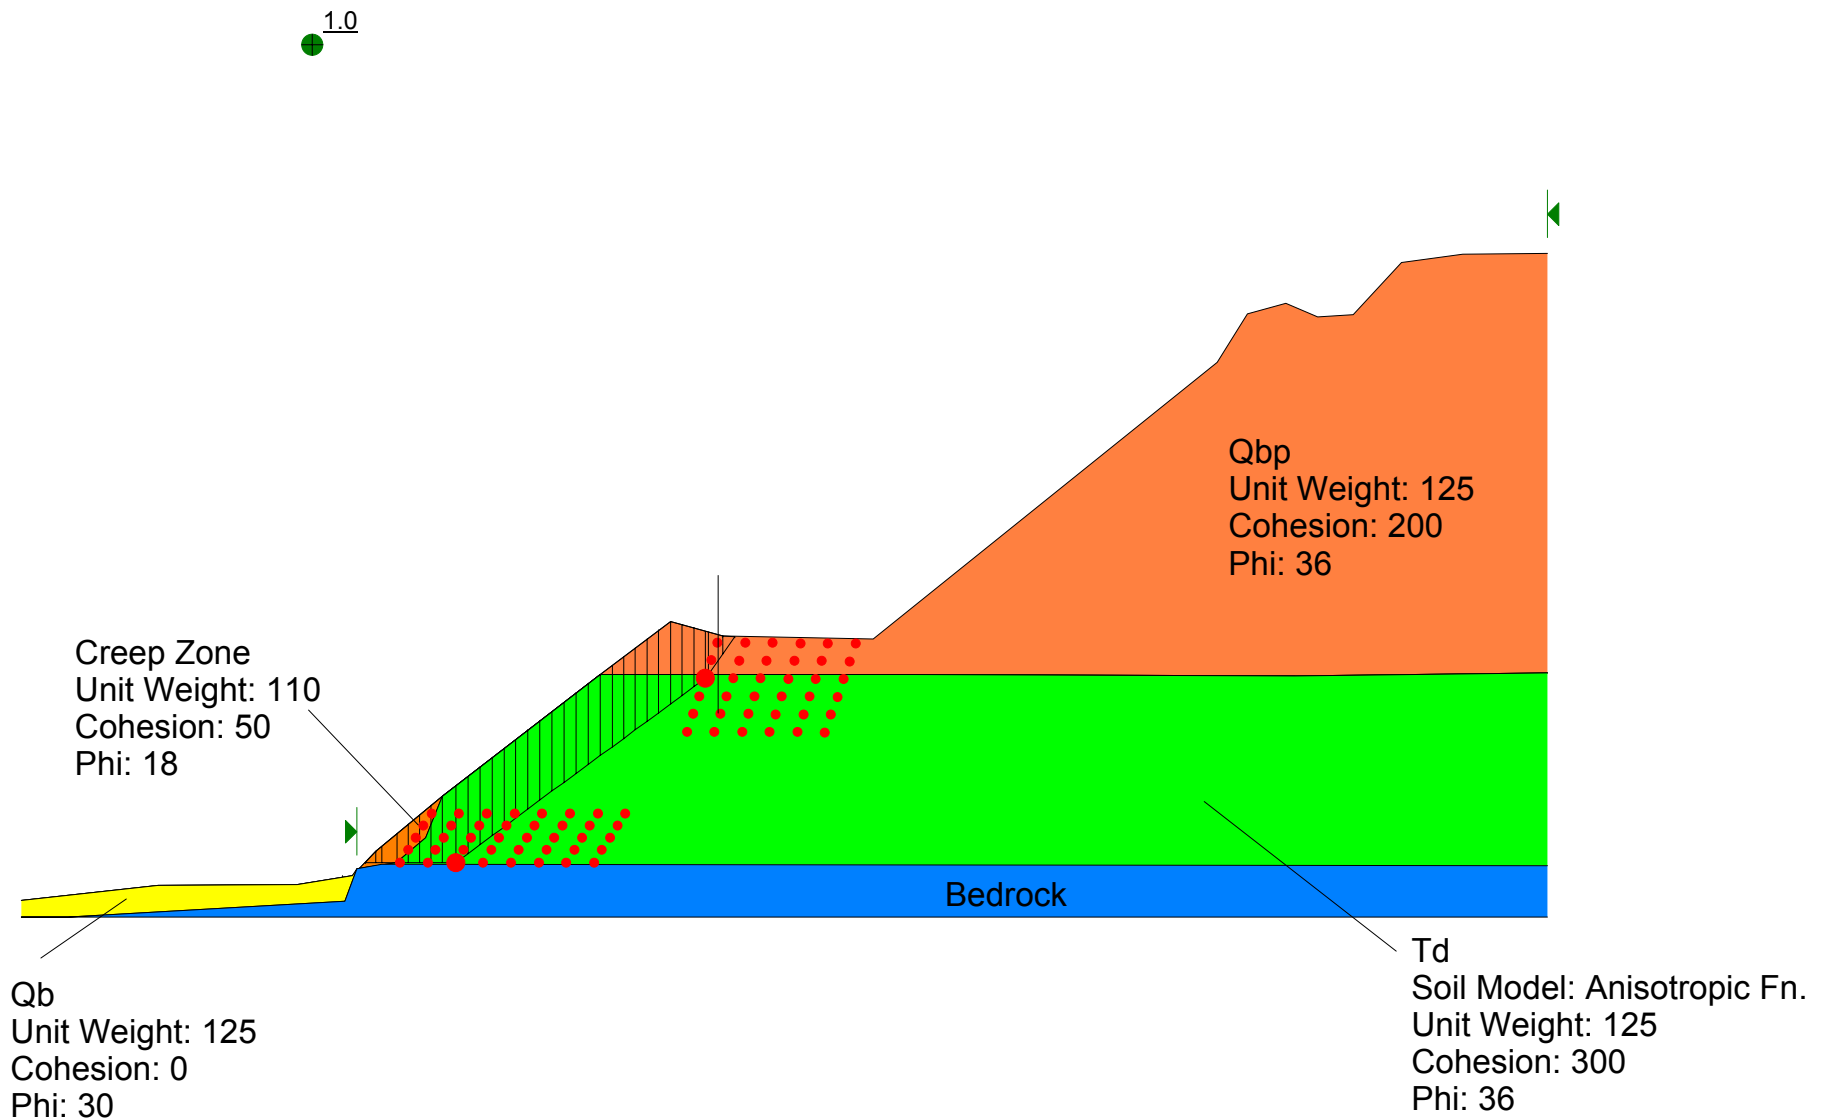
Del Mar Bluffs Cross Section 22-22'
Slope Stability Analysis
File Name: Section 2222 Psuedo Static 2.slz
Analysis Method: Spencer
Factor of Safety: 0.97
Siesmic Coefficient = 0.28

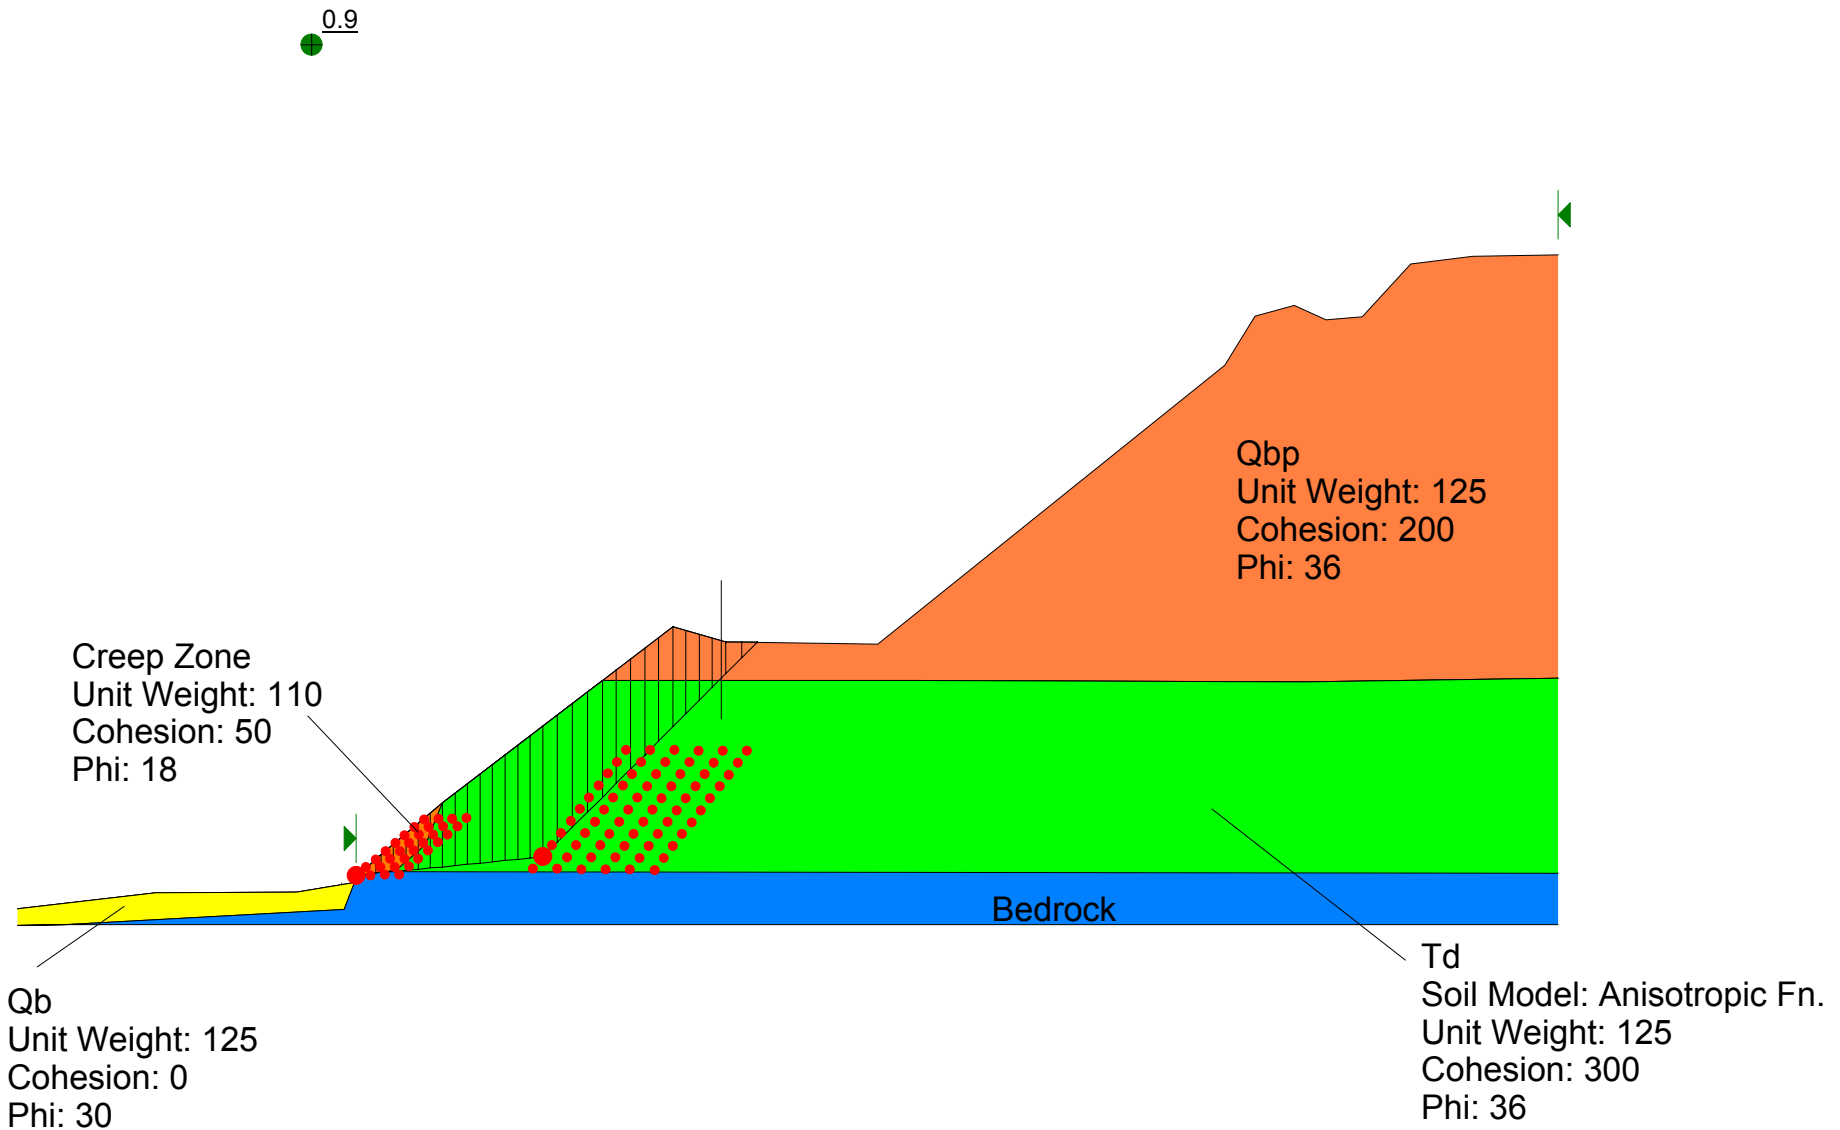
Del Mar Bluffs Cross Section 23-23'
Static Slope Stability Analysis
File Name: Section 2323 Static 1.slz
Analysis Method: Bishop
Factor of Safety: 1.49

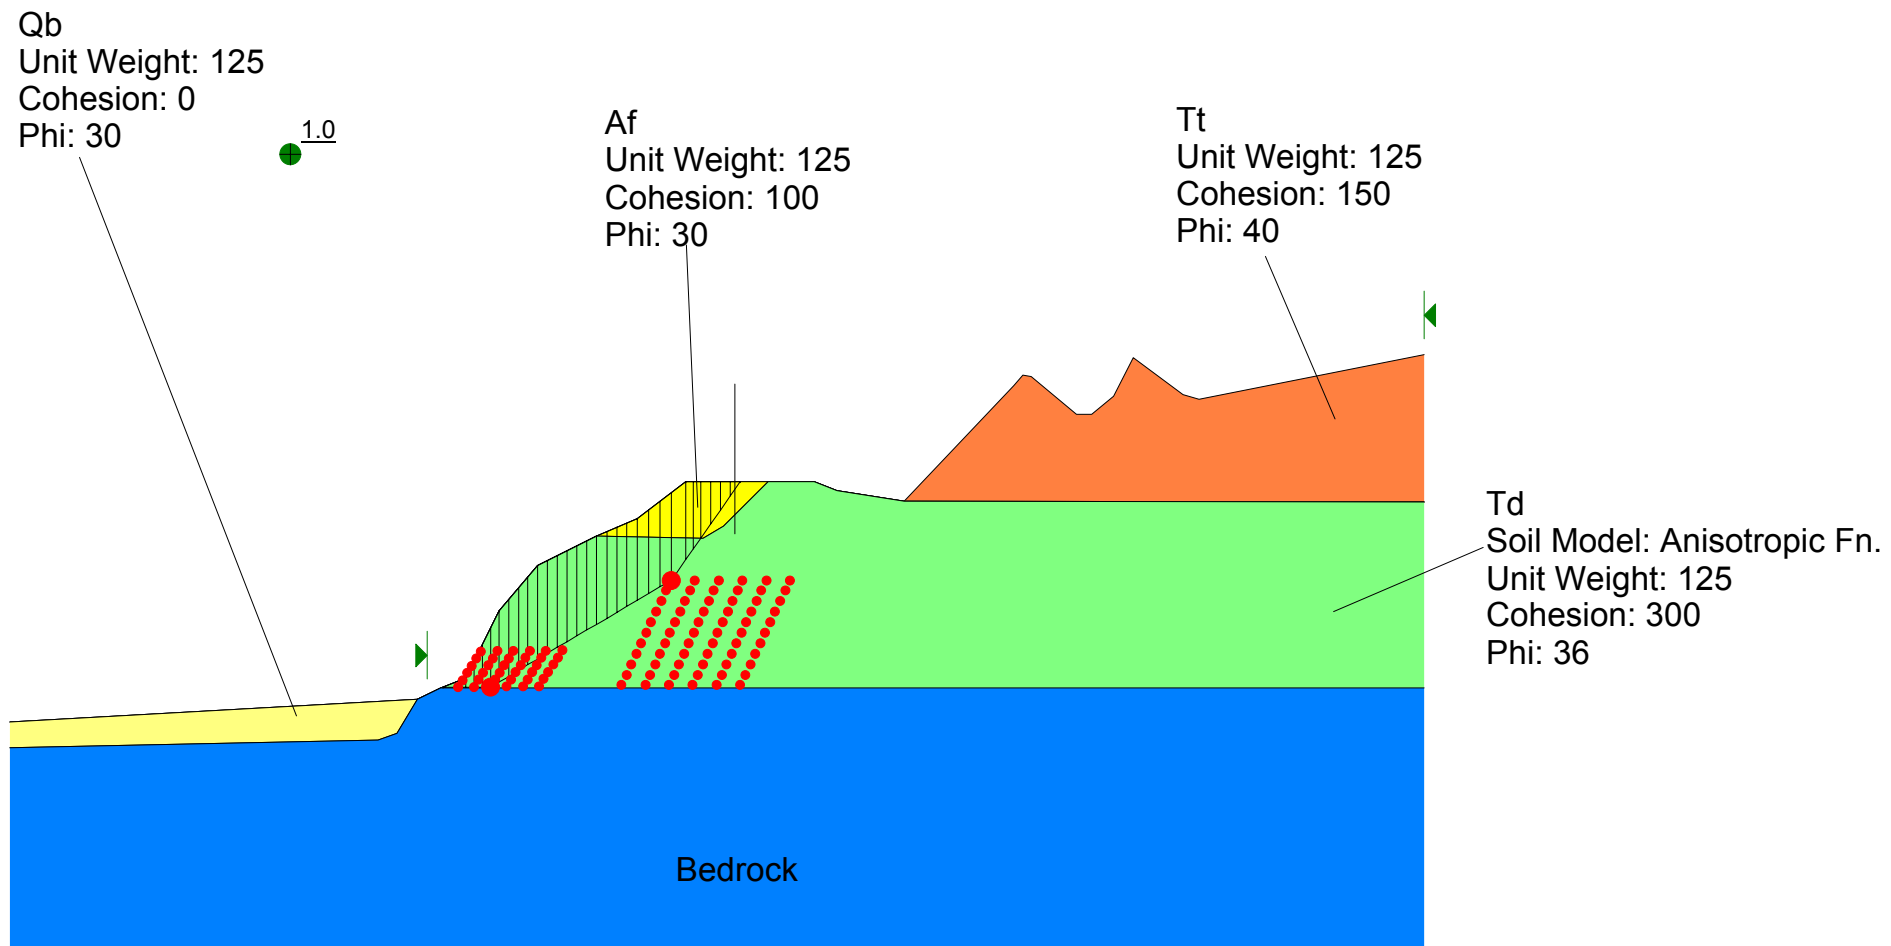
Del Mar Bluffs Cross Section 24-24'
Slope Stability Analysis
File Name: Section 2424 Static 1.slz
Analysis Method: Bishop
Factor of Safety: 1.58

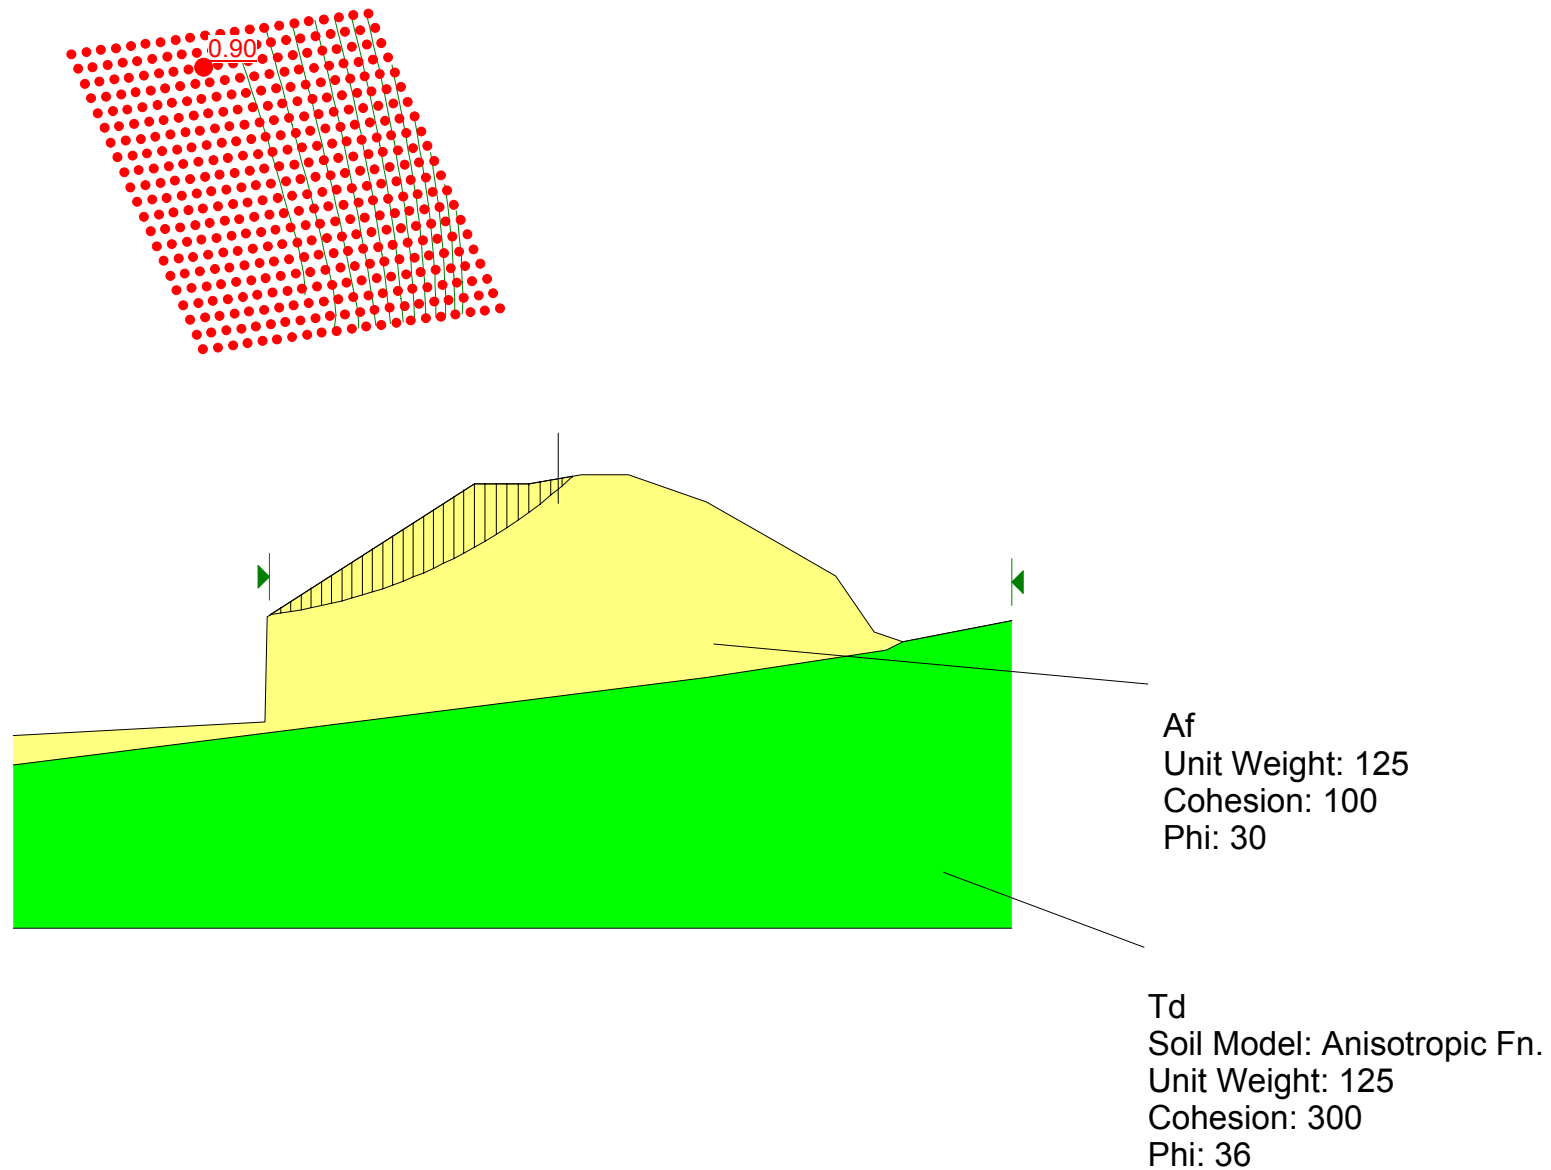
Del Mar Bluffs Cross Section 25-25'
Slope Stability Analysis
File Name: Section 2525 Water Static 1.slz
Analysis Method: Bishop

Factor of Safety: 1.74

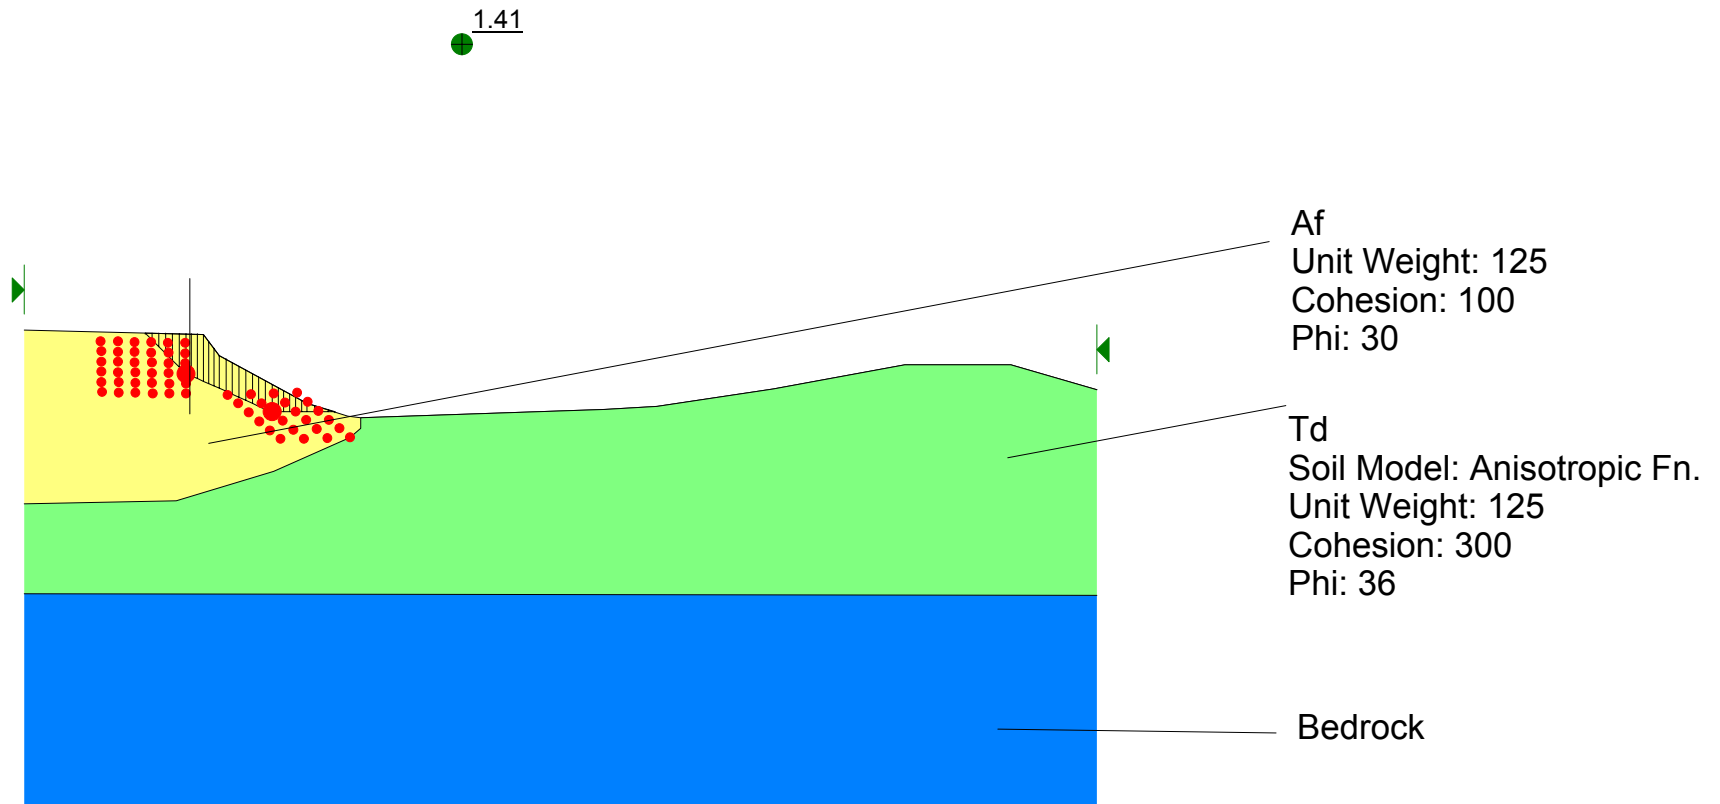
Factor of Safety: 1.41

Seismic Coefficient = 0.15

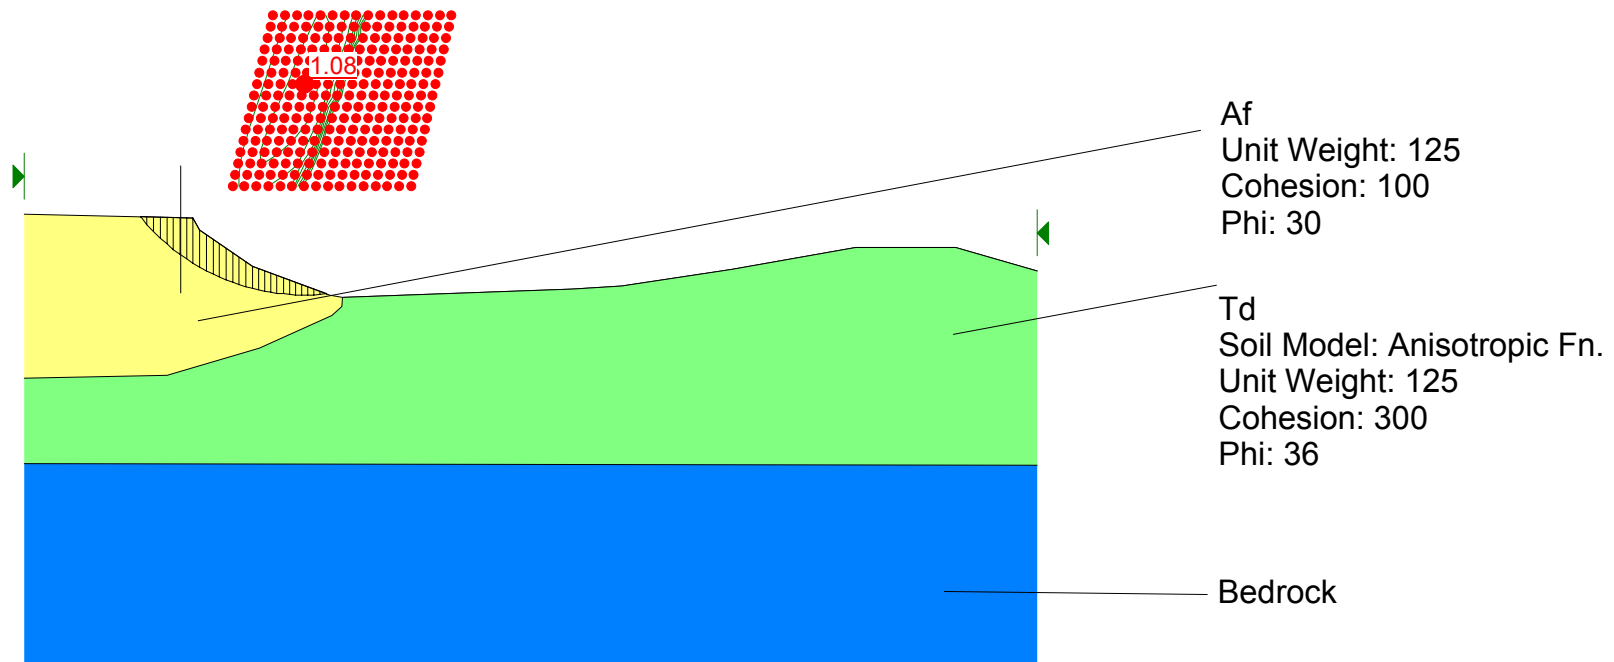
Del Mar Bluffs Cross Section 25-25'
Slope Stability Analysis
File Name: Section 2525 Psuedo Static Static 3.slz
Analysis Method: Bishop

Factor of Safety: 1.08
Seismic Coefficient = 0.28

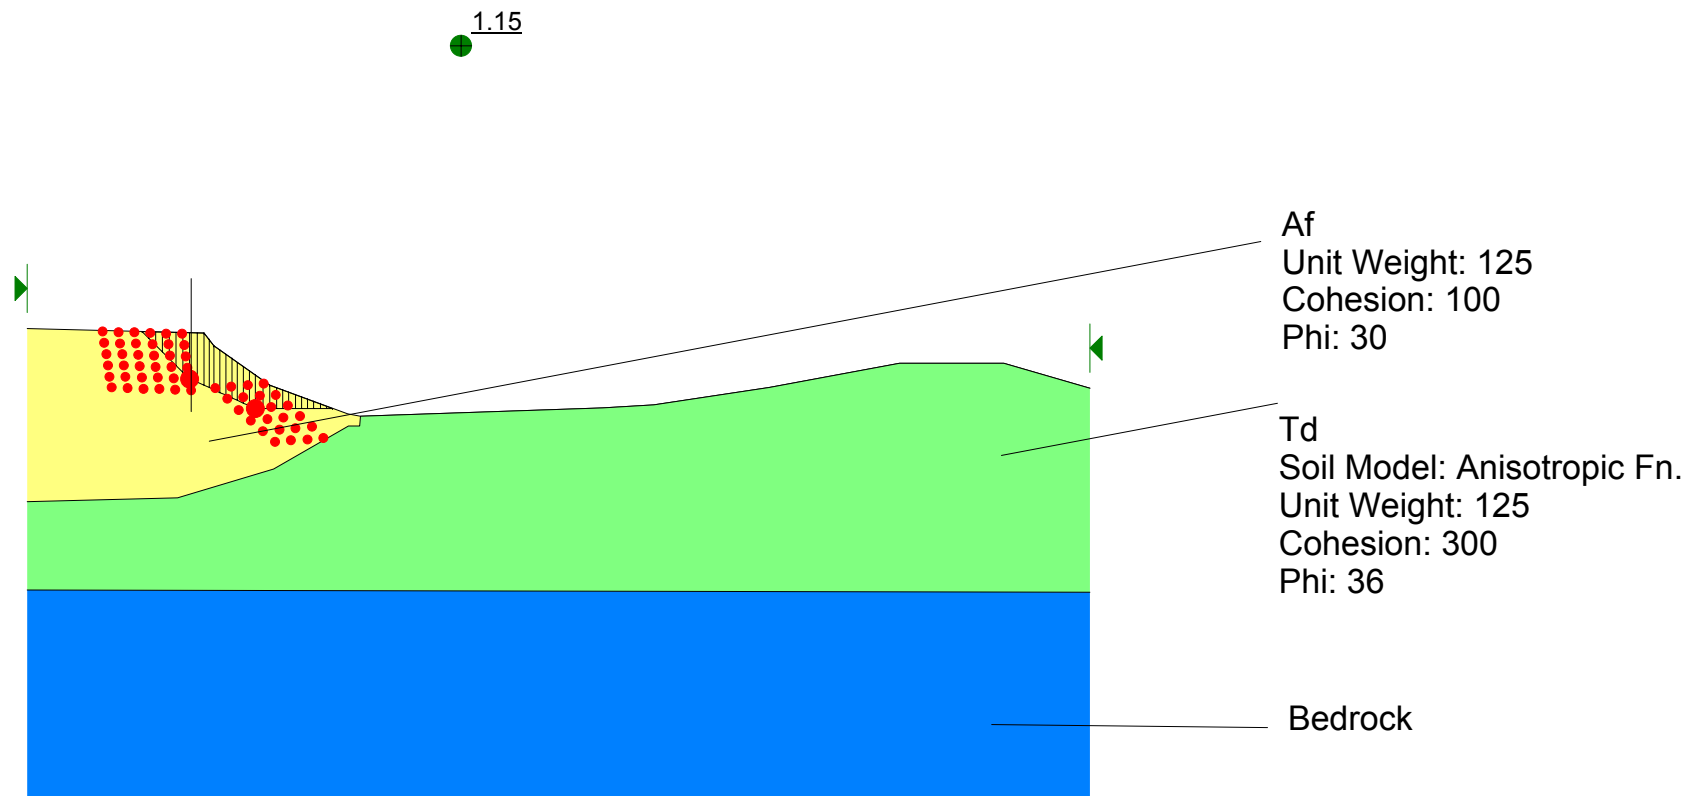
Del Mar Bluffs Cross Section 25-25'

Factor of Safety: 1.15

Seismic Coefficient = 0.28

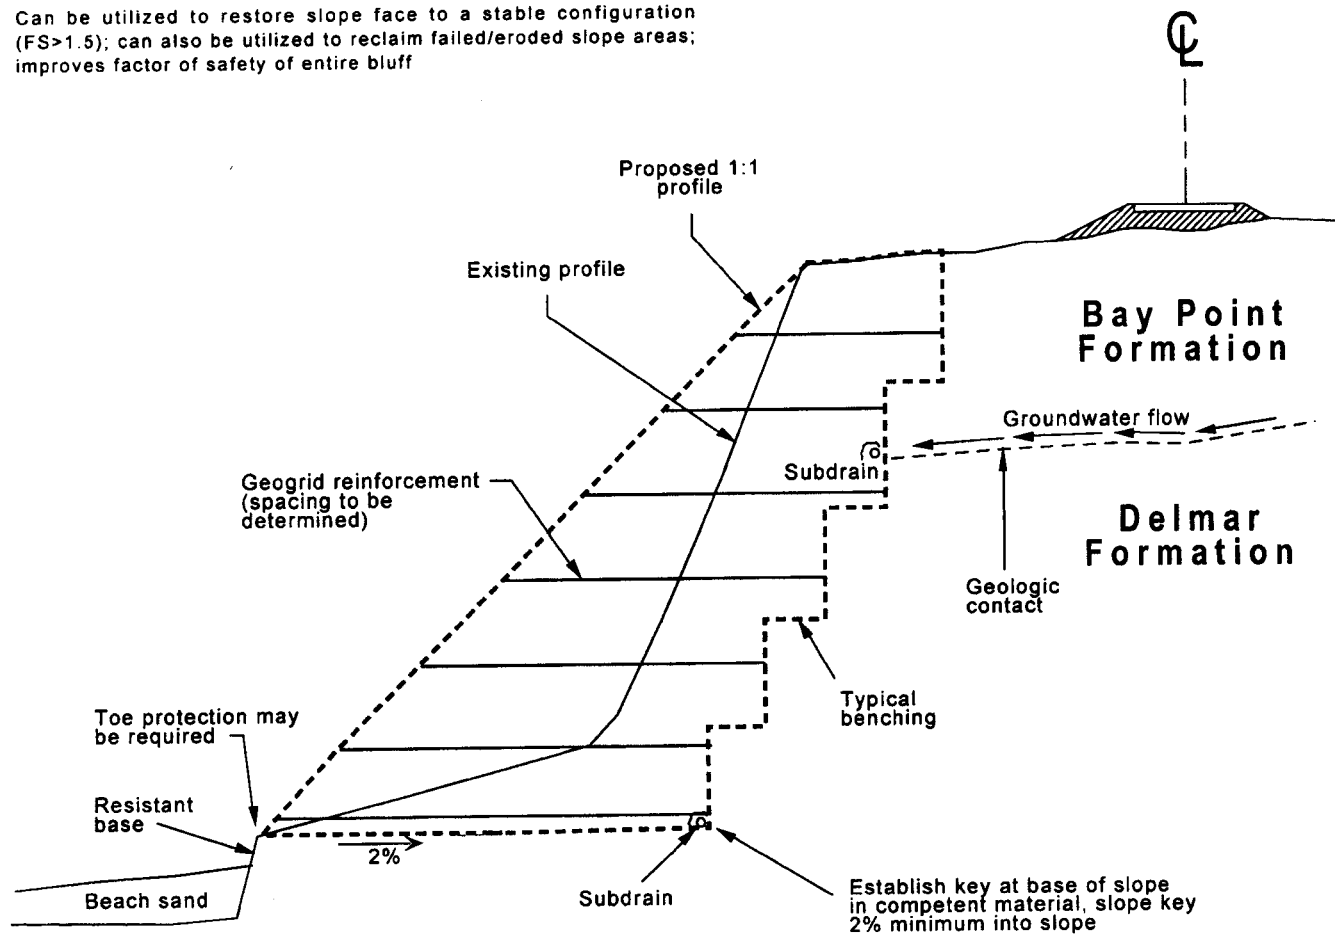
Can be utilized to restore slope face to a stable configuration (FS>1.5); can also be utilized to reclaim failed/eroded slope areas; improves factor of safety of entire bluff
