DEL MAR BLUFFS STABILIZATION
PROJECT 2 – PRESERVING TRACKBED SUPPORT

**SUPPLEMENTAL GEOTECHNICAL EVALUATION
AND
DETERMINATION OF SITE SPECIFIC CONCEPTUAL REPAIR ALTERNATIVES**

Project No. 040151-009

June 2, 2003
(Revised November 5, 2003)

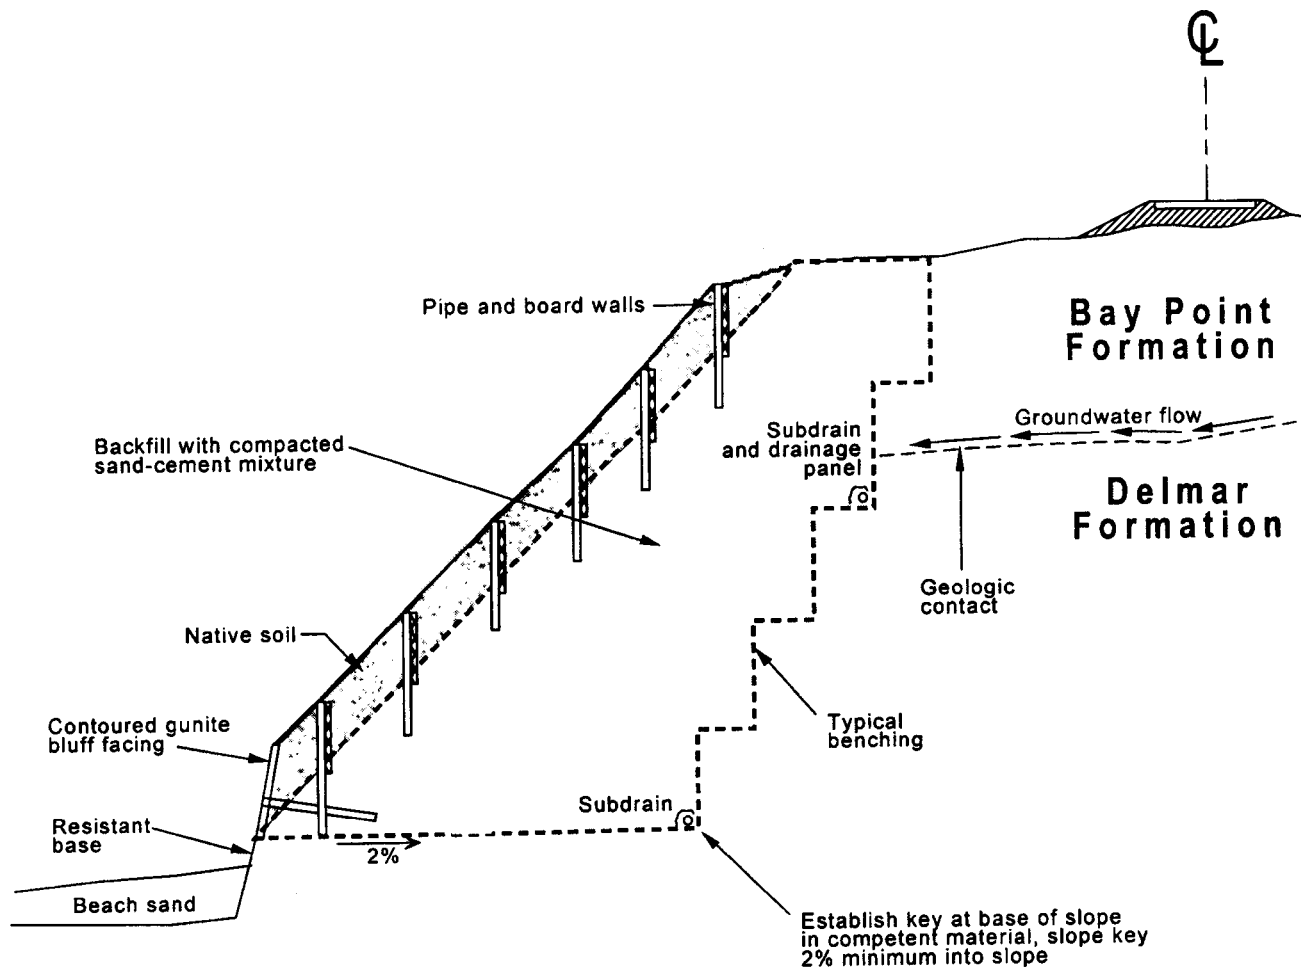
Can be utilized to restore slope face to a stable configuration ($FS > 1.5$); can also be utilized to reclaim failed/eroded slope areas; improves factor of safety of entire bluff

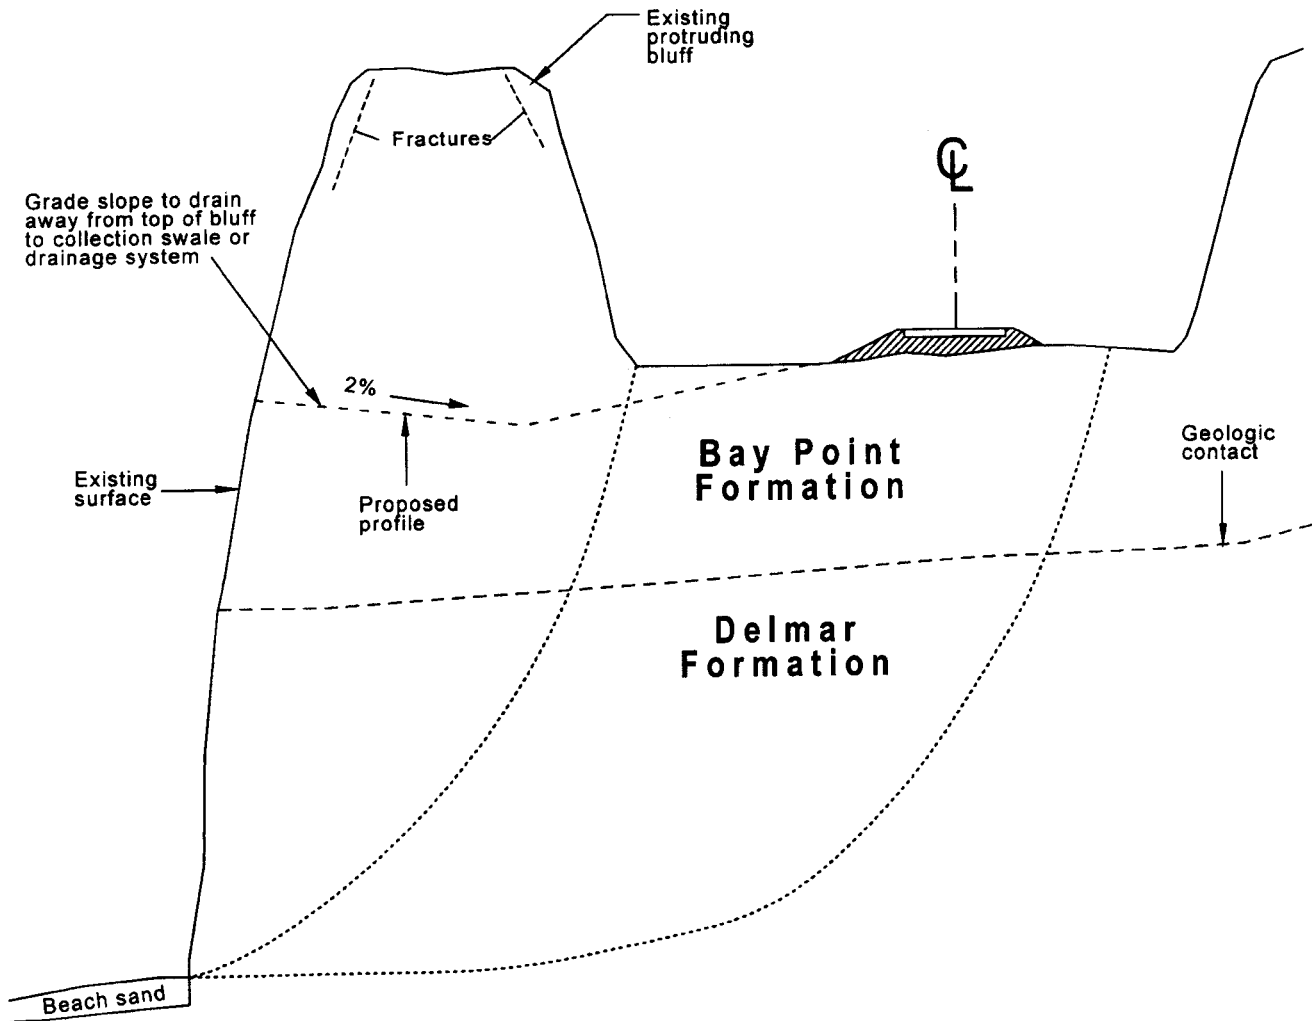
BLUFF TOP GRADING (CENTRAL PORTION OF BLUFF)

Improves stability of bluff face by removing weight from bluff top; may not improve overall factor of safety for deep seated stability

Improve stability of bluff face by reducing driving forces (weight). Generates material that can be used for slope repair/possible beach nourishment. Also reduces short term potential for block falls, improves views, provides possible source of beach nourishment and maintains positive drainage.
