LIMITED GEOTECHNICAL INVESTIGATION AND INPUT TO
BUENA VISTA LAGOON RESTORATION PROJECT
OCEANSIDE/CARLSBAD, CALIFORNIA

Prepared for
SCIENCE APPLICATIONS INTERNATIONAL CORP.
San Diego, California

Prepared by
TERRACOSTA CONSULTING GROUP, INC.
San Diego, California

Project No. 2615-02
November 7, 2008
Revised November 19, 2008

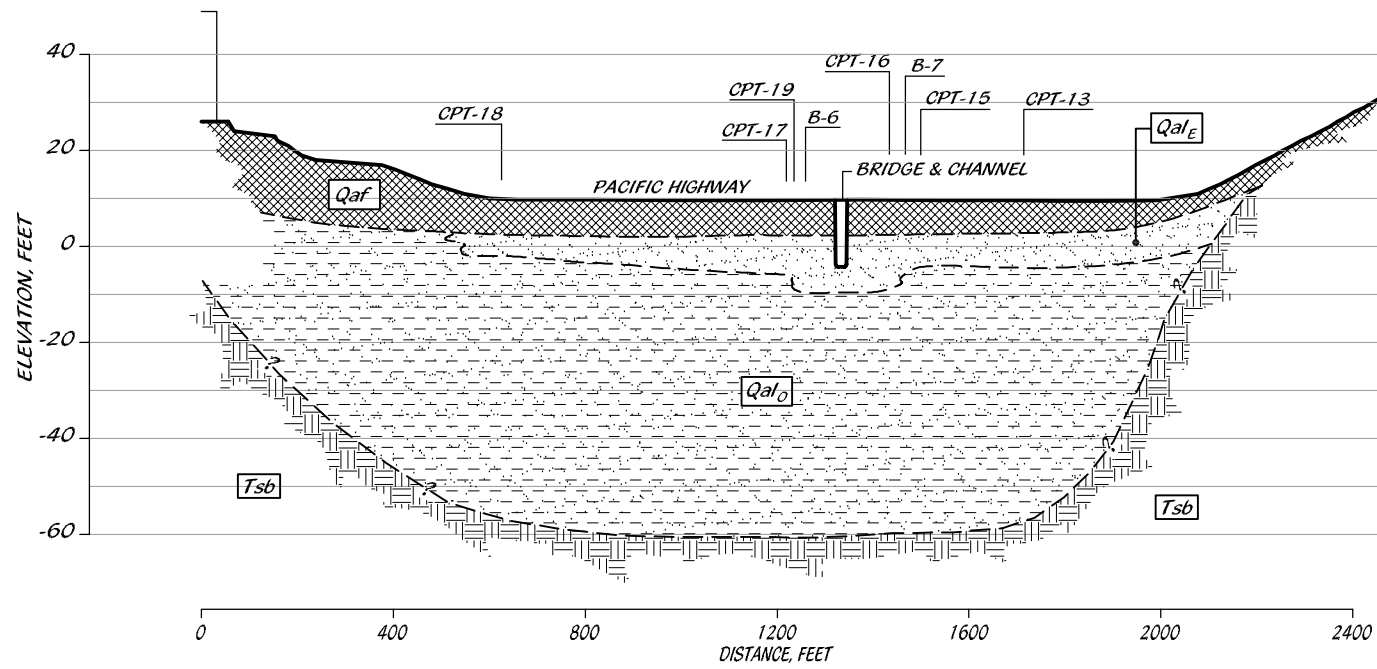
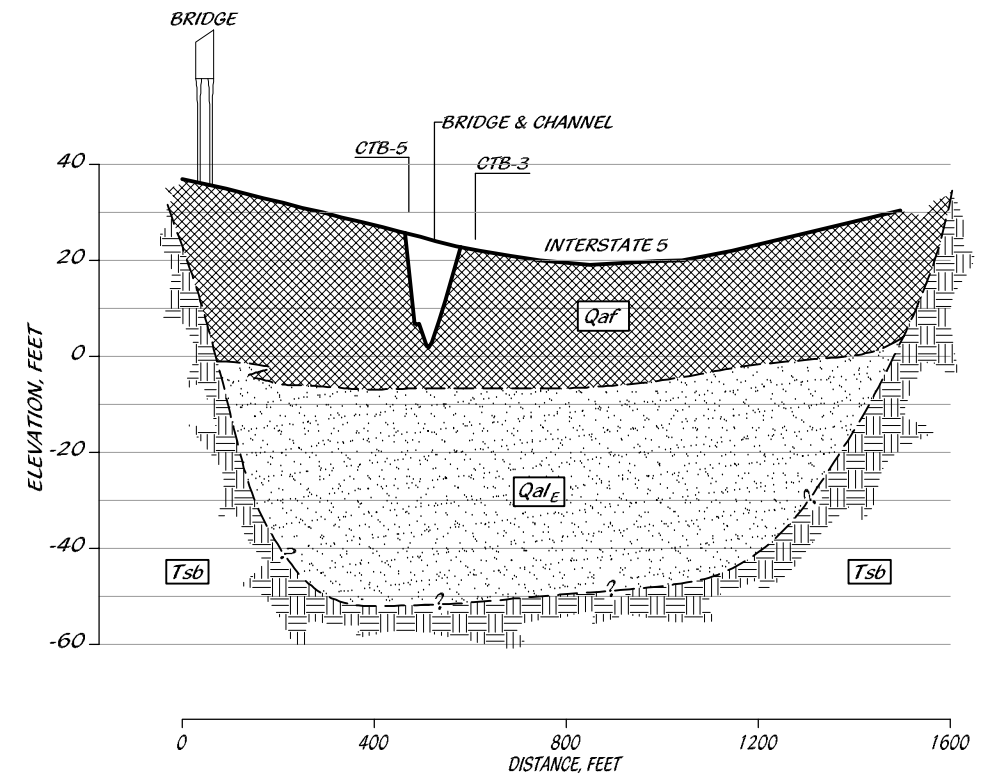
GENERALIZED GEOLOGIC CROSS SECTIONS 'B' & 'C'

CROSS SECTION B
 SCALE: HORIZ. 1"=400'
 VERT. 1"=40'
 FIG 2

CROSS SECTION C
 SCALE: HORIZ. 1"=400'
 VERT. 1"=40'
 FIG 2

The generalized geologic cross sections shown on Figures 3 and 4 present our best estimate, from a limited number of available deep boring and CPT logs, of the likely shape of the alluvial-filled lagoonal prism along CH/CB and the Interstate 5 freeway, respectively. It should be emphasized that these cross sections are exaggerated 1:10 (horizontal to vertical) in order to provide an overall picture of the relationships between the various soil and geologic units in the present day lagoonal system. Available logs of test borings made in recent years at, or near, the mouths of the principal San Diego County coastal drainages indicate that alluvial depths at the present day coastline range from approximately 80 to 130+ feet of depth. Although we do not have similar, specific test boring information in the beach bar area for Buena Vista Lagoon, extrapolations from the test borings of the Irvine Consulting Group (see Appendix A) and the Caltrans 1968 test borings (see Appendix A) indicate that the lagoonal alluvium is likely to be on the order of approximately 90± feet deep in the area of the beach bar.

Formational Soils – As indicated on the Site Plan and Geologic Map (Figure 1), and on Generalized Geologic Cross-Sections A, B, and C (Figures 3 and 4), the site is underlain by relatively horizontally-stratified sandstones and claystones of the upper-middle tertiary Santiago Formation (Tsb). Limited areas of the surface of this Eocene-age unit are exposed along the south shoreline of the lagoon. Also indicated on the Site Plan and Geologic Map are moderately-consolidated, poorly-indurated, tan to reddish-brown, sands and clays that include nearshore marine and beach sands and, in some areas, a cap of dune sands. These relatively thin (generally less than 20 feet thick) but extensive terrace deposits overlie a wave-cut platform, abraded during higher eustatic sea stands.
