**VISUAL IMPACT ASSESSMENT FOR THE  
INLAND RAIL TRAIL PROJECT**

**Cities of San Marcos and Vista, County of San Diego**

**11-SD-CML 5381(003)**

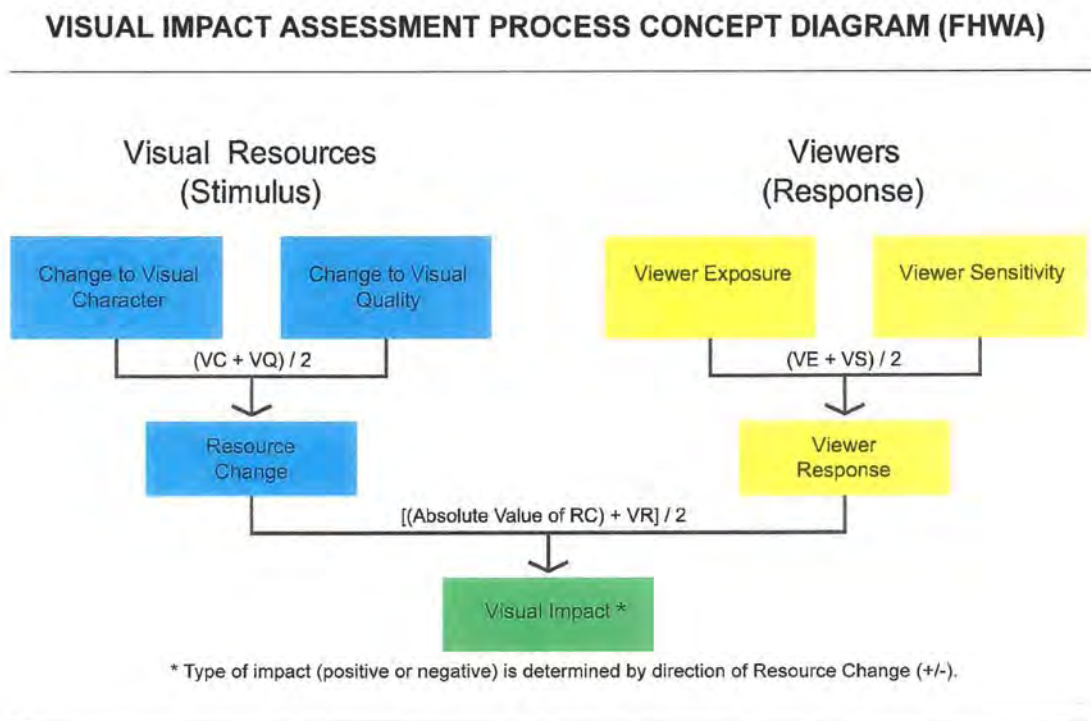
**Figure 4: Visual Impact Assessment Process Concept Diagram**

The visual impacts of project alternatives are determined by assessing the visual resource change due to the project and predicting viewer response to that change. Visual resource change is the sum of the change in visual character and change in visual quality. The first step in determining visual resource change is to assess the compatibility of the proposed project with the visual character of the existing landscape. The second step is to compare the visual quality of the existing resources with projected visual quality after the project is constructed. The viewer response to project changes is the sum of viewer exposure and viewer sensitivity to the project as determined in the preceding section. The resulting level of visual impact is determined by combining the severity of resource change with the degree to which viewers are likely to oppose the change. Figure 4 below is a flowchart which details the process of assessing project impacts for both visual resources and viewers. The average of these two quantified values is used to determine the project's visual impact.

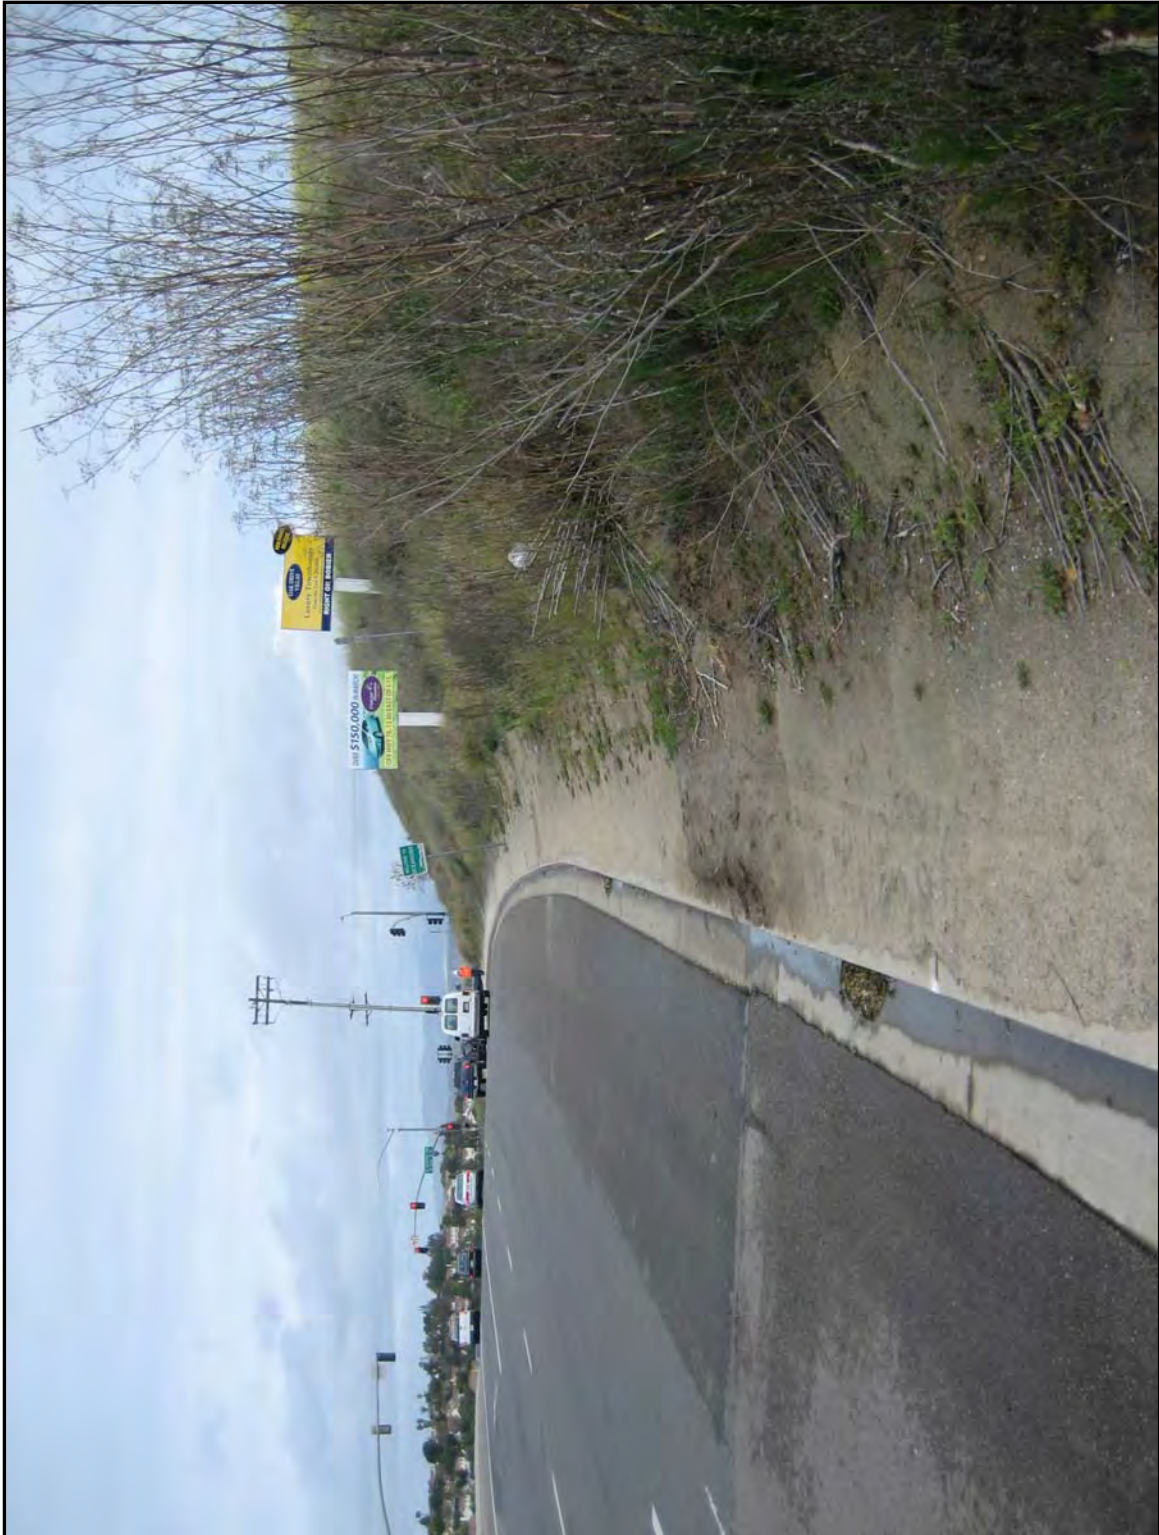
**Figure 5: Key View 1: Existing**

**a. Orientation:** Key view 1 is the view from the northbound lanes along Melrose Drive looking north towards the intersection of Melrose Drive and Oceanside Boulevard (Figure 4). This photograph was taken on the easternmost side of the road, closest to the location of the proposed project.

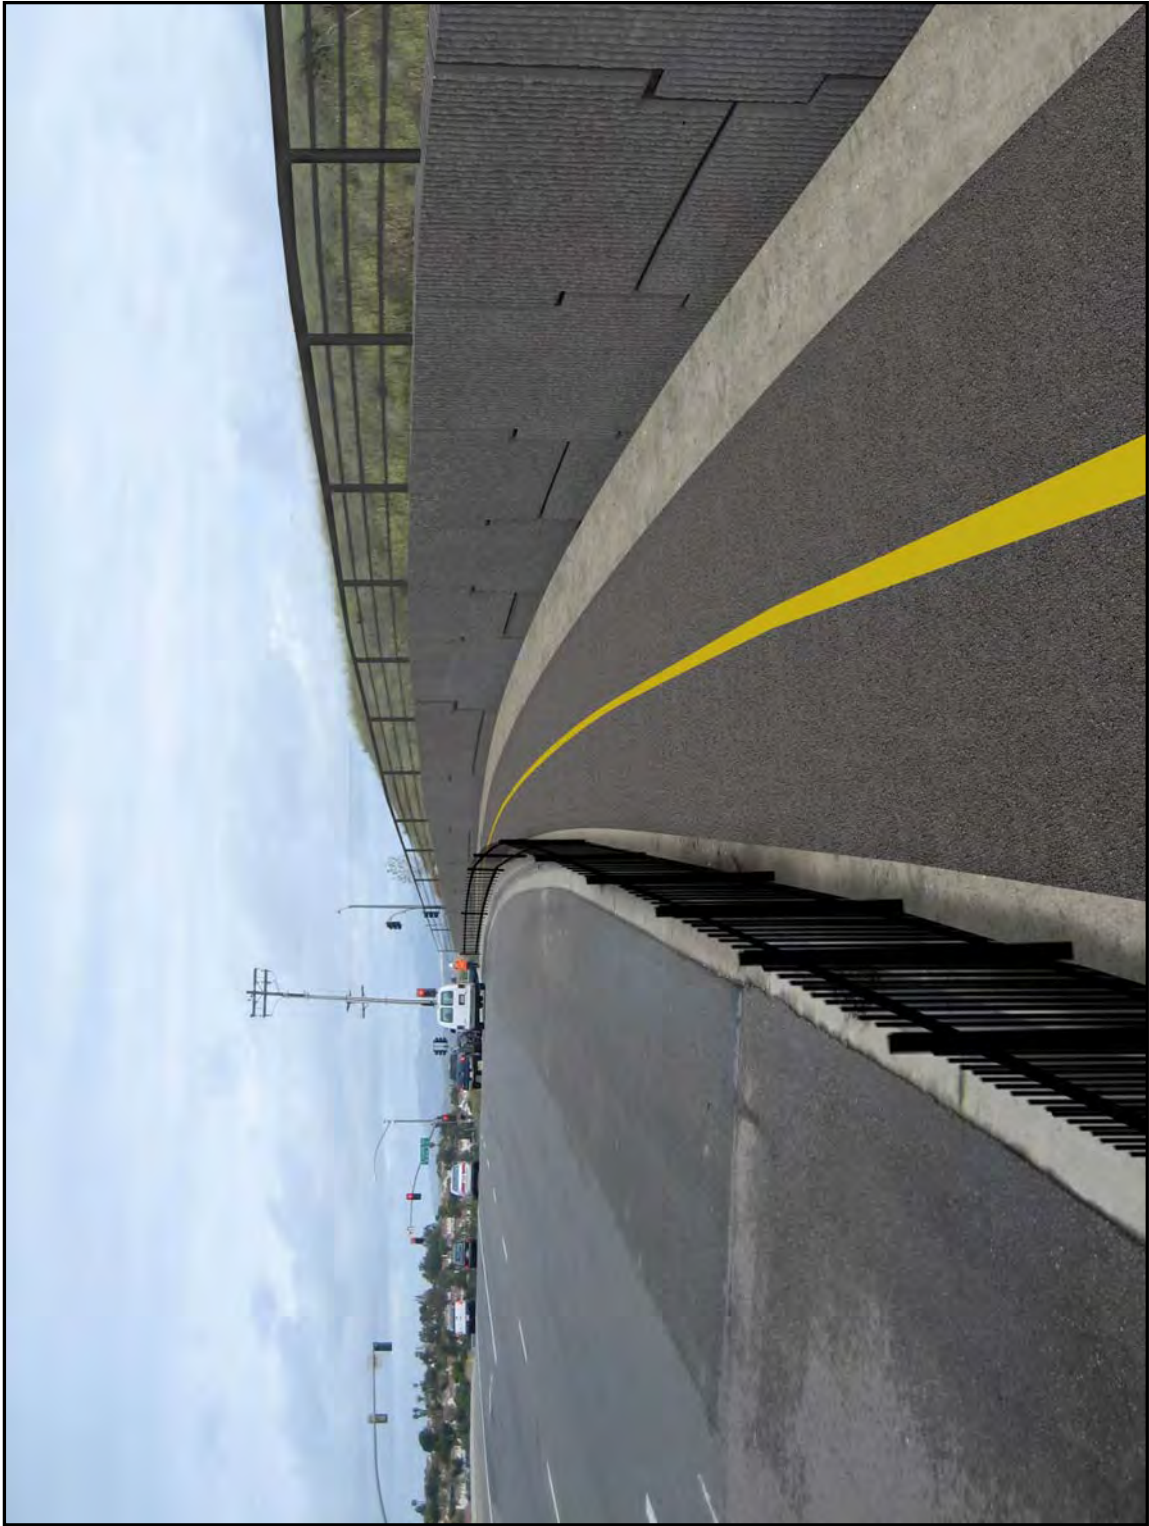
**Figure 6: Key View 1 - Visual Simulation with the Proposed Project**

**c. Proposed Project Features:** Project features within Key View 1 include a bike path with asphalt concrete paving and with concrete shoulders, potential graffiti resistant textured retaining wall, and wrought iron fencing on both sides of bike trail for safety and access control. Wall texture shown in Figure 6 is representative of the texture that may be selected. The need for the retaining wall and the final choices for aesthetic design will be determined during final design and with the consensus with the Cities of San Marcos, Vista, the County of San Diego, and SANDAG.

**f. Resulting Visual Impact:** The visual simulation of key view 1 with the proposed project shows that the project fits in well with the existing road (Figure 6). Vividness improves slightly (+0.44) due to the introduction of the bike path and clean fence lines; memorability of the view is improved. Views of the background topography and landscaping are unaffected. Intactness improves (+0.50) because the proposed project improves the integrity of the visual order – the proposed project is consistent with existing visual patterns. The addition of the proposed project improves unity (+0.67) as it continues the dominant pattern of a paved road in the view. The proposed project helps tie together the road with the vegetated area.

\*Wall texture shown in this Figure is representative of the texture that may be selected

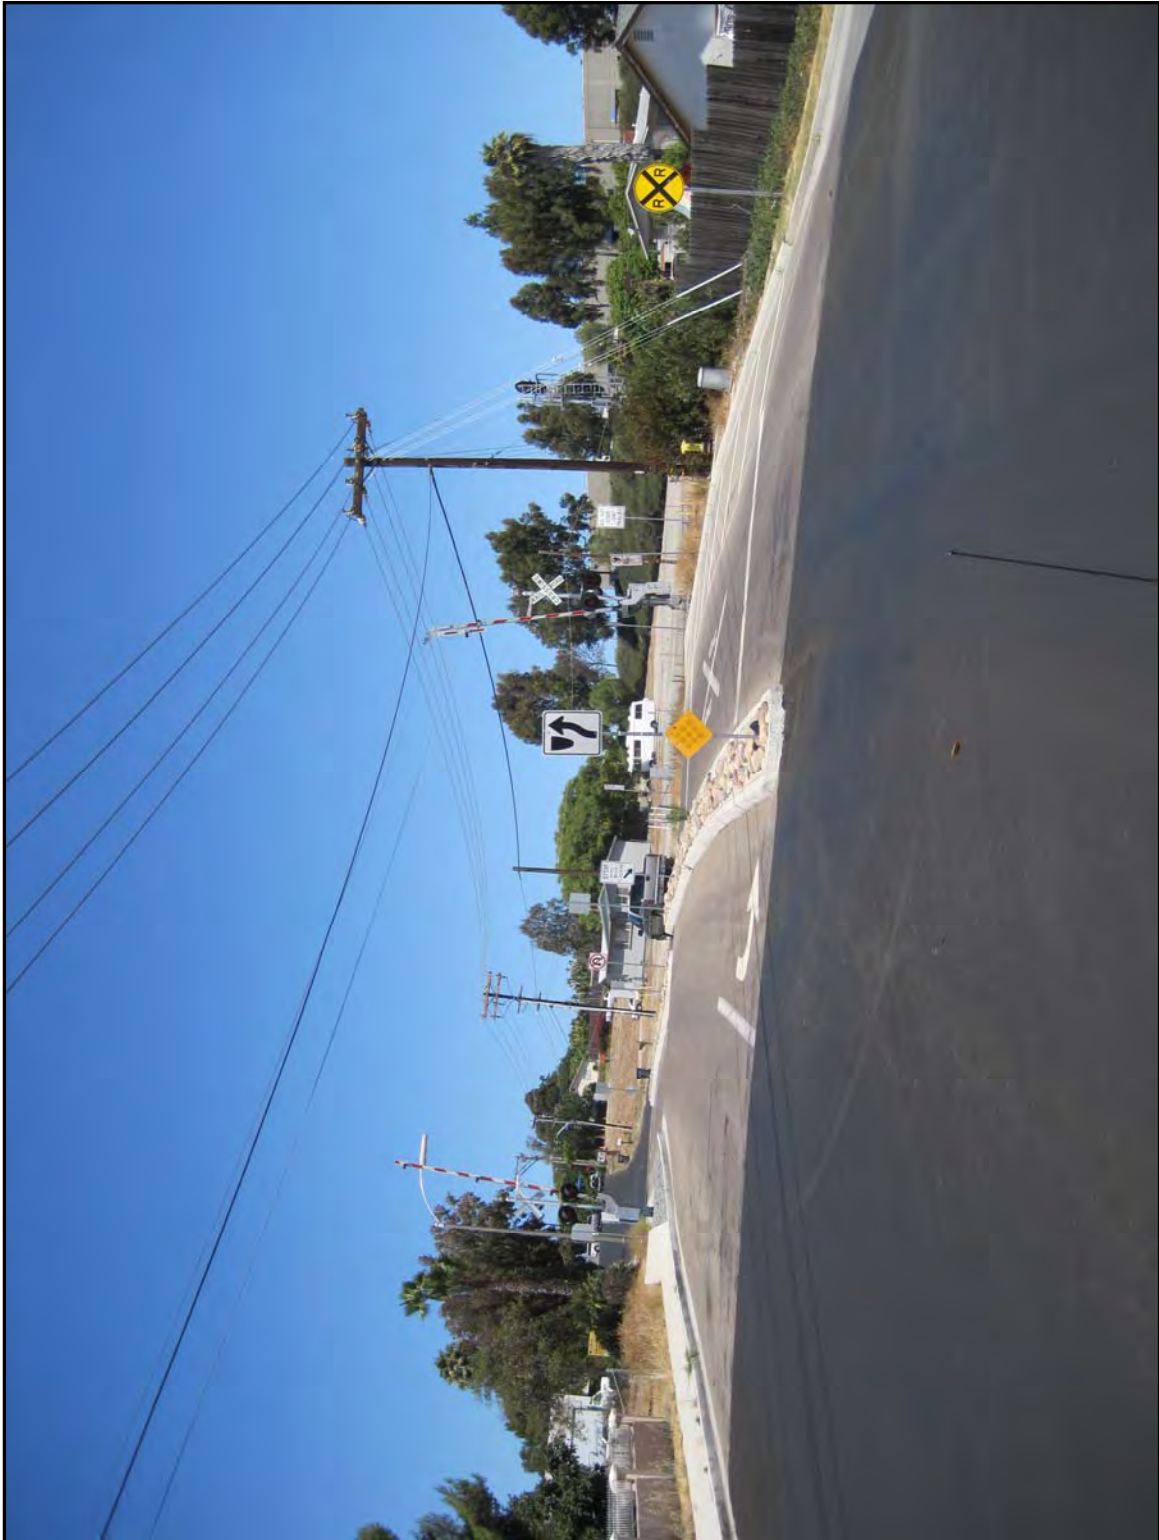
Figure 7: Key View 2 – Existing

**a. Orientation:** Key view 2 represents the view from North Drive facing towards the SPINTER Railroad Crossing (Figure 6). This photograph was taken at the intersection of North Drive and Waxwing Drive facing west.

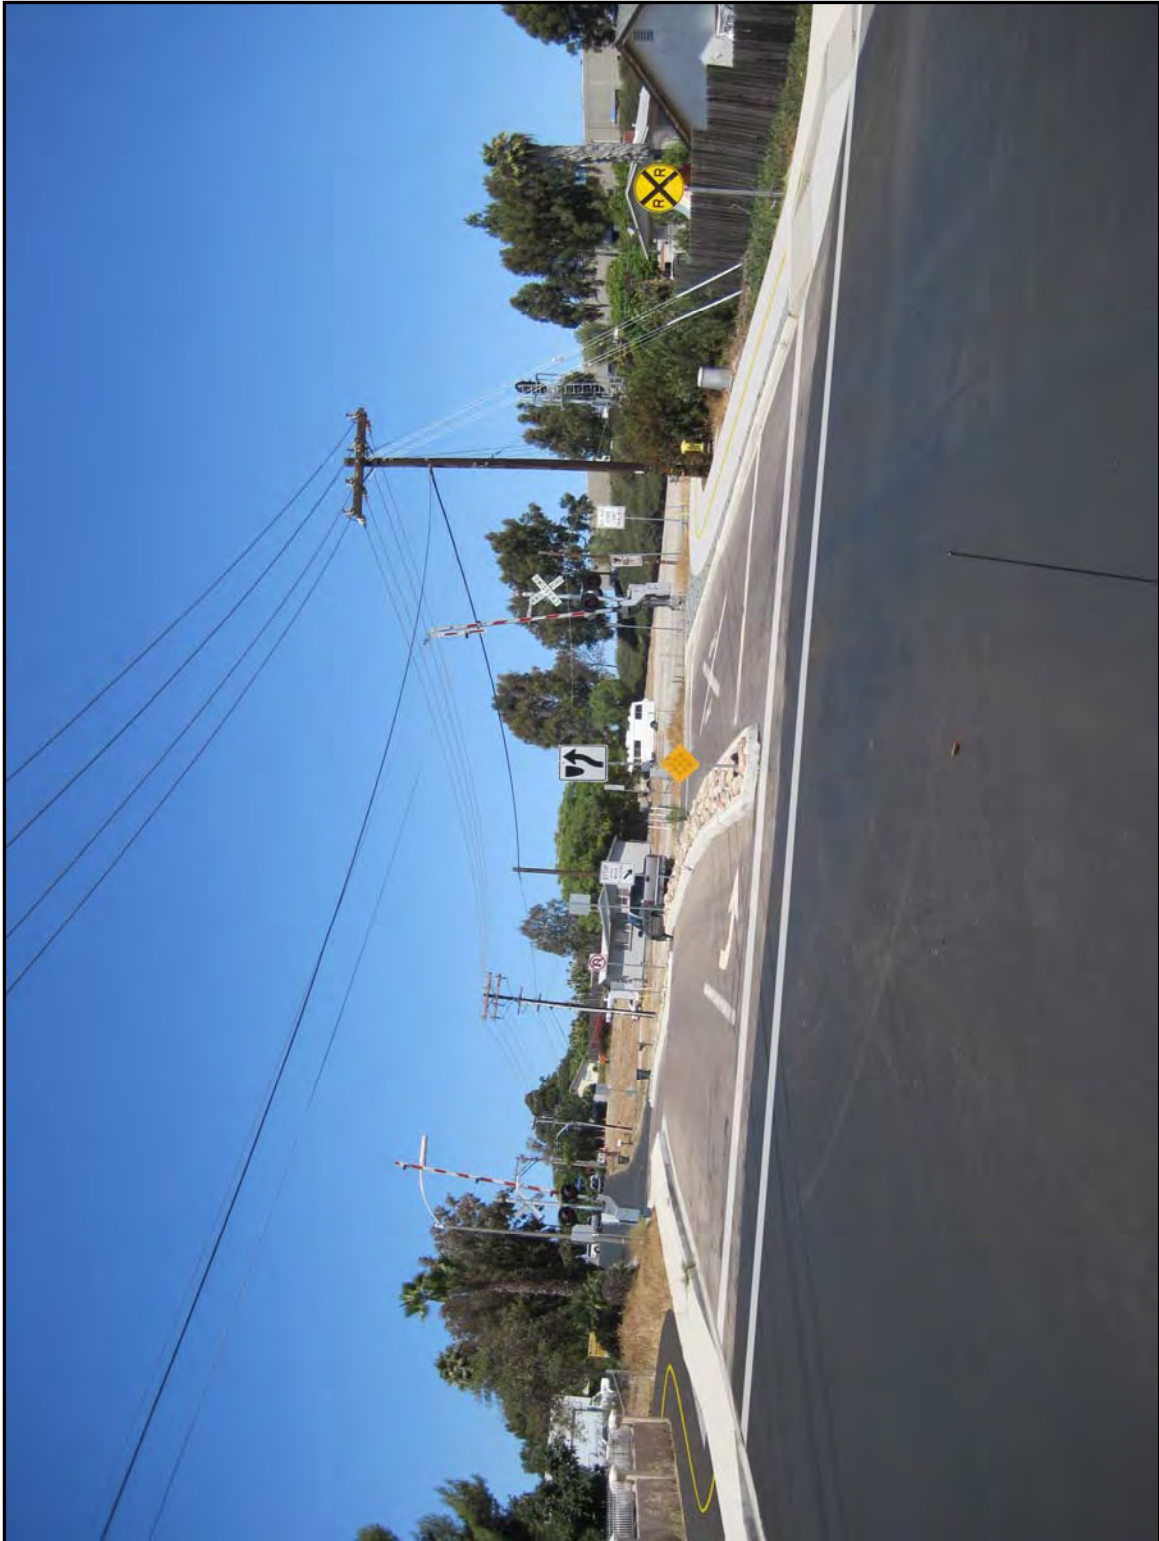
**Figure 8: Key View 2 –Visual Simulation with the Proposed Project**

**f. Resulting Visual Impact:** The proposed project will keep the visual quality of key view 2, visual quality will remain moderate at a rating of 4. As shown in the visual simulation of key view 2 with the proposed project, vividness is improved slightly (+0.33) because the project slightly improves the memorability of the view (Figure 8). Similarly, intactness (+0.04) and unity (+0.50) are slightly improved because the project introduces a paved bike path into a view already dominated by a paved road and other transportation features. The project improves compatibility among landscape elements and improves the degree to which visual resources join to form a coherent visual pattern.

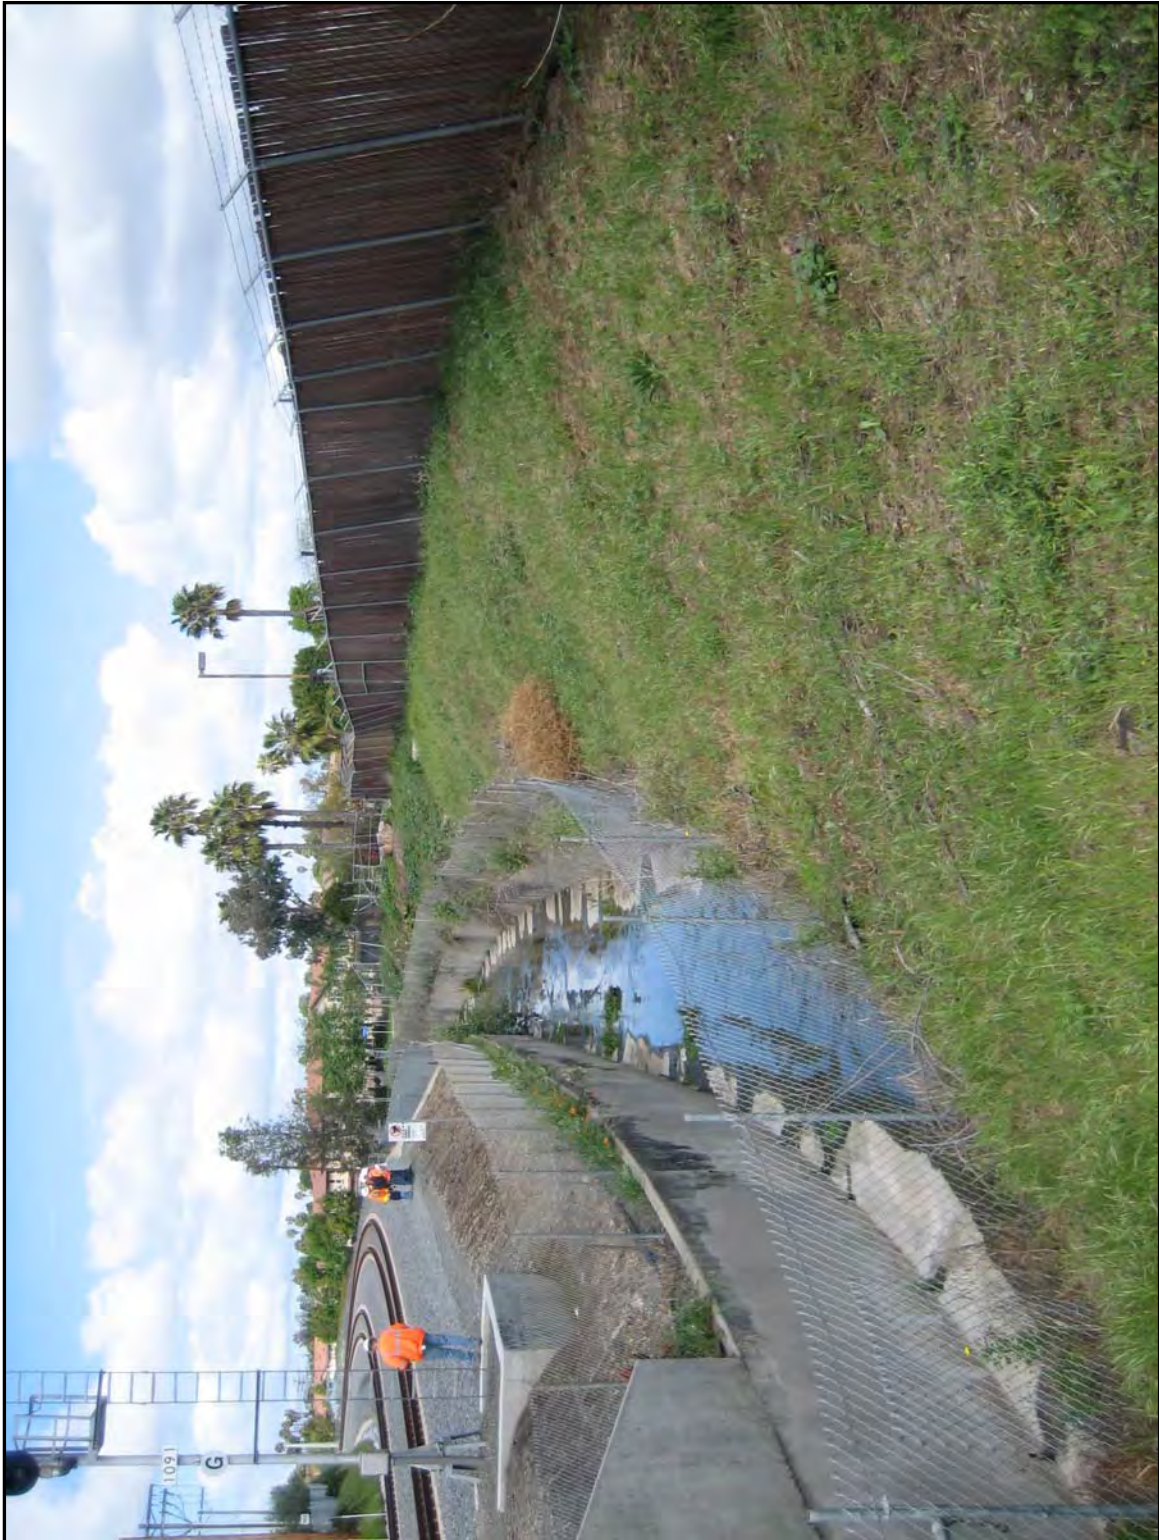
**Figure 9: Key View 3 – Existing**

**a. Orientation:** Key view 3 represents the view of the north side of the SPRINTER railroad looking down the tracks to the west (Figure 8).

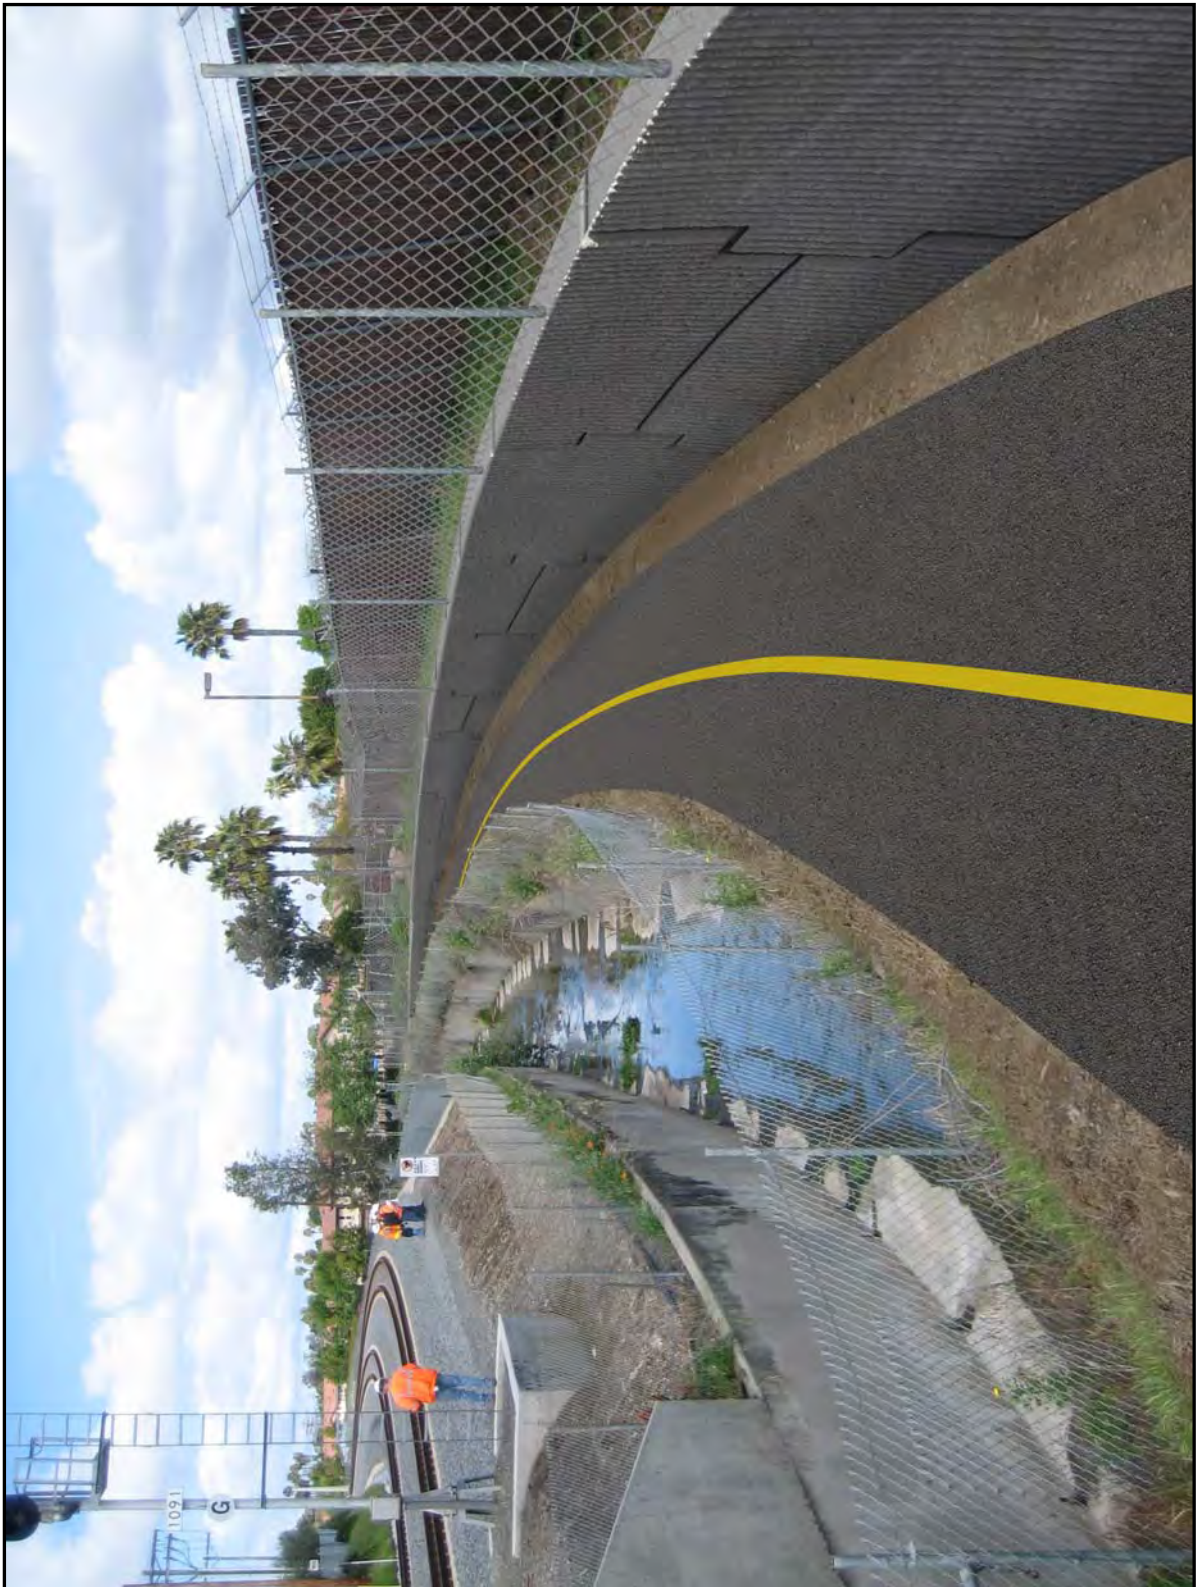
**Figure 10: Key View 3 – Visual Simulation with the Proposed Project**

**c. Proposed Project Features:** Project features within key view 3 include a bike path with asphalt concrete paving and dirt shoulders, a potential graffiti resistant textured retaining wall, chain link fences along the outsides of the path for safety and access control. Wall texture shown in Figure 10 is representative of the texture that may be selected. The need for the retaining wall and the final choice of aesthetic design will be determined during final design and with the consensus with the Cities of San Marcos, Vista, the County of San Diego, and SANDAG.

**f. Resulting Visual Impact:** Visual quality of key view 3 will improve to moderate with a rating of 4. The visual simulation of key view 3 with the proposed project shows a reduction in the amount of grassy vegetation (Figure 10). The trail adds a transportation feature that ties together the developed nature of the area and slightly increases the view's vividness. Intactness is improved because the integrity of the natural and man-built visual order is improved slightly with introduction of the project. Unity is improved as the grass/vegetation element is replaced with the path; the path is more compatible with the built and transportation visual elements than the existing grass/vegetation.

\*Wall texture shown in this Figure is representative of the texture that may be selected

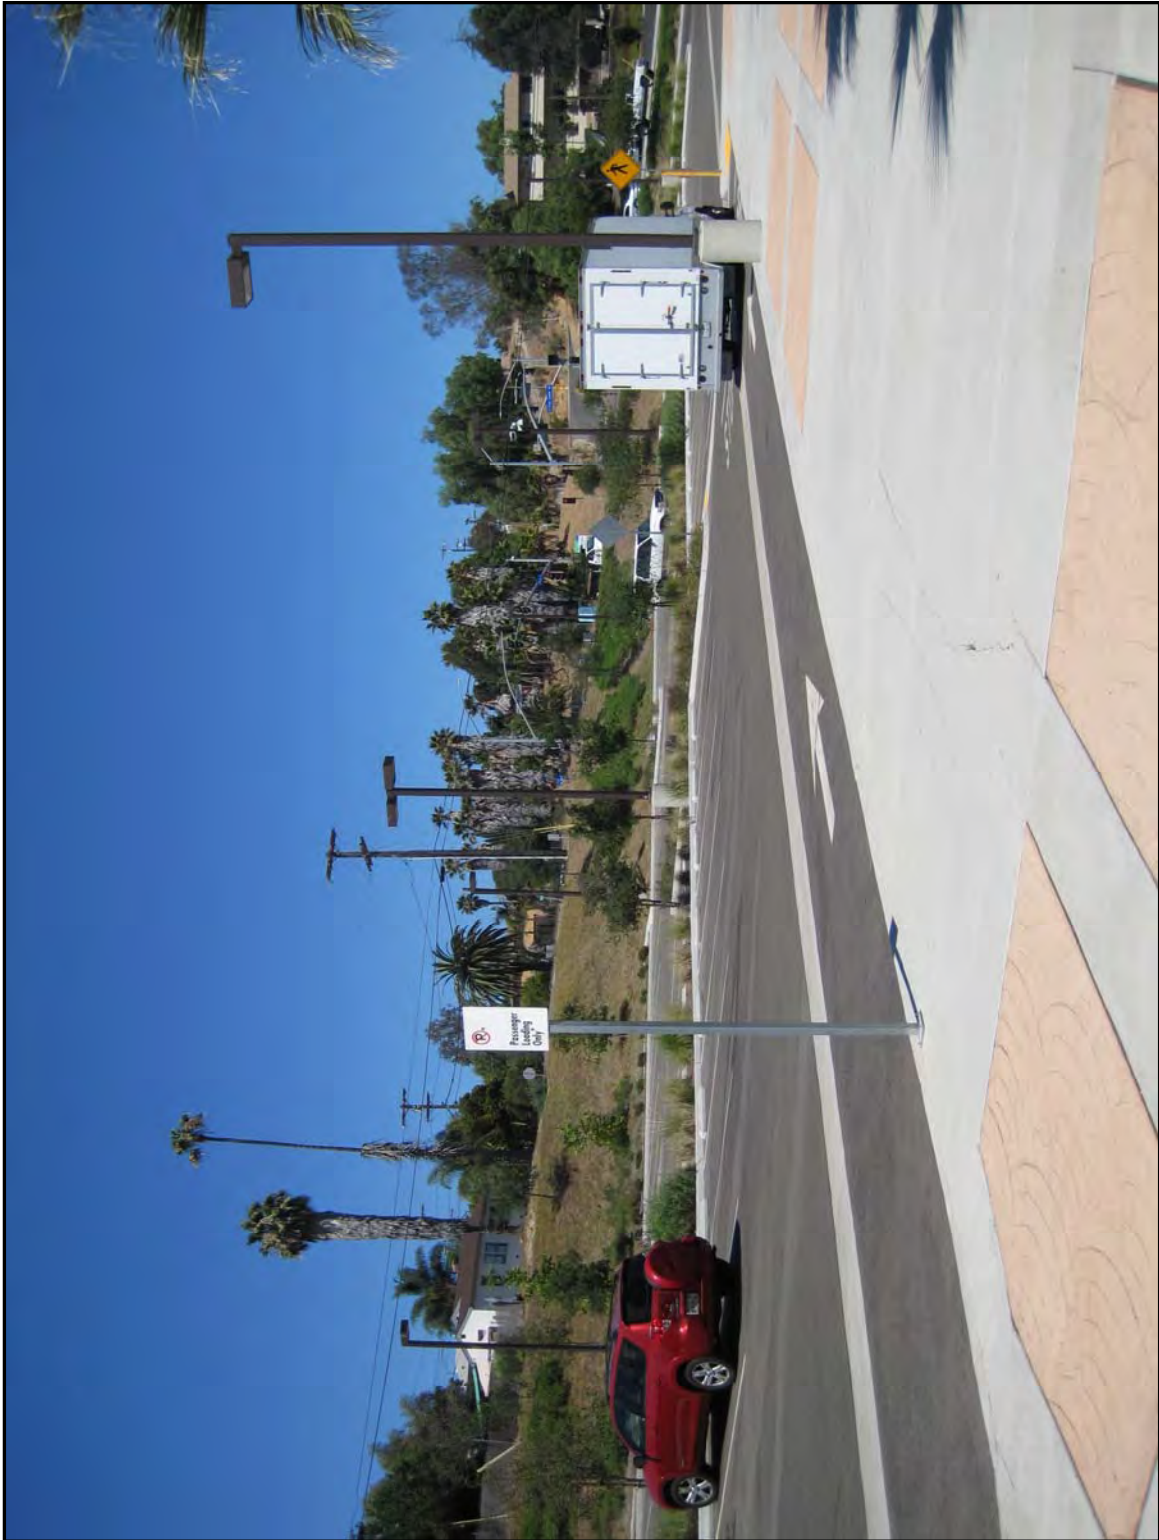
Figure 11: Key View 4 – Existing

**a. Orientation:** Key view 4 represents the view from pedestrians and passengers using the Escondido Avenue SPRINTER Station (Figure 10). This photograph was taken near the station waiting area looking west.

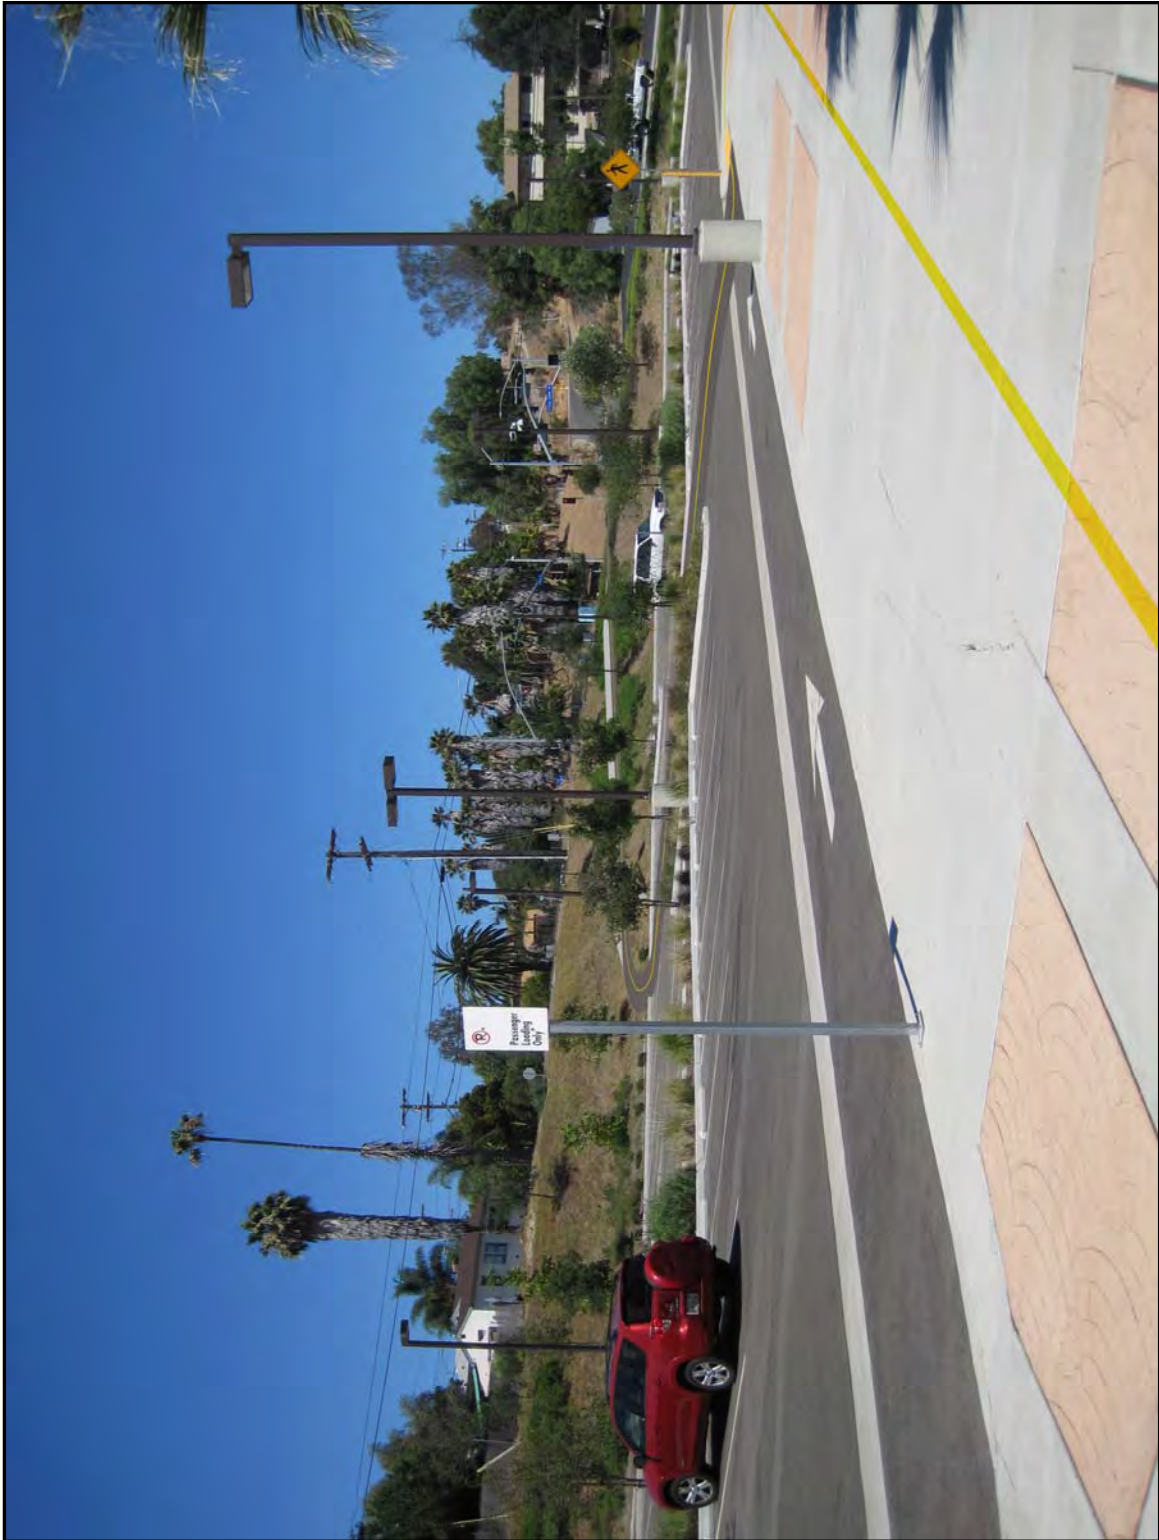
**Figure 12 - Key View 4 - Visual Simulation with the Proposed Project**

**f. Resulting Visual Impact:** Visual quality of key view 4 will remain the same as the proposed project with a moderate rating of 4. As shown in the visual simulation of key view 4 with the project, additional striping and a new bike path are visible in the middle ground (Figure 12). Vividness is nearly identical (-0.03) as the project does not affect the memorability of the view. Intactness slightly decreases (-0.08) because the hardscape trail encroaches into a landscaped hill. Unity also slightly decreases (-0.08) because the manmade and natural visual patterns are disrupted by introduction of the paved bike path in a landscaped view. The proposed project will not obscure any existing views.

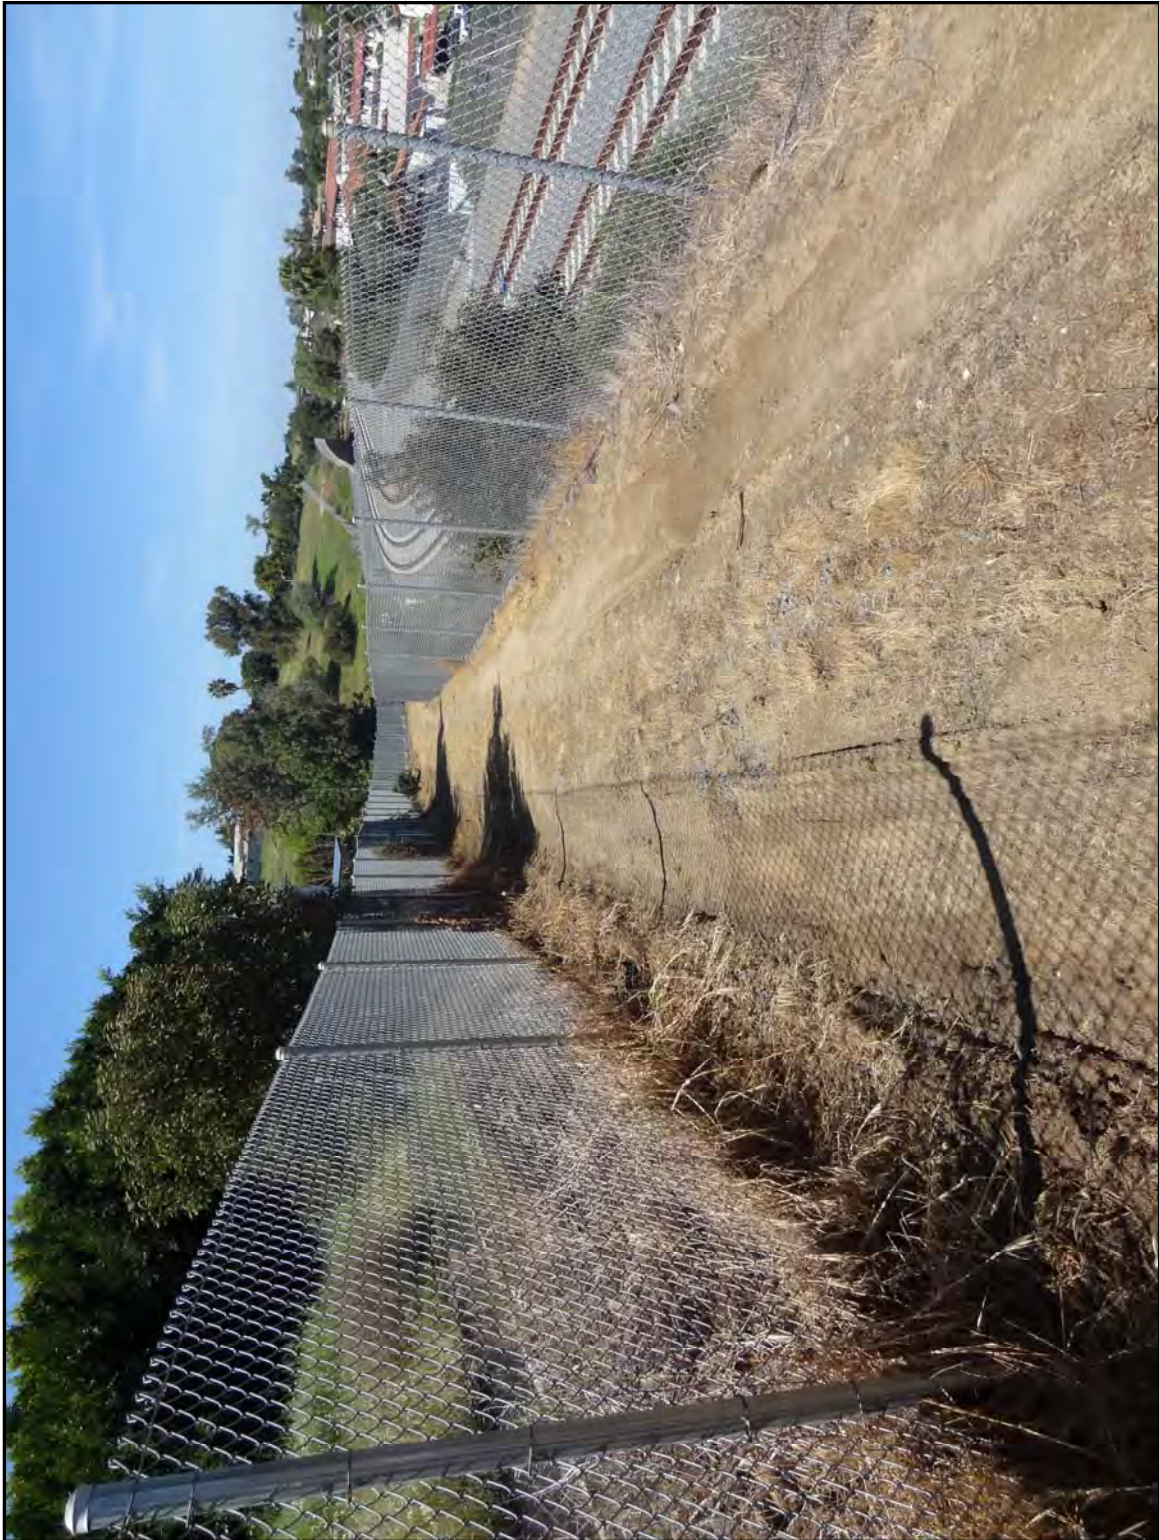
**Figure 13: Key View 5 – Existing**

**a. Orientation:** Key view 5 represents the view from residents living adjacent to the proposed project (Figure 12). This photograph was taken in an elevated area south of the SPRINTER railroad tracks approximately 150 feet north of the Vista Bonita Drive cul-de-sac.

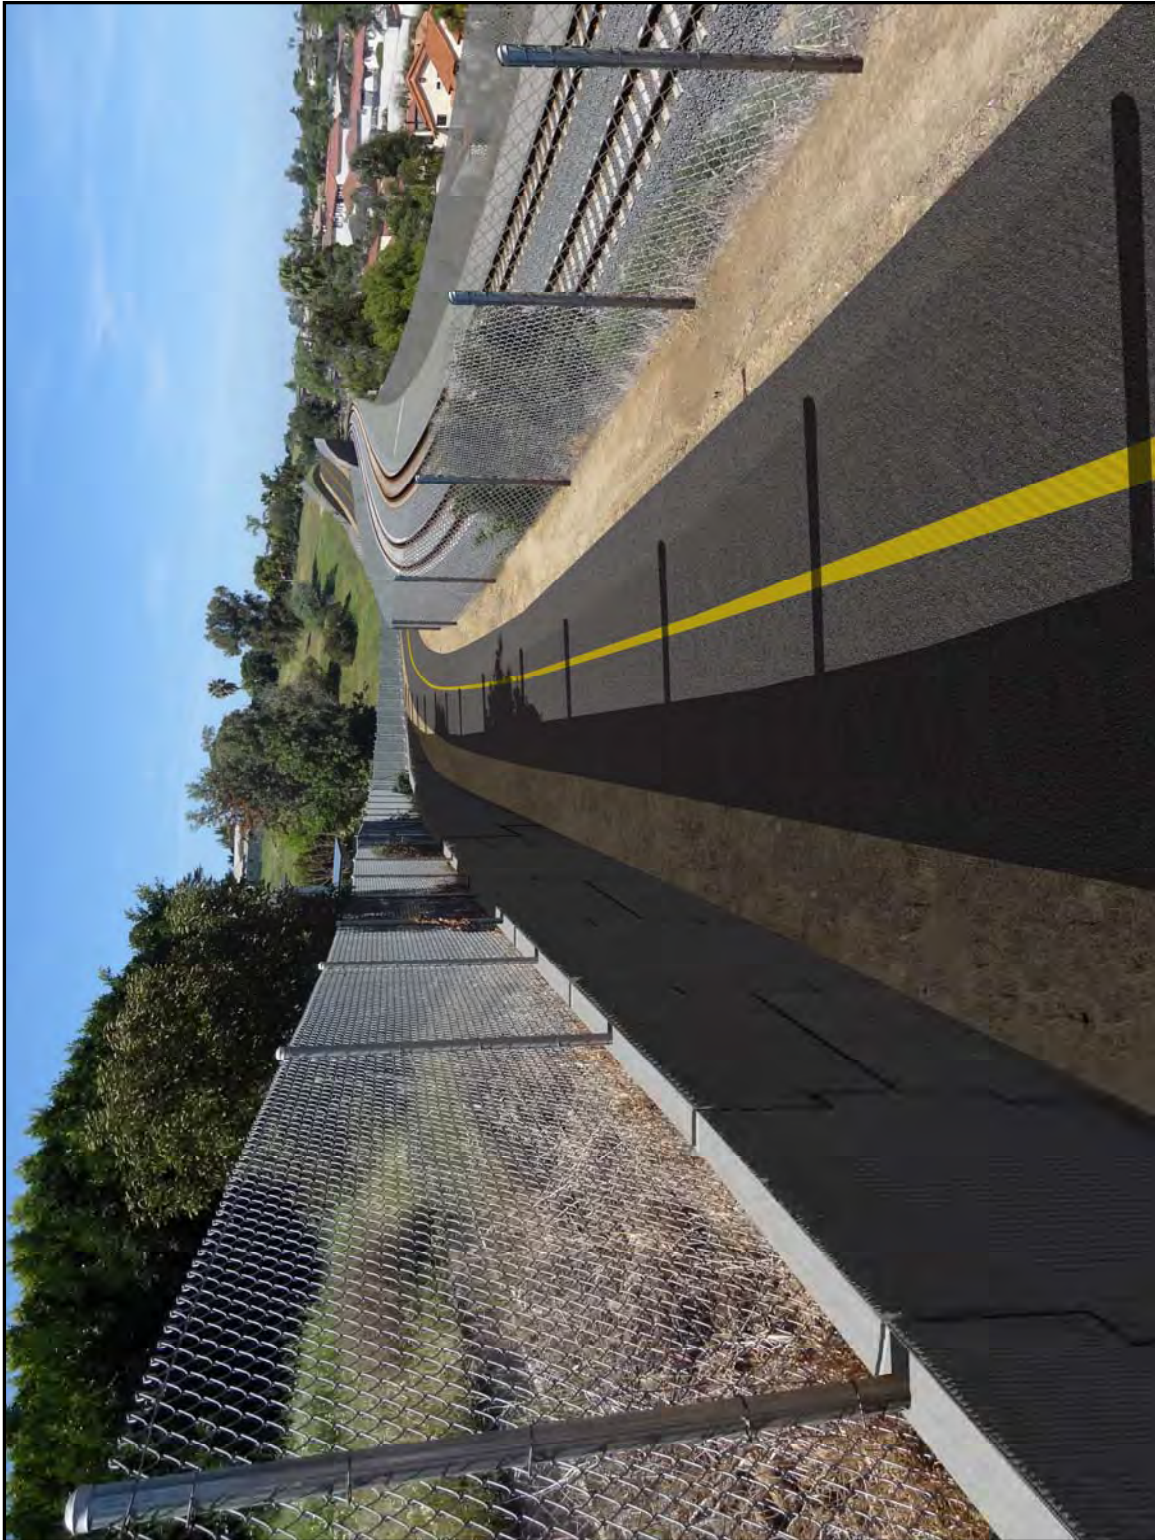
**Figure 14: Key View 5 – Visual Simulation with the Proposed Project**

**c. Proposed Project Features:** Project features within key view 5 include a bike path with asphalt concrete paving and dirt shoulders and a graffiti resistant textured retaining wall. The existing chain-link fencing will remain on both sides of the path for safety and access control. Wall texture shown in Figure 14 is representative of the texture that may be selected. The need for the retaining wall and the final choice for aesthetic design will be determined during final design and with the consensus with the Cities of San Marcos, Vista, the County of San Diego, and SANDAG.

**f. Resulting Visual Impact:** As shown in the visual simulation of key view 5 with the proposed project, it fits agreeably into the disturbed vacant plot of land, provides a striking element in the view, and improves the memorability of the visual impression (Figure 14). Intactness is slightly higher (+0.50) because the visual order in the natural and man-made environments are improved with the addition of the project. Unity is improved (+0.67) because the project is more compatible with the railroad facility than the existing condition and provides a compositional harmony between the existing landscape elements.

\*Wall texture shown in this Figure is representative of the texture that may be selected

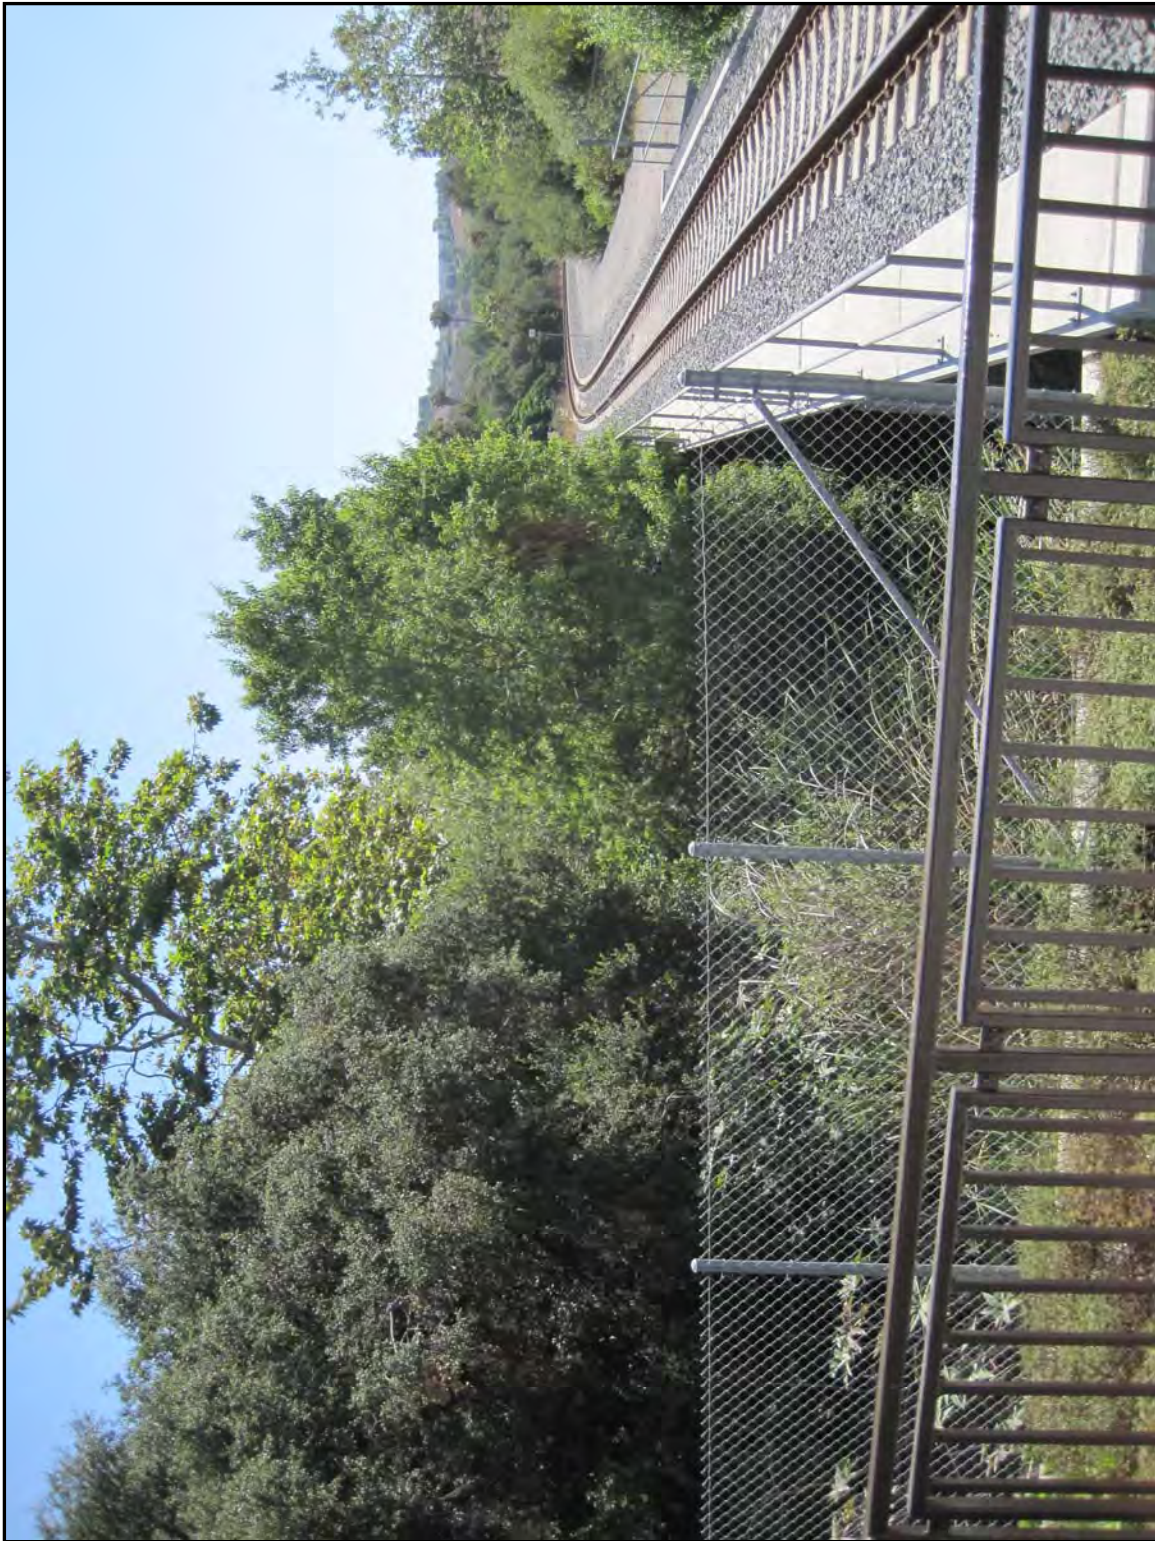
**Figure 15: Key View 6 – Existing**

**a. Orientation:** Key view 6 was taken just south of Buena Creek looking north towards Buena Creek and towards the SPRINTER railroad bridge over the creek (Figure 14).

**b. Existing Visual Character/Quality:** This is one of the few undeveloped natural areas remaining within the project limits. Key view 6 shows the view observed by passengers riding the SPRINTER over Buena Creek. The viewshed includes transportation and open space landcover components.
