**VISUAL IMPACT ASSESSMENT FOR THE  
INLAND RAIL TRAIL PROJECT**

**Cities of San Marcos and Vista, County of San Diego**

**11-SD-CML 5381(003)**

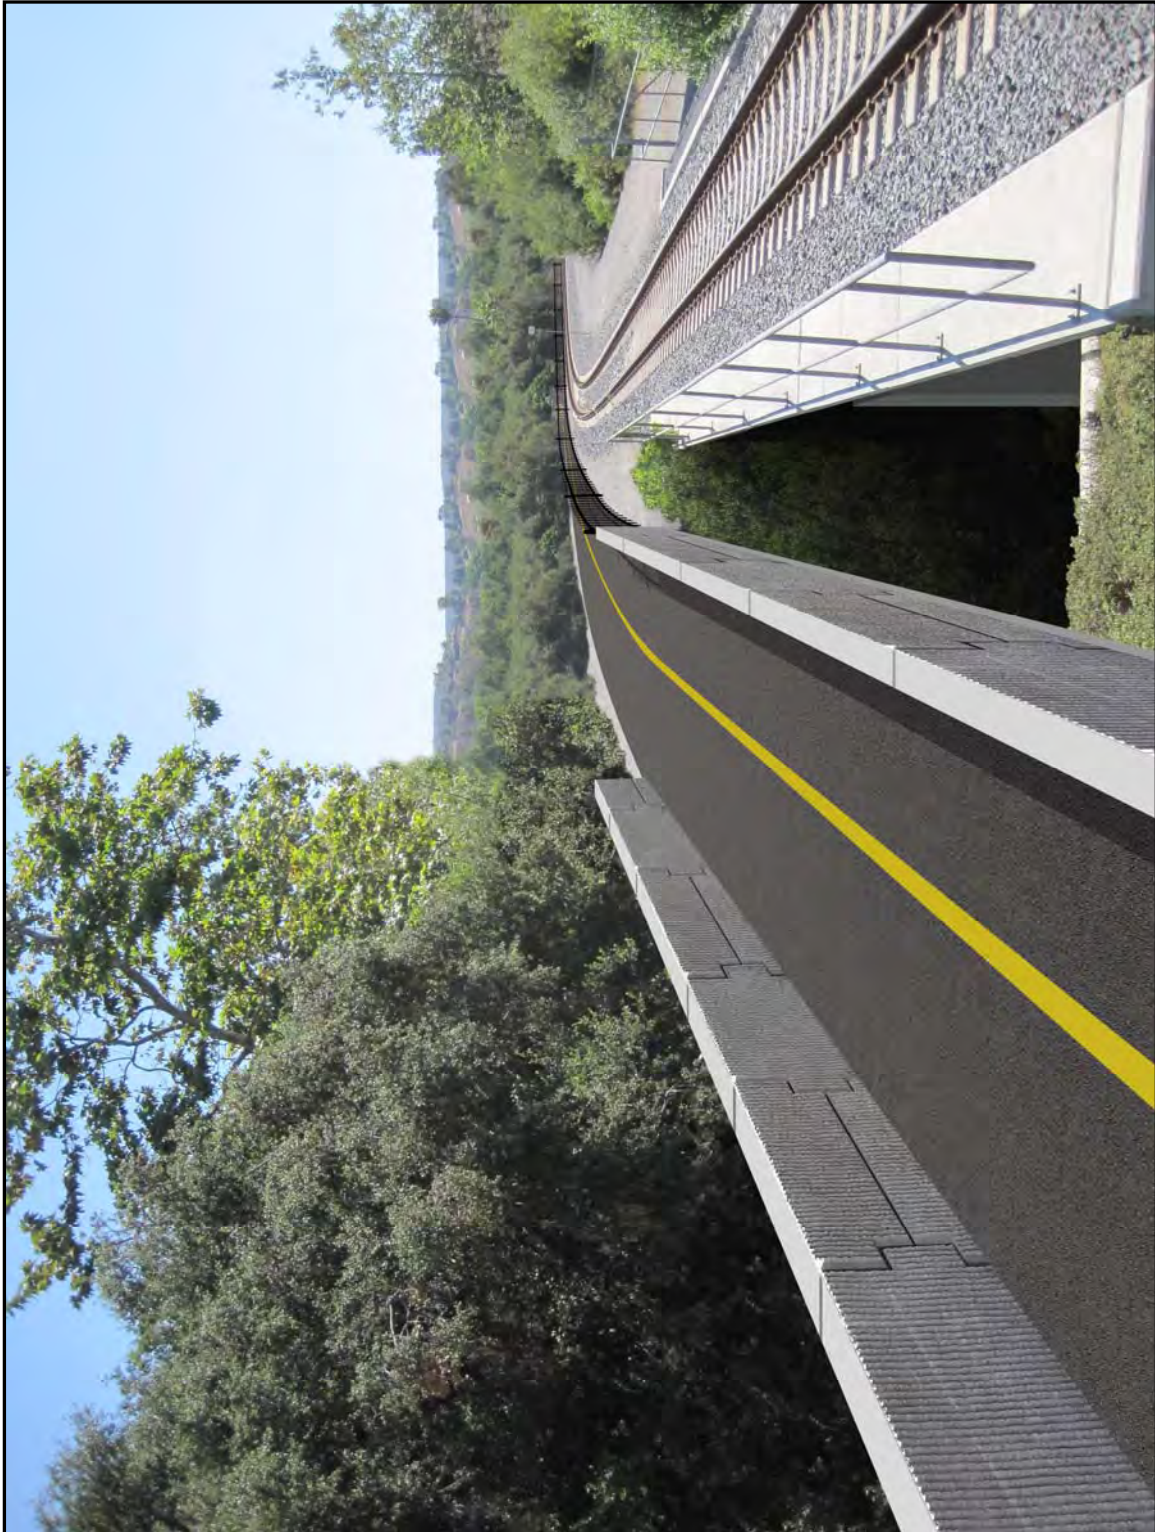
**Figure 16: Key View 6 - Visual Simulation with the Proposed Project**

**c. Proposed Project Features:** Project features within key view 6 include a bridge over Buena Creek to accommodate the bike path, which runs adjacent to the SPRINTER railroad bridge. The bike path bridge is expected to have asphalt concrete paving and graffiti resistant textured walls along the bridge for safety. The bridge structure type and wall texture shown in Figure 16 is representative of the bridge type and texture that may be selected. Final choice of the bridge structure type and the bridge's aesthetic design will be determined during final design. Outside of the bridge, the bike path will have asphalt concrete paving. A wrought iron or chain link fence will be constructed along the path for safety and access control.

**f. Resulting Visual Impact:** The visual simulation of key view 6 with the proposed project shows the addition of the project through the riparian corridor (Figure 16). Vividness is reduced slightly (-0.52) as a second manmade feature is introduced and a small patch of the riparian corridor is removed in the foreground of the view. Vividness is unaffected in the middle ground and background. The proposed project would result in lower level of intactness (-0.59) because the trail bridge acts as an additional

encroachment on the foreground view. In the foreground, unity is very low as there are additional manmade features (trail and railroad bridges) crossing the riparian corridor. Unity remains intact in the middle ground and background as the compatibility between landscape elements is improved. Overall, unity would decrease slightly (-0.45).

\*The color of barrier on the bridge crossing Buena Creek will blend into the surroundings
