**FINAL PHASE I ENVIRONMENTAL
SITE ASSESSMENT
BAYSHORE BIKEWAY SEGMENT 8B
SANDAG**

March 21, 2016

**Subject: FINAL PHASE I ENVIRONMENTAL SITE ASSESSMENT
BAYSHORE BIKEWAY SEGMENT 8B
SANDAG
AGE Project No. 71C2**

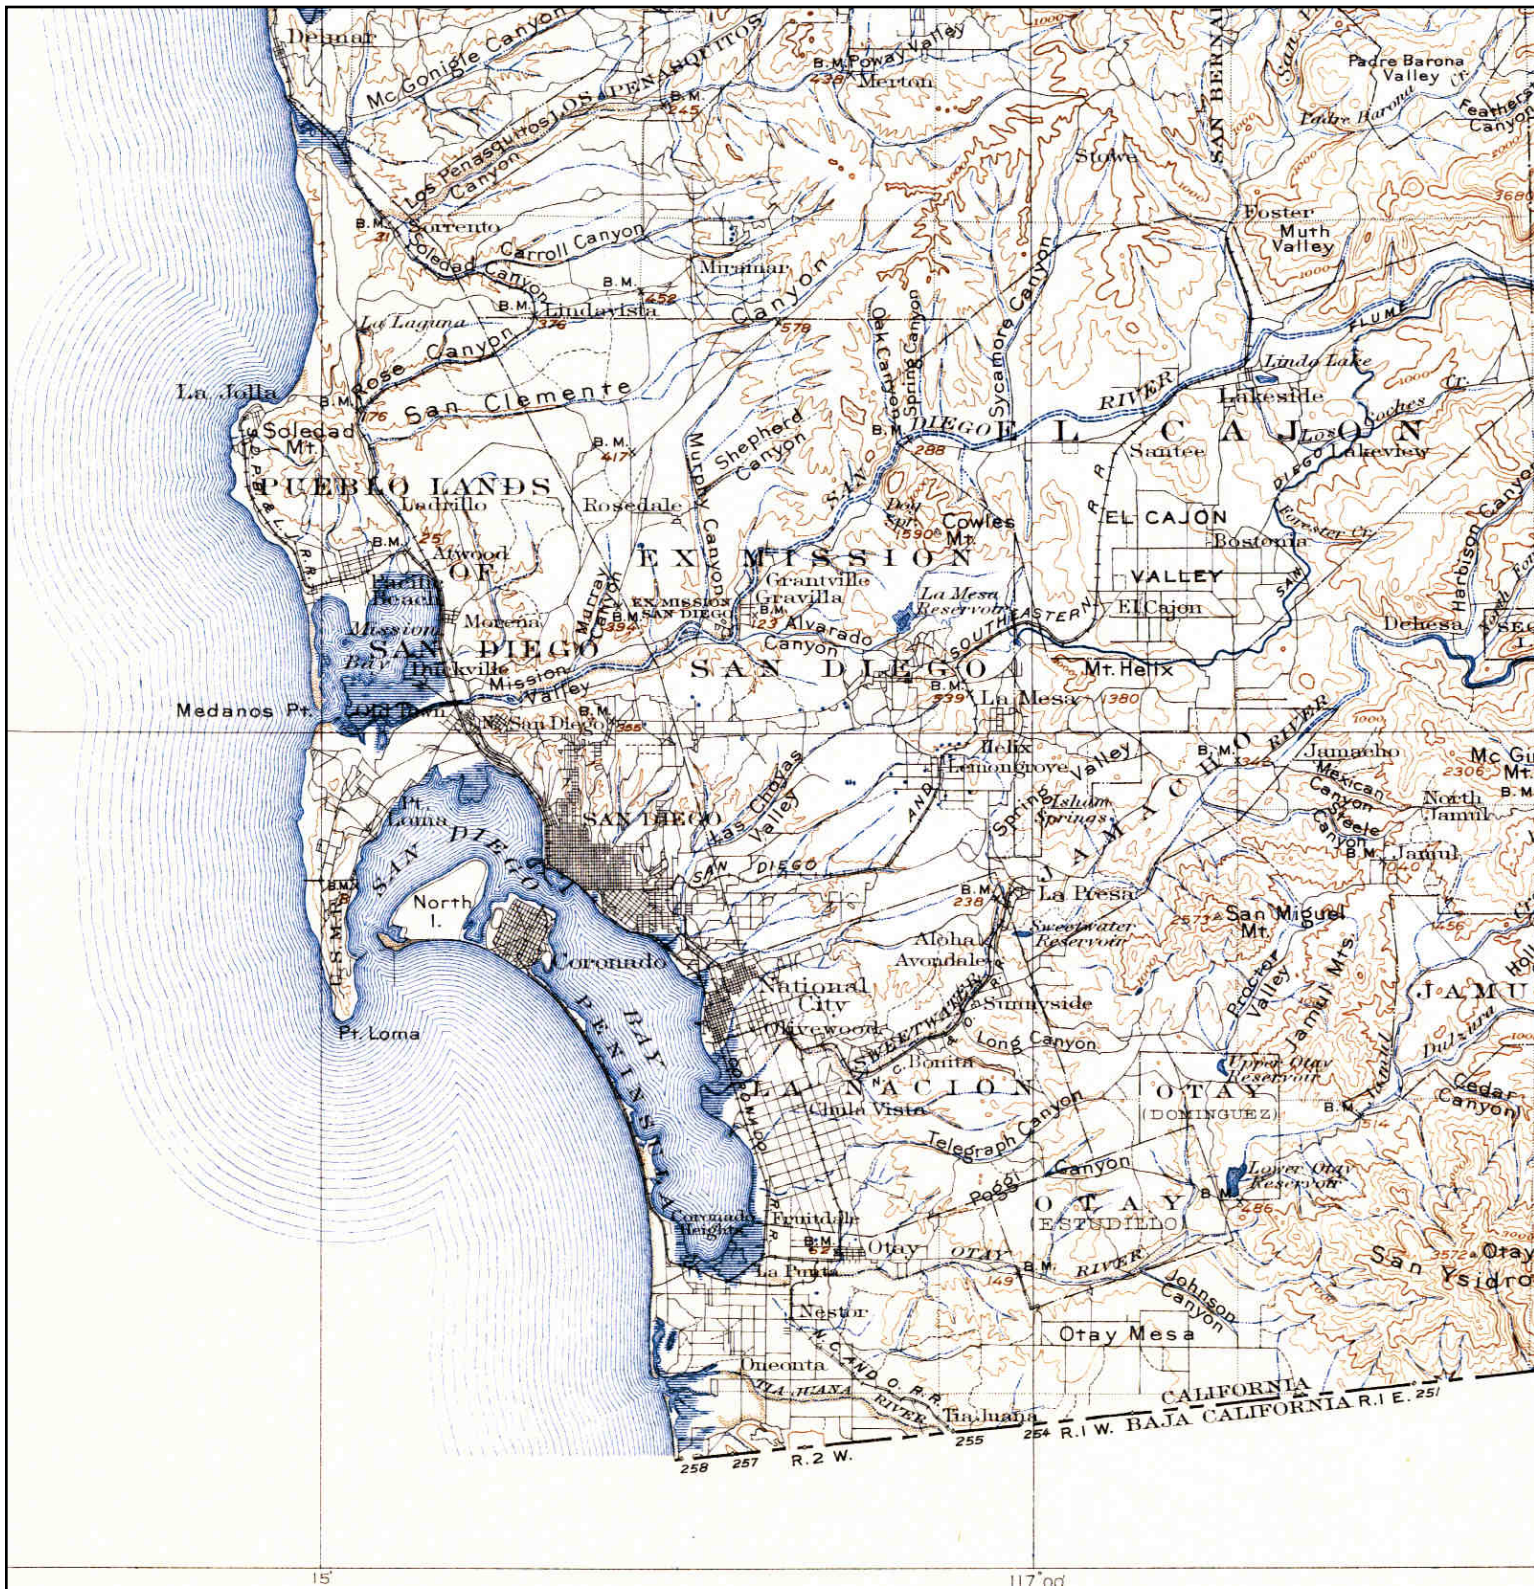
Historical Topographic Map

TARGET QUAD NAME: SOUTHERN CA SHEET 2 MAP YEAR: 1904	SITE NAME: Bayshore Bikeway Segment 8B ADDRESS: Bikeshore Bikeway Between Palomar & Main San Diego, CA 92154	CLIENT: Allied Geotechnical CONTACT: Sani Sutanto INQUIRY#: 4017097.4 RESEARCH DATE: 07/24/2014
	SERIES: 60 SCALE: 1:250000	LAT/LONG: 32.5998 / -117.0916

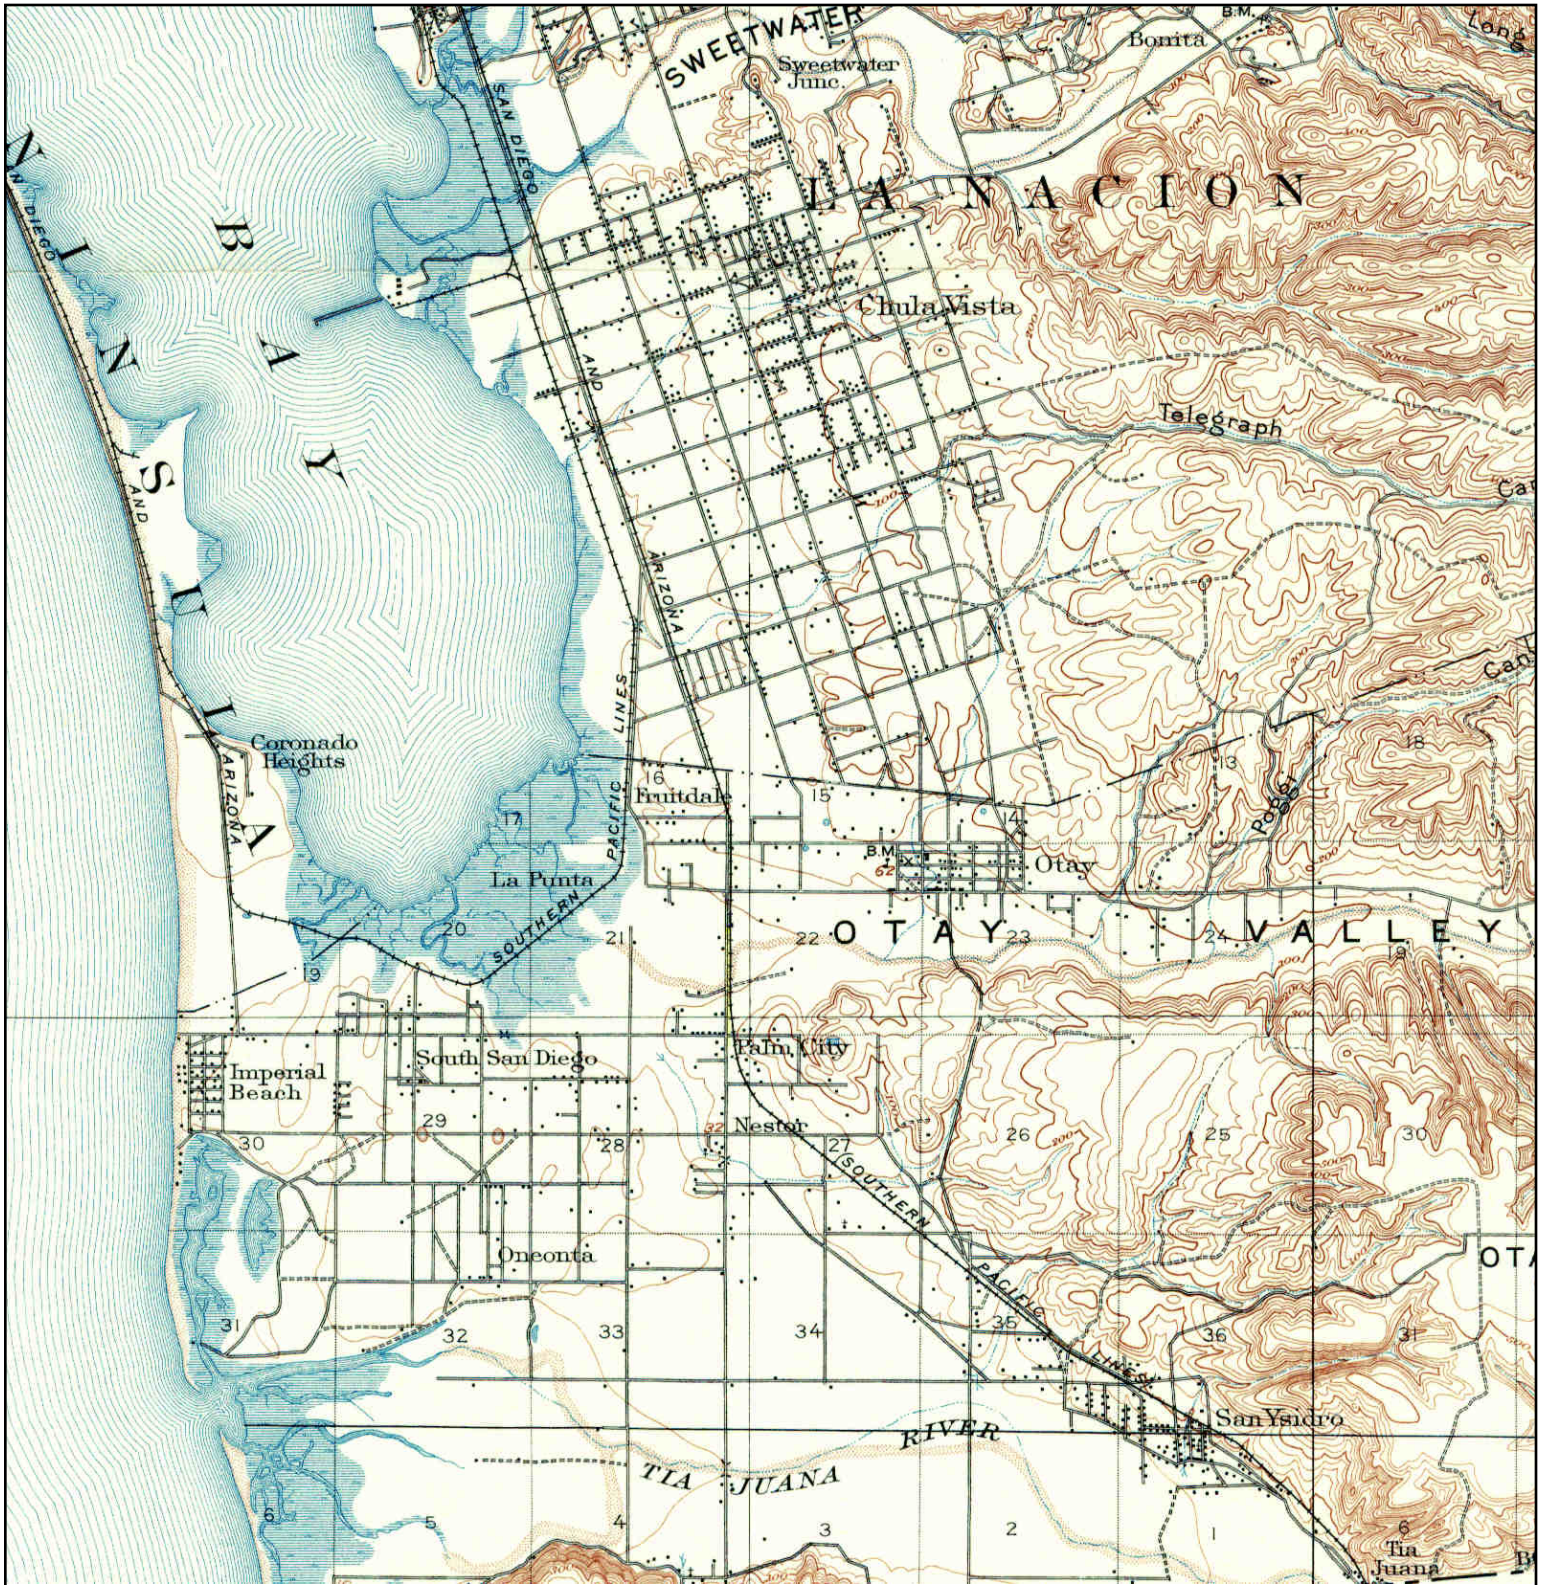
Historical Topographic Map

TARGET QUAD	SITE NAME: Bayshore Bikeway Segment 8B	CLIENT: Allied Geotechnical
	NAME: SAN DIEGO	ADDRESS: Bikeshore Bikeway Between Palomar & Main	CONTACT: Sani Sutanto
	MAP YEAR: 1930	San Diego, CA 92154	INQUIRY#: 4017097.4
	SERIES: 15	LAT/LONG: 32.5998 / -117.0916	RESEARCH DATE: 07/24/2014
	SCALE: 1:62500

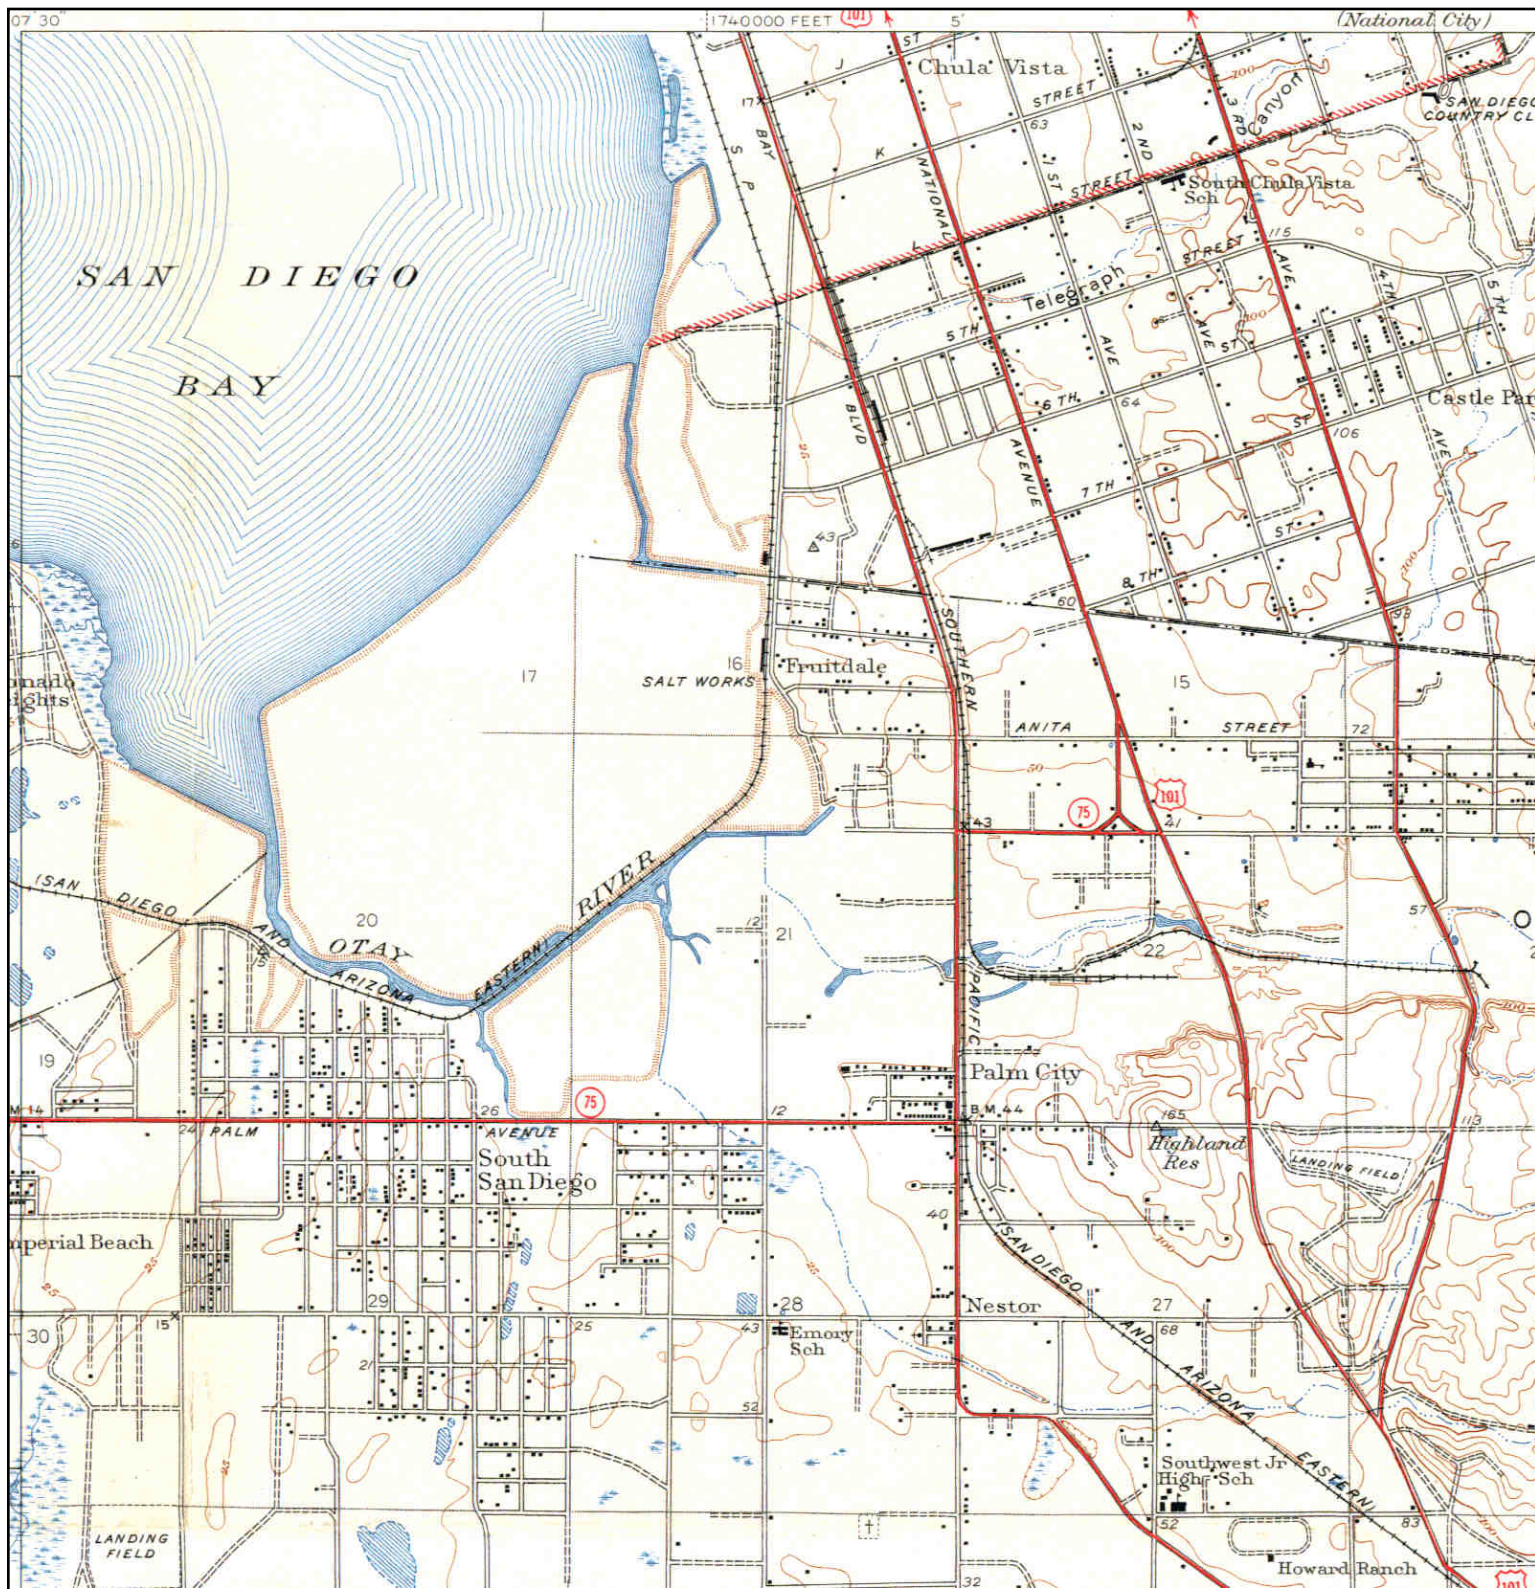
Historical Topographic Map

TARGET QUAD NAME: SAN YSIDRO MAP YEAR: 1943	SITE NAME: Bayshore Bikeway Segment 8B ADDRESS: Bikeshore Bikeway Between Palomar & Main San Diego, CA 92154	CLIENT: Allied Geotechnical CONTACT: Sani Sutanto INQUIRY#: 4017097.4 RESEARCH DATE: 07/24/2014
	SERIES: 7.5 SCALE: 1:31680	LAT/LONG: 32.5998 / -117.0916

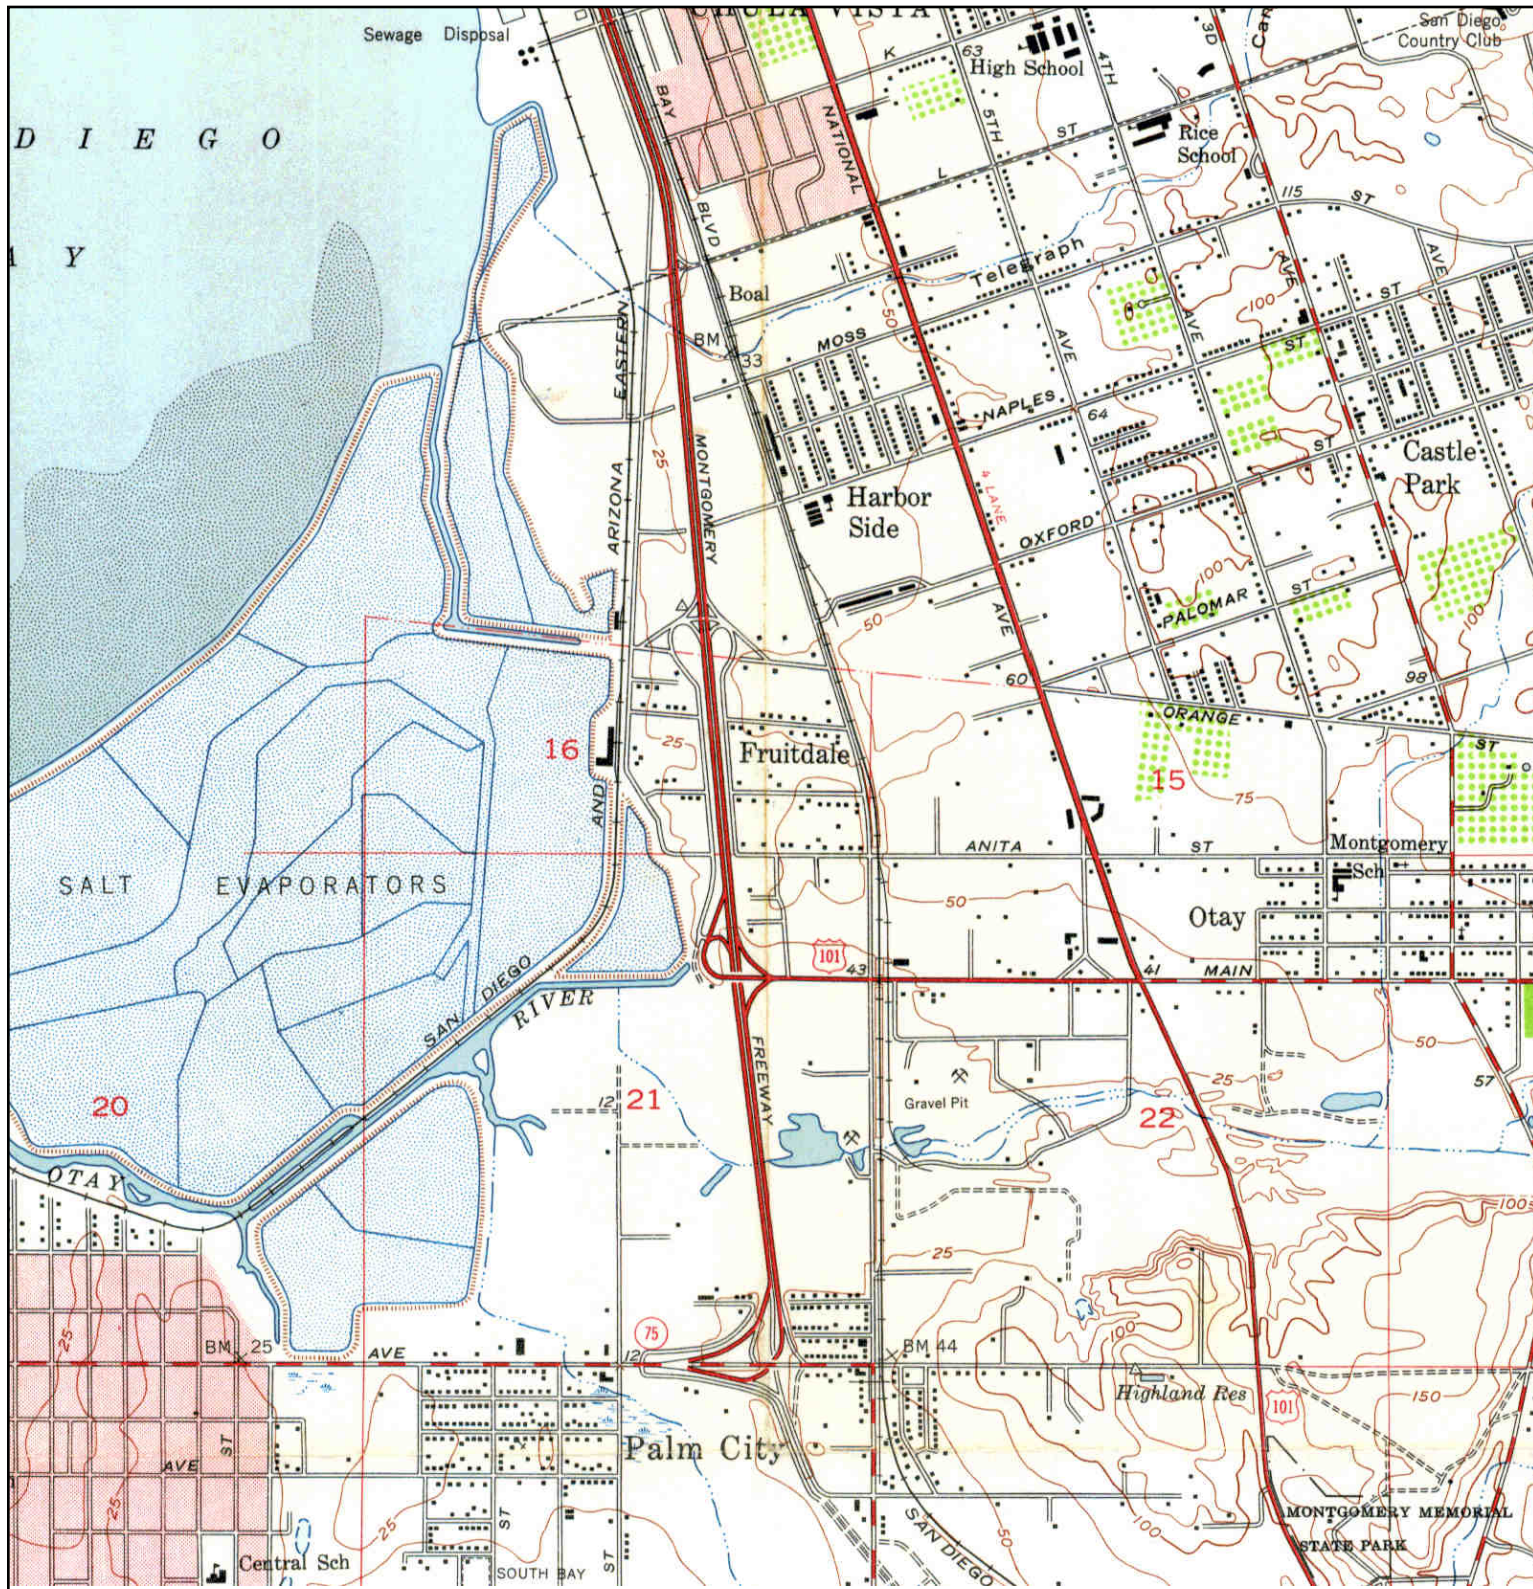
Historical Topographic Map

TARGET QUAD NAME: SAN YSIDRO MAP YEAR: 1953	SITE NAME: Bayshore Bikeway Segment 8B ADDRESS: Bikeshore Bikeway Between Palomar & Main San Diego, CA 92154	CLIENT: Allied Geotechnical CONTACT: Sani Sutanto INQUIRY#: 4017097.4 RESEARCH DATE: 07/24/2014
	SERIES: 7.5 SCALE: 1:24000	LAT/LONG: 32.5998 / -117.0916

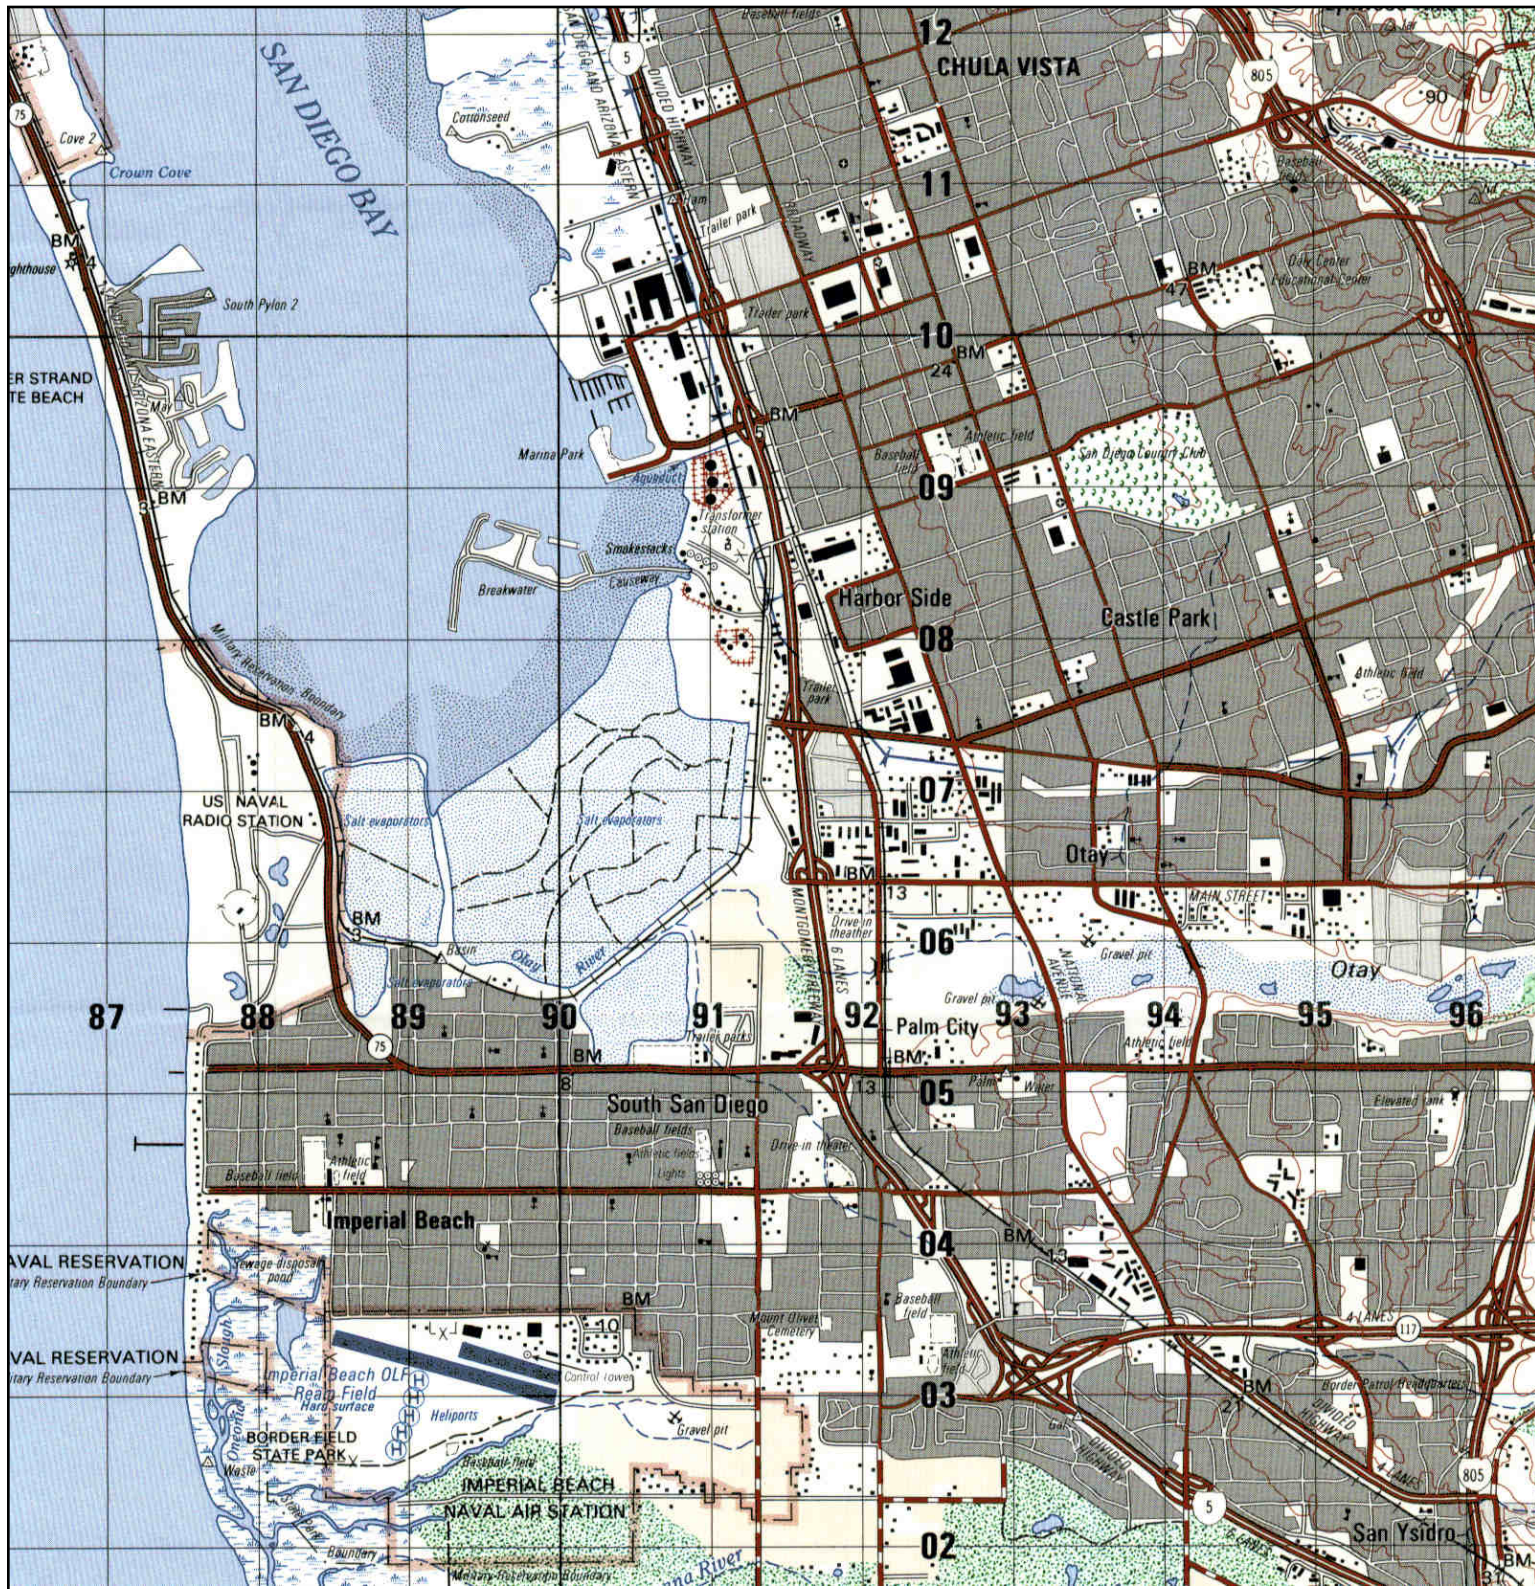
Historical Topographic Map

TARGET QUAD NAME: SAN DIEGO MAP YEAR: 1991	SITE NAME: Bayshore Bikeway Segment 8B ADDRESS: Bikeshore Bikeway Between Palomar & Main San Diego, CA 92154	CLIENT: Allied Geotechnical CONTACT: Sani Sutanto INQUIRY#: 4017097.4 RESEARCH DATE: 07/24/2014
	SERIES: 15 SCALE: 1:50000	LAT/LONG: 32.5998 / -117.0916

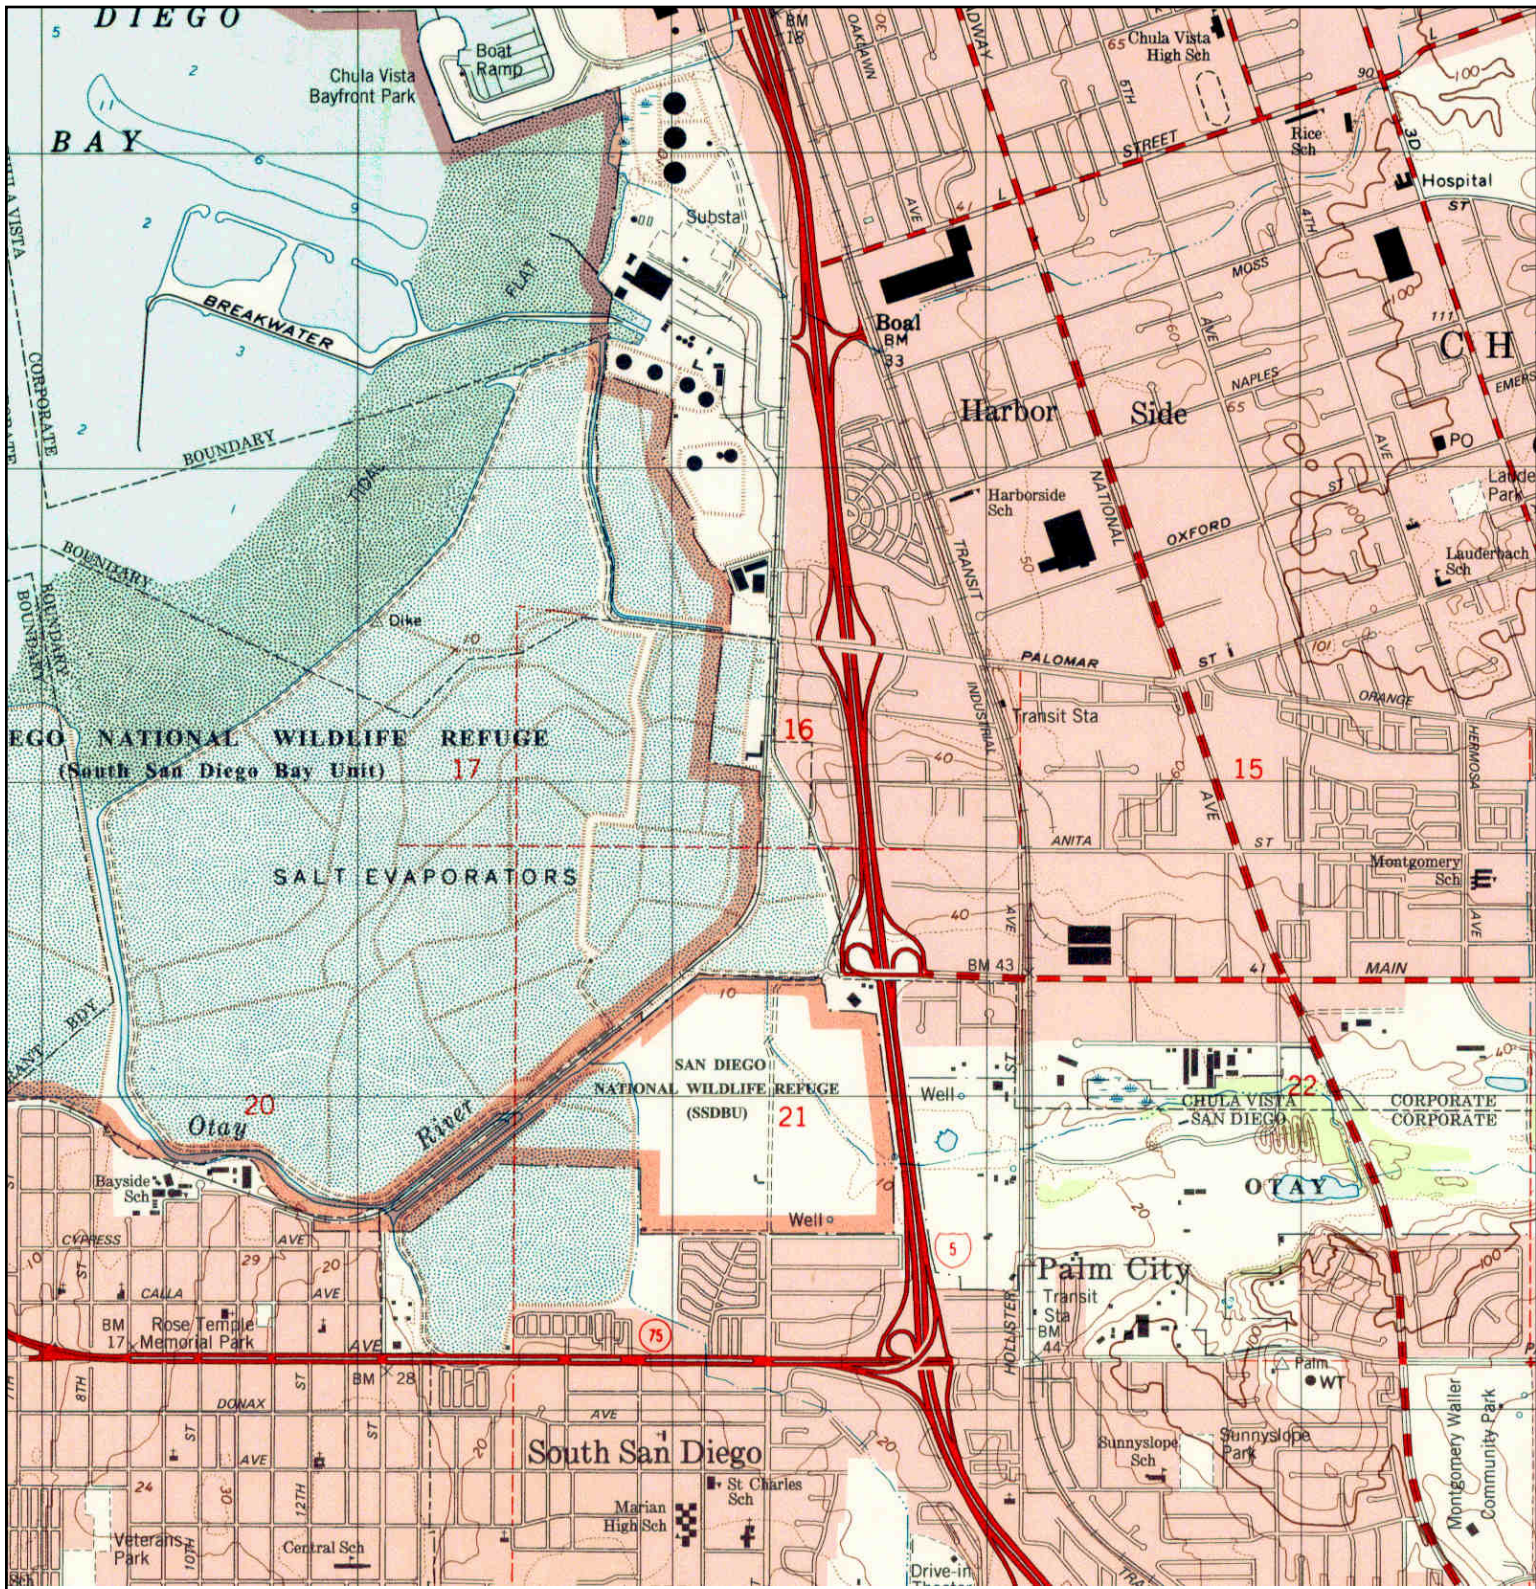
Historical Topographic Map

TARGET QUAD	SITE NAME: Bayshore Bikeway Segment 8B	CLIENT: Allied Geotechnical
	NAME: IMPERIAL BEACH	ADDRESS: Bikeshore Bikeway Between Palomar & Main	CONTACT: Sani Sutanto
	MAP YEAR: 1996	San Diego, CA 92154	INQUIRY#: 4017097.4
	SERIES: 7.5	LAT/LONG: 32.5998 / -117.0916	RESEARCH DATE: 07/24/2014
	SCALE: 1:24000

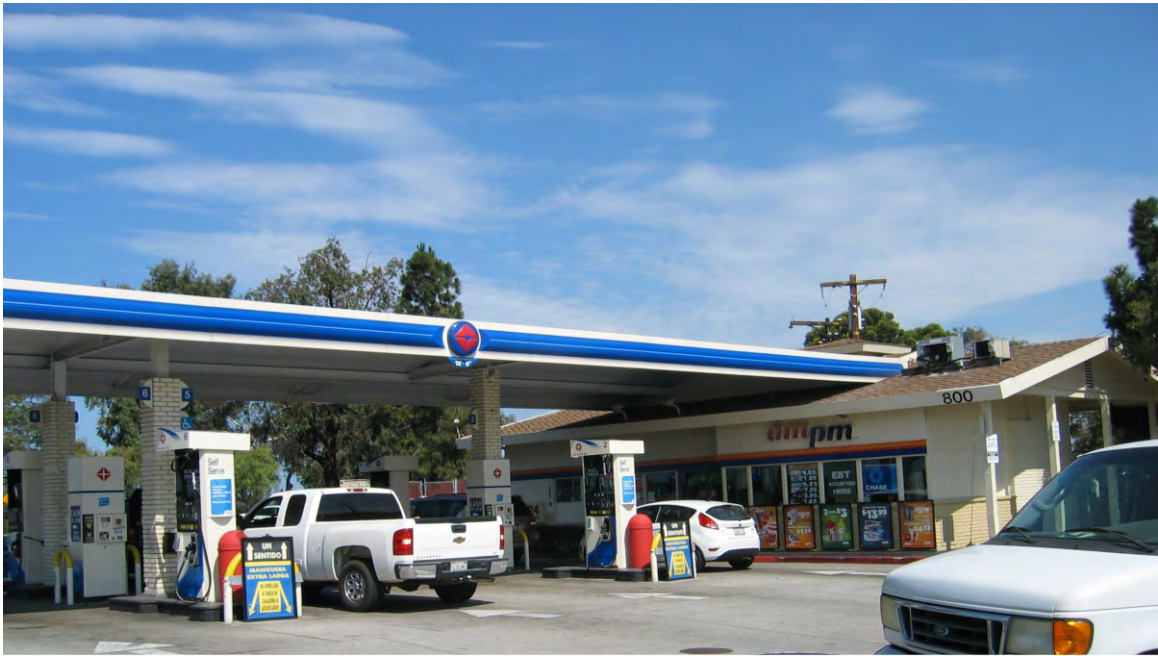
PHOTOGRAPH B-1

View of ARCO Service Station at 800 Palomar Street (EDR Map ID No. H36-H41)

Based on the Stantec findings, it appears unlikely that hydrocarbon contamination from the ARCO site will affect the project alignment. Furthermore, the ARCO site is located across Interstate 5, approximately 1/8 mile east of the northern terminus of the bikeway alignment, and the soil and groundwater contamination is reported to be largely confined to the immediate footprint of the service station site. Additionally, the report states that groundwater flow at the ARCO site is in a northwesterly direction, which is in a direction away from the bikeway alignment. However, it must be noted that large volume dewatering operations at the project site may result in migration of contaminated ground water from the ARCO site towards the project alignment.

The ARCO Service Station is located approximately 1/8 mile east of the project alignment, and the case is currently open and involves groundwater contamination. However, the ARCO Service is located across the Interstate 5, and groundwater flow at the site is in a northwesterly direction. It is unlikely that groundwater contamination from the ARCO site to impact the proposed project. It must be noted, that in the event that large volume dewatering operations are performed, either for the proposed project or any nearby projects, there is a potential that contaminated groundwater may migrate toward the project alignment. We do recommend, that in the event that dewatering is performed for construction of the project, it is recommended that the groundwater be tested for the presence of hazardous substances. The contractor should be prepared to handle and dispose of such materials in accordance with current industry practices and applicable Local, State and Federal regulations.

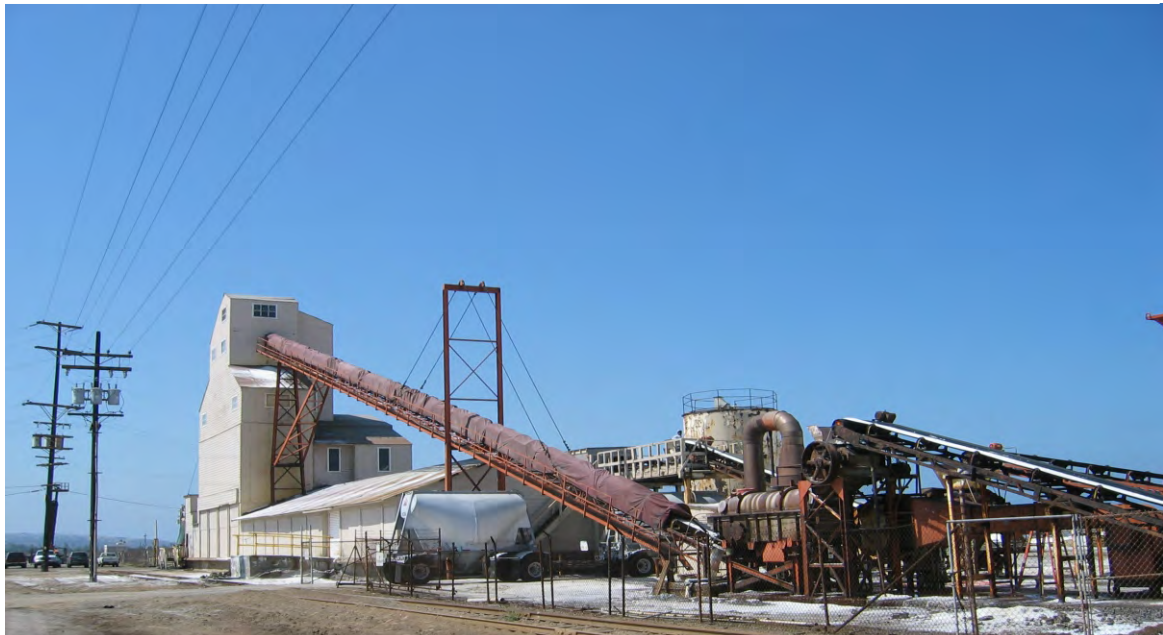
View of South Bay Salt Works main facility looking southwest from Bay Boulevard

The South Bay Salt Works abuts the west side of the bikeway alignment along Bay Boulevard and West Frontage Road. The EDR database indicates that in 1997 approximately 0.2 tons of contaminated soil from a site cleanup was disposed of at a transfer station. In 1998, three underground storage tanks were removed from the site. There are no reports of leaks/releases from the tanks. The database also indicates that hazardous materials which include hydrocarbon solvents, waste oil and mixed oil, and off specification, aged or surplus organics were transported from the site during the periods from 1998 to 2002, and between 2008 and 2012.

The last three USTs at the South Bay Salt Works were removed in 1998 and groundwater flow is in a westerly direction. It is unlikely that these USTs will impact the proposed project. Currently the South Bay Salt Works uses an above ground storage tank (AST). The AST is located in their maintenance yard on the east side of Bay Boulevard. No visual observations of long term leaks/releases from the AST were observed at the time of our site reconnaissance. The DEH inspection records did not indicate any leaks/releases in connection with the AST. Therefore, it is our opinion that the presence of the AST is not likely to impact the proposed project. It is noted that during high wind, airborne particles from the salt ponds may drift toward the project alignment.

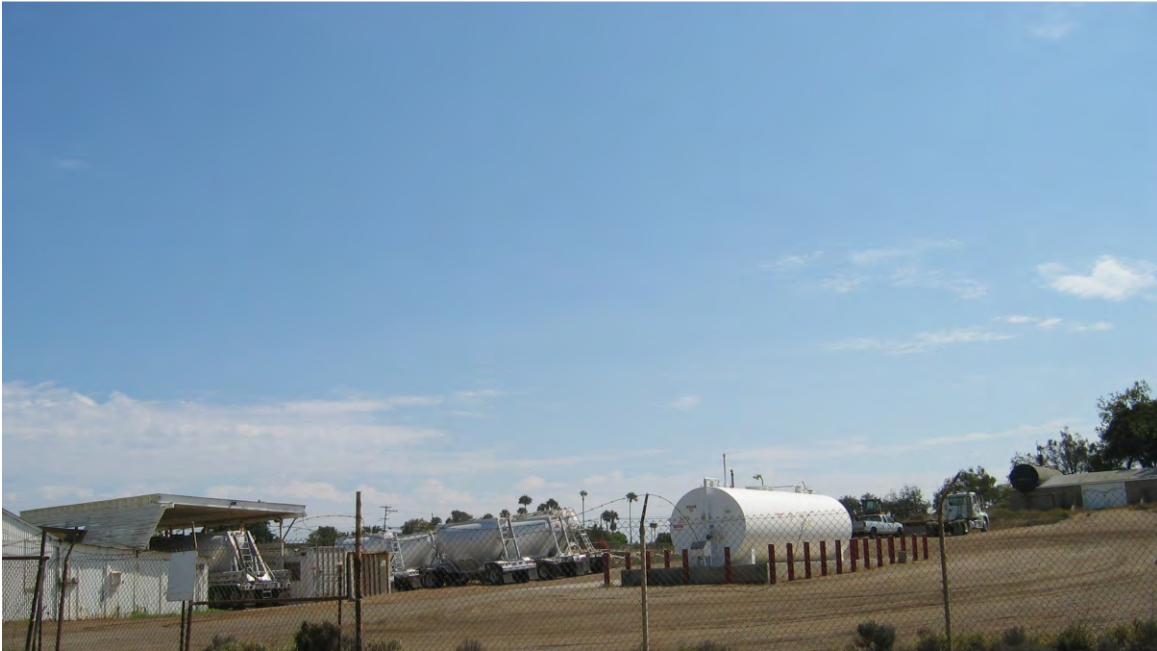
PHOTOGRAPH B-2

View of 10,000-gallon above ground fuel tank at South Bay Salt Works maintenance yard located on the east side of Bay Boulevard, accross from the entrance to the main facility

Our site reconnaissance started at ARCO Service Station at 800 Palomar Street (EDR Map ID Nos. 36 - 41) which is currently active, and proceeded west along Palomar Street to Bay Boulevard. We then continued along Bay Boulevard which is bounded to the south by the South Bay Salt Works (EDR Map ID Nos. C4, B5, B15, and B17). The South Bay Salt Works facility also includes a maintenance yard located on the east side of Bay Boulevard, across from the main entrance to the facility. A 10,000-gallon above ground fuel tank was observed at the maintenance yard.

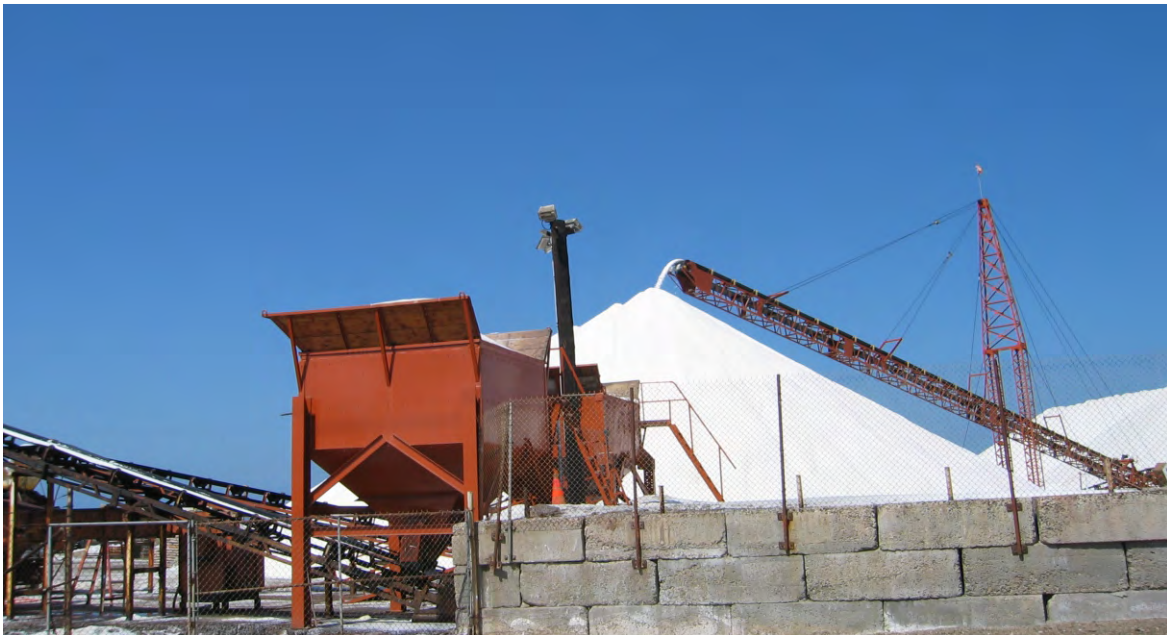
View of salt processing at South Bay Salt Works from Bay Boulevard

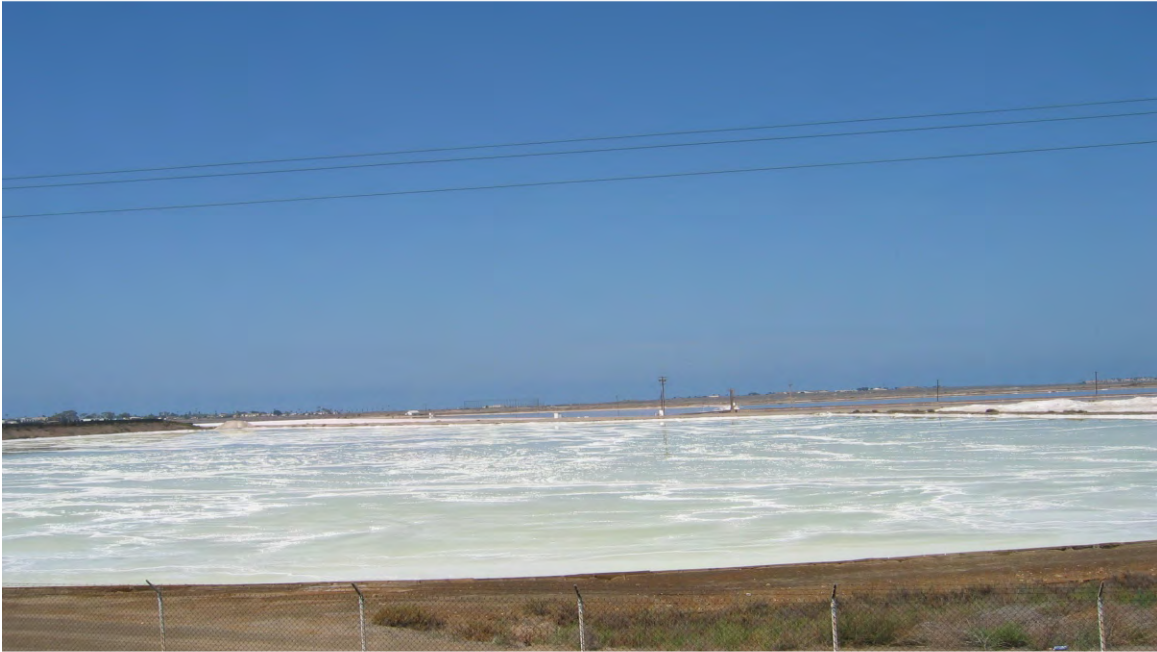
View of salt pond from West Frontage Road looking west

It must be noted, however, that under certain atmospheric conditions, there may be a potential health hazard from airborne particles originating from the salt ponds. The degree of public health risk is dependent on the type, frequency and duration of exposure and can therefore be anticipated to be low to very low for people who infrequently or only occasionally use the bikeway.

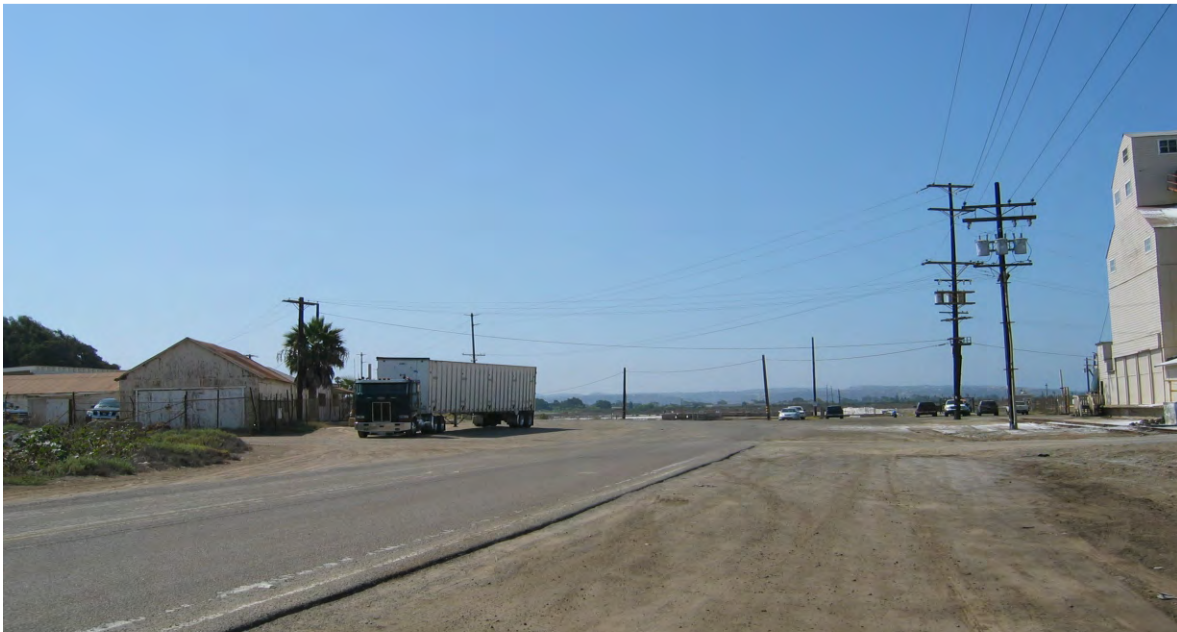
View of Bay Boulevard looking south. South Bay Salt Works main facility entrance is visible on the right, and the maintenance yard is on the left.
